Twelvemile Creek Basin Assessment and Restoration Prioritization

A Tributary of the Middle Fork Coquille River

Coquille Watershed Association

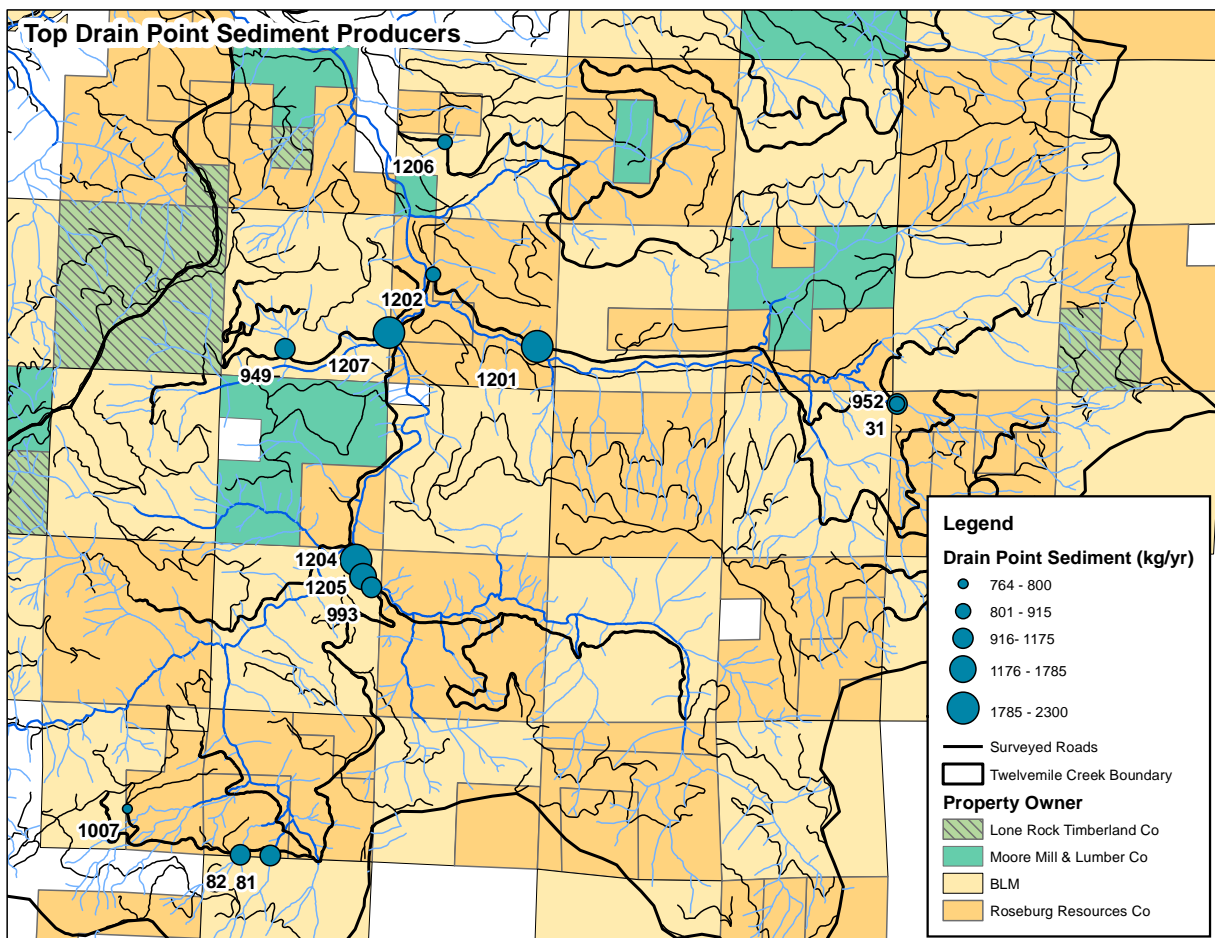
Figure 11. Locations of top sediment delivering drain points and gullies of the Twelvemile Creek GRAIP survey.

The GRAIP model identified 271 drain points that produced and delivered sediment to Twelvemile Creek and 13 gullies that produced and delivered sediment to Twelvemile Creek. The top seven delivering drain points and the top six delivering gullies are identified as high priority candidates for road improvements, Table 1 and Figure 11.

The top four sediment producing points are gullies. Currently Gully 1207 is inactive as the road is in poor shape and impassable further up the road. The road acts like a sump for all of the water and sediment draining off the steep road and if the road were to be re-opened the gully would become active and contribute high quantities of sediment to the creek if it was not addressed, Figure 16. Gully 1204 is on the outlet of a ditch relief culvert (DRC) that drains a long steep section of road (road 54, below). The ditch of road 54 is eroded and flows through a DRC, creates a gully on the outlet of the DRC and discharges directly into Dice Creek, Figure 17. The third largest sediment deliverer, Gully 1201, is another gully on the outlet of the DRC draining a road segment. There is an increased amount of water in the ditch being drained by the DRC due to a wet swale that has been diverted into the ditch. The gully drains down the hillslope while gullying on and off until it discharges directly into Boulder Creek. Gully 1205 is just uphill of road segment 54 and Gully 1204. A wet swale is diverted into the ditch and drains through a DRC into a sump like area. The outlet of the sump area is highly gullied, due to the steep hillside, and discharges straight into Dice Creek.

Stream crossing 952 and broad based dip 31 are located on the same section of road. The broad based dip is at the intersection of the road with the stream crossing. The western section of road diverts some of the water from a ditch onto the road and then into the stream. In addition, the ditch intercepts a wet swale sending some of the water and sediment laden ditch water into the upstream side of the stream crossing. Compounding these issues is the long steep eastern section of road (RD 244, below) that drains to both the stream crossing and the broad based dip, this section of road lacks any cross drains. Broad based dips 81 and 82 are near each other and share similar features. Both of these broad based dips occur at stream crossings and drain long steep sections of road that concentrate water on the road bed and drain directly into streams. Stream crossing 993 serves as a ditch relief culvert that drains a very steep section of road that intercepts multiple small seasonal streams or wet swales along the length of the ditch. This drain point produces lots of sediment due to the increased water flowing in the steep ditch and the erosion on the outlet of the culvert caused by excess water flowing over the steep hillside. Stream crossing 949 is washing out the road significantly and contributing lots of sediment directly to the stream, Figure 18.

Gully 1202 is on the outlet of a ditch relief culvert whose ditch drains a steep eroded section of road. Additionally, this ditch drains water from the road above it in a cascading fashion, this has increased the amount of water in this drain point causing gullying that drains directly into Twelvemile Creek. Gully 1206 occurs on the inside corner of a tight bend in the road that is also a stream crossing. The water drains in a concentrated fashion down a steep eroded section of road. A gully occurs in the road crossing fill where the concentrated flow path leaves the road and drains directly into a small seasonal stream, Figure 19. Stream crossing 1007 is on a section of hillside that has slumped many times. The current road is impassable and flow sometimes overtops the slumped road washing sediment into the stream crossing. This location would be an ideal road segment to decommission as it services a young timber stand and the far side of the stream crossing can be accessed from a different route.

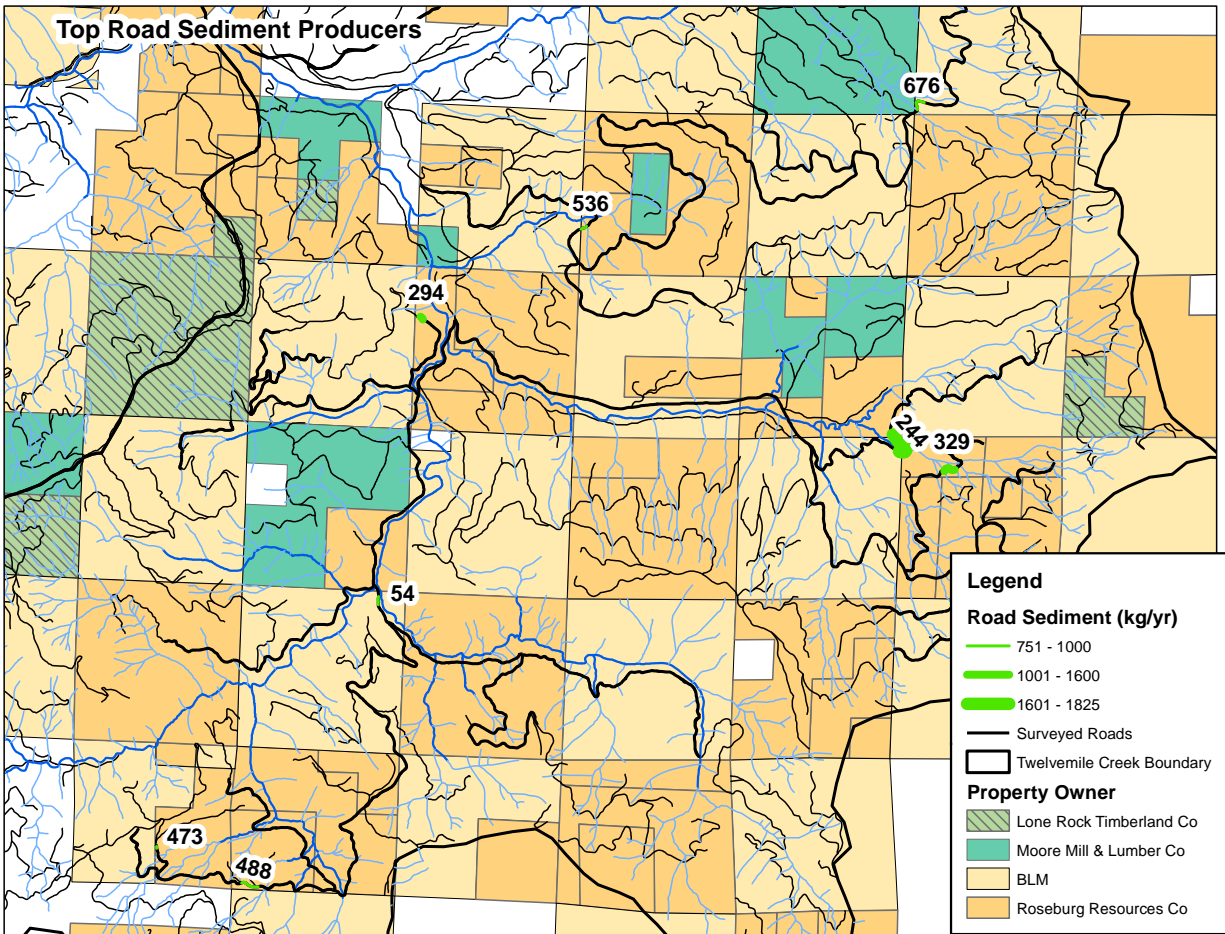
Figure 12. Top sediment delivering road segments of the Twelvemile Creek GRAIP survey.

The GRAIP survey and analysis identified 338 segments of road whose drain flow paths connect to the stream network and deliver sediment. Of those the top eight have been identified as candidates for road improvements, Table 2 and Figure 12.

The top sediment producing road, Road 244, drains to the stream crossing 952 and broad based dip 31 discussed above. This road is long and steep and the water flows down the road in a concentrated path eroding the road bed and depositing the water and sediment into the creek. The road segment 294 is a short steep section of road that is highly gullied and almost impassable, Figure 20. Another long steep road with few cross drains is road segment 329, this road section is delivering sediment from road surface run off and delivering it directly to the stream via the ditch. Road 536 contributes sediment to the stream network in two major ways. A good portion of the road drains in a concentrated flow path on the road surface eroding the road, this flow path then enters the ditch and erodes the ditch adding further sediment to the ditch water. The ditch then flows directly into a small stream. The road segment 488 is associated with the broad based dip 82, discussed above, and is a long steep section of road that has erosion in both the road bed and the ditch. All road sediment from road 488 drains directly into the stream crossing at its base. Road 54 is associated with gully 1204, discussed above, this segment of road is steep and the ditch is eroded and delivering the sediment laden water directly into the stream. Another long, steep road segment, Road 676, with few DRCs delivers all of the road sediment directly into the stream via a broad based dip and ditch. Lastly, the ditch flow path of

road 473 drains directly into the stream system and further erodes the road bed where the road has slumped at stream crossing 1007.

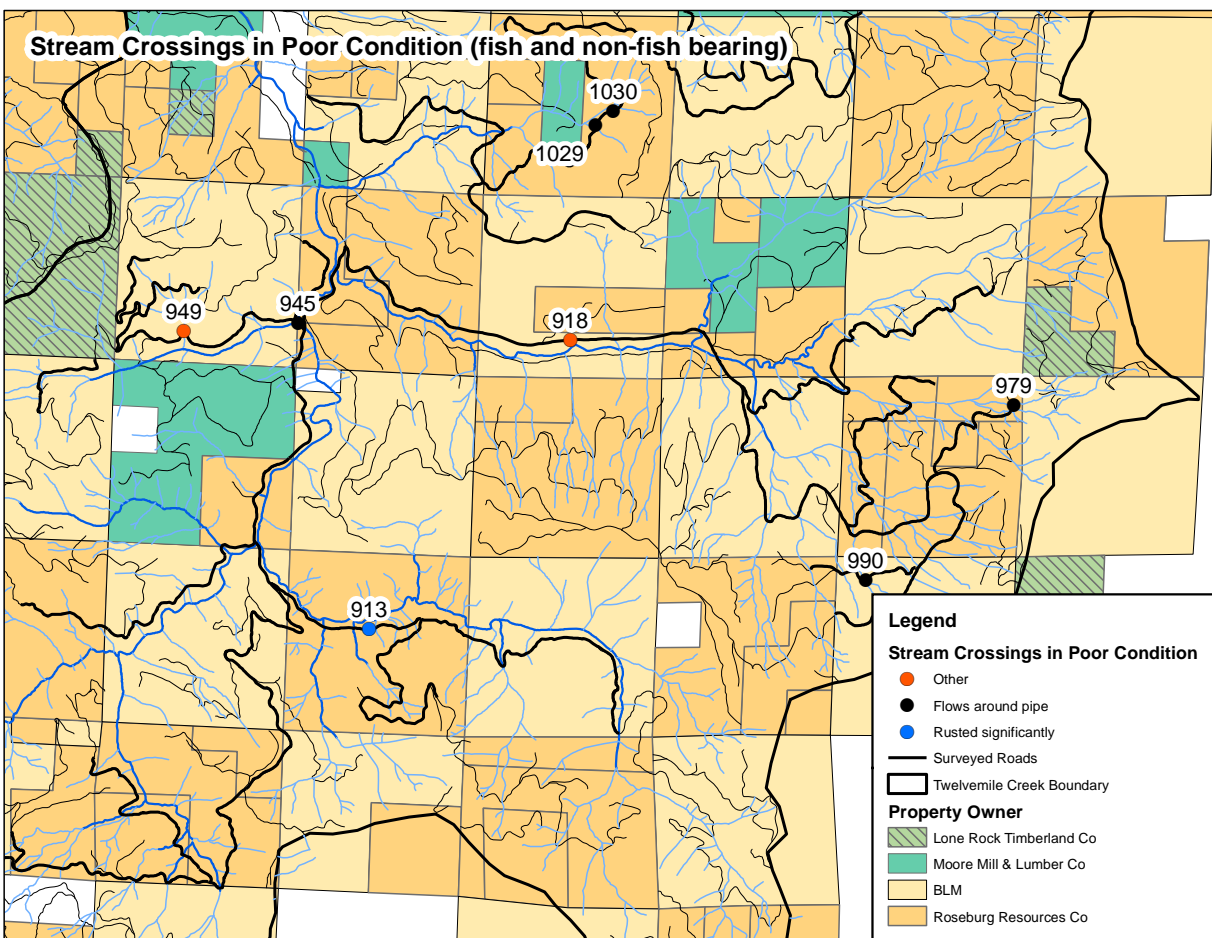
Figure 13. Locations of the 7 stream crossings in poorest condition as identified in the Twelvemile Creek GRAIP survey.

The GRAIP surveys have also identified 81 stream crossings in poor condition. These stream crossings are a combination of fish-bearing, perennial and seasonal streams. The condition of the stream crossing ranges from rusted significantly to partially blocked to flows around pipe with flows around pipe being the most severe condition. There is the greatest chance of mass wasting and stream crossing failure when the stream flows around the pipe; therefore, all identified stream crossings where the stream flows around the pipe are listed below, Table 3 and Figure 13.

Stream crossing 913 is a small seasonal stream whose culvert is extremely rusted and has the potential of failing therefore is listed as requiring repair. Although the actual stream crossing at location 918 is in good condition, the small seasonal stream has been diverted from its channel

into the road ditch for 75m before it crosses the road at location 918. Additionally, more sediment is added to the stream network because the channel is incised downstream of the crossing due to the added ditch water draining to this point and the stream diversion has caused erosion in the flow path of the ditch. Stream crossing 945 is the only fish bearing culvert listed in Table 3. This culvert was first identified during an ODFW AQI survey in 2018 (ODFW, 2018) and further identified during the GRAIP surveys. The culvert is rusted significantly and water is flowing underneath the culvert creating a fish barrier. Stream crossing 949 is on a section of road that has been washed out, therefore every storm event the stream is contributing more road sediment (from the washed out road) to the stream network. Stream crossing 979 is at a known mass-wasting site where a large slide upstream occurred and a debris torrent traveled down the stream bed and washed out the stream crossing at this location. Since this site is already known and with the hazardous nature of this site the mass-wasting event was not surveyed.

Stream crossing 990 is a seasonal stream whose culvert is rusted and causing water to flow around the culvert. The road over this stream crossing is still in good condition and does not appear to be failing, but there is the possibility of failure at a future date due to water flowing around the culvert through road material. Stream crossing 1029 is rusted significantly and the stream water is flowing below the pipe. In addition to the potential of failure at this stream crossing a lot of fine road sediment is draining straight into the stream crossing. At stream crossing 1030 there are 2 road sections that are slumping, it is uncertain if it was the stream flowing around the pipe that caused the road to become saturated and slump or if the slump occurred and caused the stream to flow around the pipe, Figure 21. At this point there is not a lot of sediment added to the stream network from the slumping but it has the potential to completely fail and send a large pulse of sediment into the network.

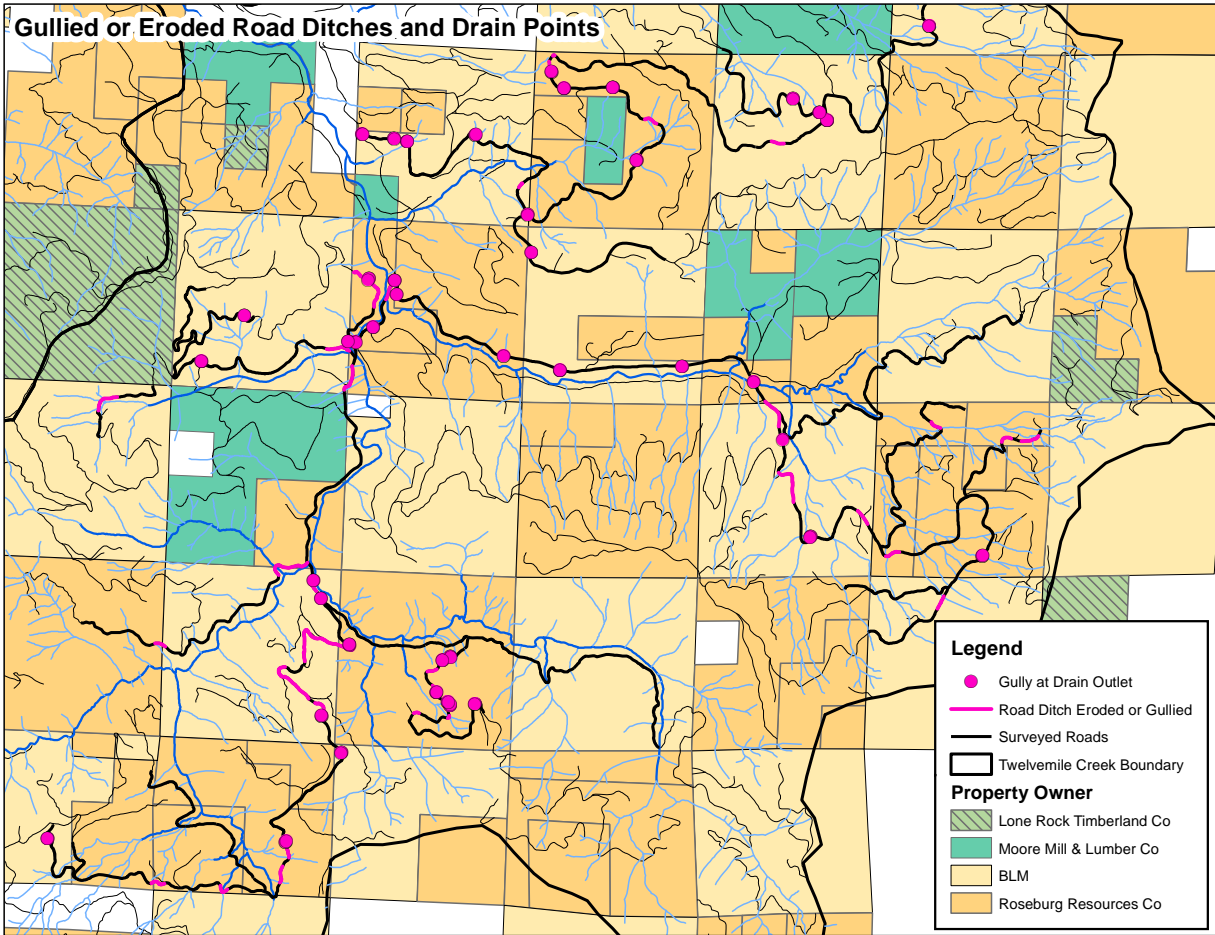
Figure 14. Gullied or eroded drain points and road ditches or flow paths identified in the GRAIP surveys of Twelvemile Creek.

An indication of a drain point or road segment that is draining too much water is the formation of a gully. When the hillslope or road beds are steeper gullies will form more easily from smaller quantities of water than when the grade is gentler. A map of gully locations occurring on the outlet of drain points and where flow paths (e.g., ditches) have been gullied or eroded identifies stretches of road that would benefit from more cross drains, Figure 14. Even though some of these gullies don't connect to streams they are still moving road material from the road prism onto the hillslope requiring costly maintenance more frequently. Some of these road segments have been identified in the above analysis as benefiting from more cross drains, such as Roads 54, 294, 488 and 536.

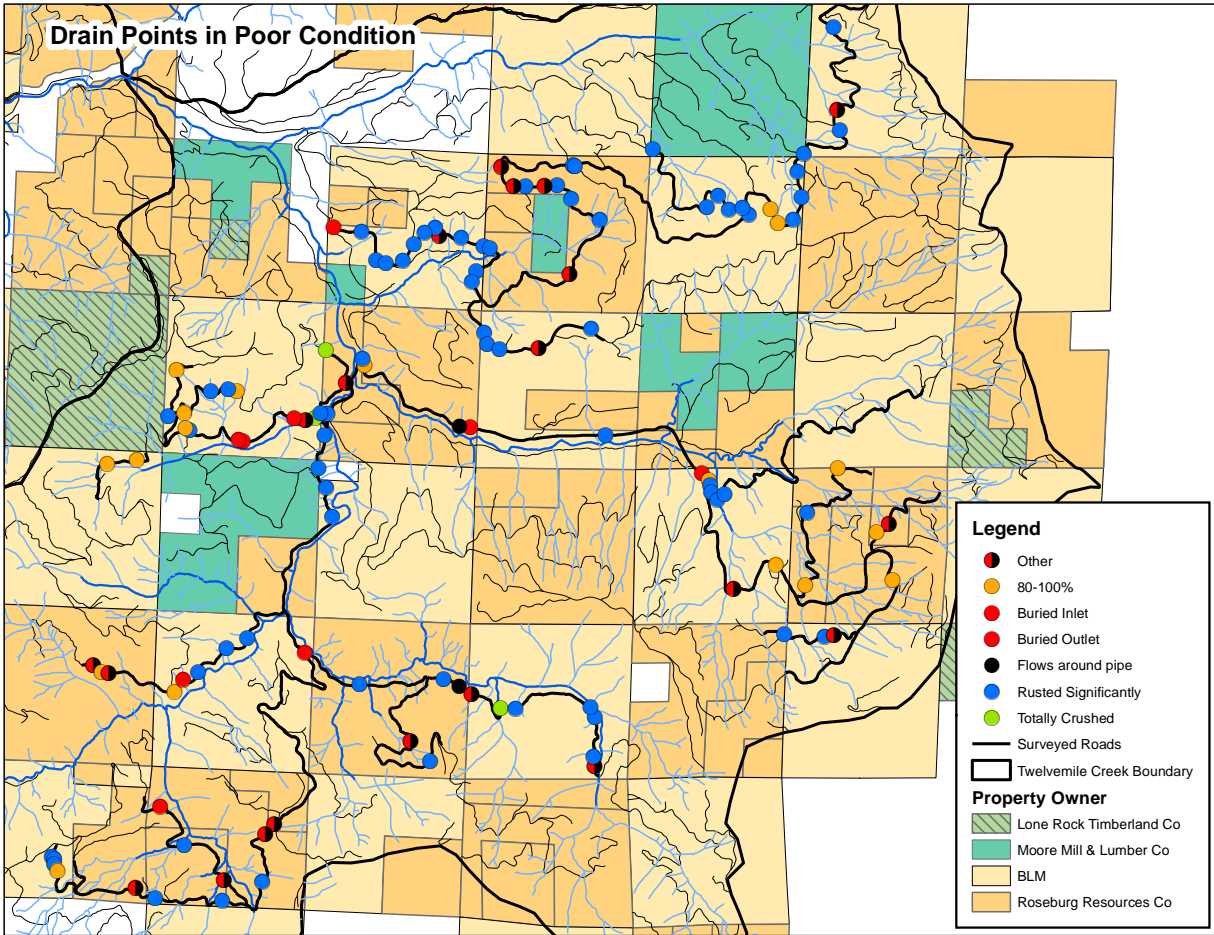
Figure 15. All drain points identified in the Twelvemile Creek GRAIP survey that are in poor condition.

In addition, many of the drain points that were surveyed were in poor condition, Figure 15. There is a range of how poor the drain point is from being 20-80% blocked all the way to being totally crushed. A list of drain points in poor condition will be provided to all land managers to aid in maintenance.
