4. SHADOW MODELING

4.1. DATA ACQUIRED FOR EVALUATIONS OF STREAM SHADING

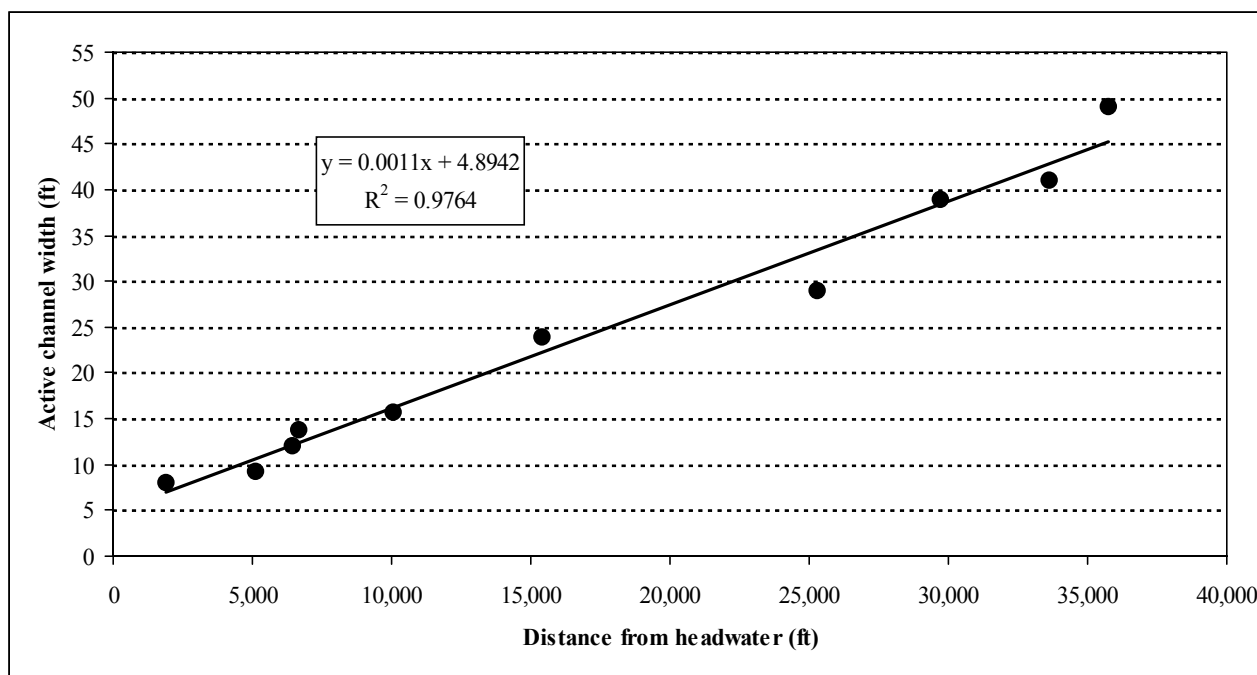
Figure 10. Active (bankfull) channel width versus distance from headwater for 10 channel segments on tributaries to the lower South Fork Coquille River, Oregon.

As indicated, channel widths for tributary reaches within the study area were either measured in the field or predicted. Predicted values were derived through the use of a relationship developed by regressing channel width versus distance from headwater (per 7.5 minute USGS topographic maps) for the 10 tributary reaches that were measured (Figure 10). For each unmeasured reach, active channel width was predicted as $4.8942 + (0.0011)(\text{distance [in feet] from the tributary's headwater})$. Active channel widths incorporated into the SHADOW database for the 87 tributary reaches varied from 6 to 49 feet.

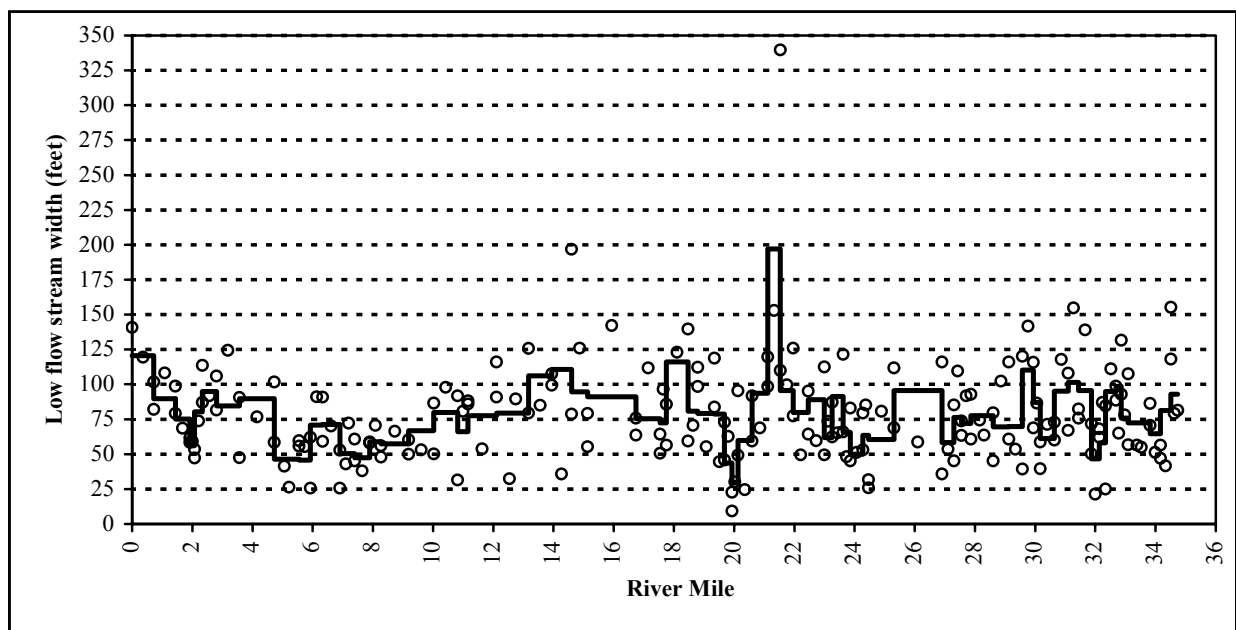
Figure 11. Low-flow width versus River Mile, lower South Fork Coquille River, Oregon, September 2001. Open circles represent individual width measurements and the bold black line depicts variation in mean width among 67 channel segments delineated during the study.

Low-flow Stream Width (Feet). Low-flow widths were measured by project staff within each of the channel segments delineated along the mainstem South Fork, measured in seven tributary reaches for which information on active channel width was also available, and estimated for the remaining tributary reaches. Low-flow widths entered into the SHADOW database for segments of the South Fork were the means of values measured during September 2001 at the same 3-4 evenly spaced cross-sections per segment that were measured for active channel width. The pattern of variation in low flow width along the length of the lower South Fork and among the mainstem channel segments is shown in Figure 11. The mean low-flow width of the segments ranged from 30 to 197 feet and in multiple instances differed substantially between adjacent segments.

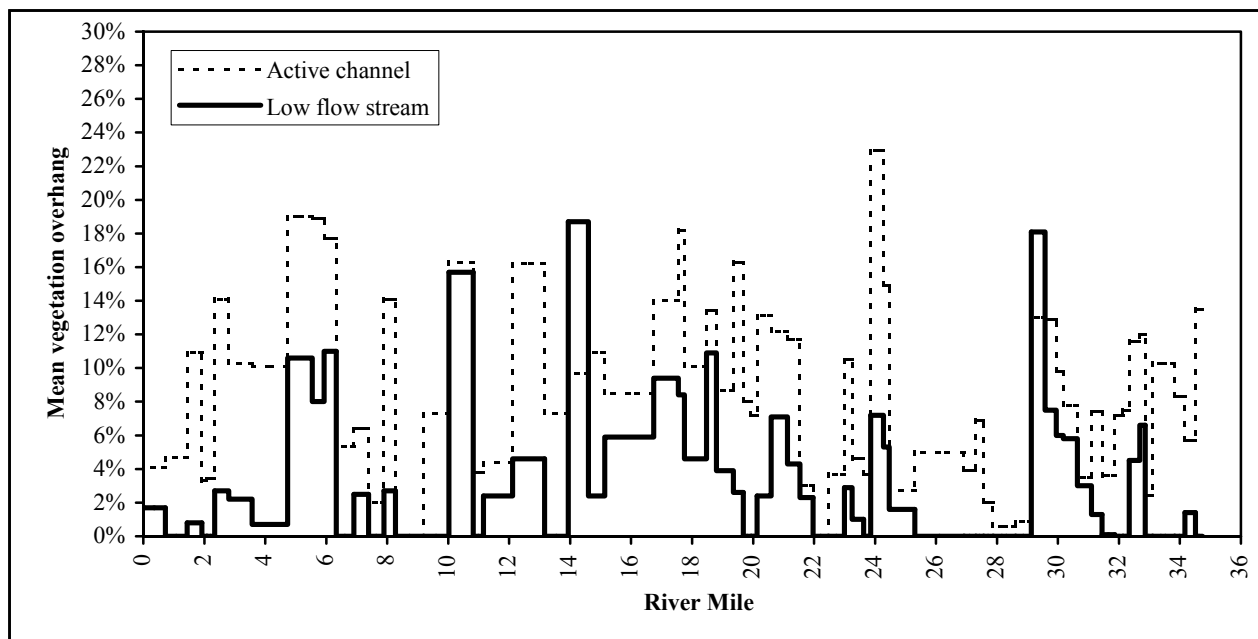
Figure 12. Longitudinal variation in the percentage of active channel width and of low-flow (wetted) stream width overhung by riparian vegetation, lower South Fork Coquille River, September 2001. Values shown are means for each of 67 study segments of the river.

Percent Tree Overhang (Decimal Percent). The percent of active channel width and of low-flow stream width overhung by riparian vegetation were measured at the multiple cross-sections examined within each study segment of the mainstem South Fork during September 2001. Segment-specific means for percent vegetative overhang varied considerably along the lower river (Figure 12), ranging from 0 to 23% (average = 9%) for the channel and 0 to 19% (average = 3%) for the wetted stream. The values for vegetation overhanging the wetted stream were incorporated into the SHADOW database as “Percent tree overhang” because they were more strongly related to levels of stream shading observed in the field.

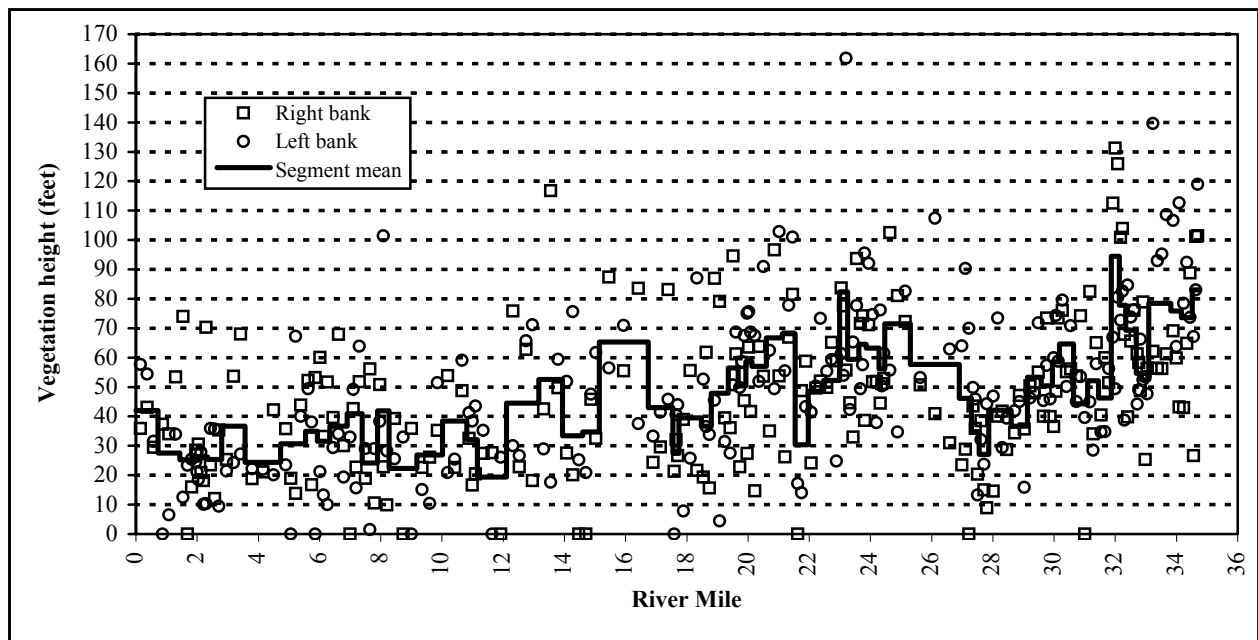
Figure 13. Longitudinal variation in the height of dominant, shade-producing riparian vegetation, lower South Fork Coquille River, September 2001. The bold line gives mean values for each of 67 study segments of the river.

Tree Height (Feet). Existing condition values used for this SHADOW parameter were based on direct measurements of the height of vegetation along the mainstem South Fork and on air photo interpretations plus limited field-checks of conditions for stream reaches in the tributary watersheds. On the South Fork, we measured the heights of the primary shade-producing vegetation at the bank ends of the multiple cross-sections examined within each study segment. These heights varied both within and among segments (Figure 13), with segment-specific mean heights ranging from 19 to 94 feet. A high level of variation found within individual mainstem segments often reflected patterns of riparian disturbance and caused us to use the 75th percentile height measured along each segment of channel or riverbank as a best approximation of the dominant “tree height”. This approach was used so that unusually tall or short vegetation would not skew estimates of the height of dominant vegetation and allowed us to use the “shade density” parameter in SHADOW to account for measured variability in the height of shade-producing vegetation bordering individual channel segments (described later).

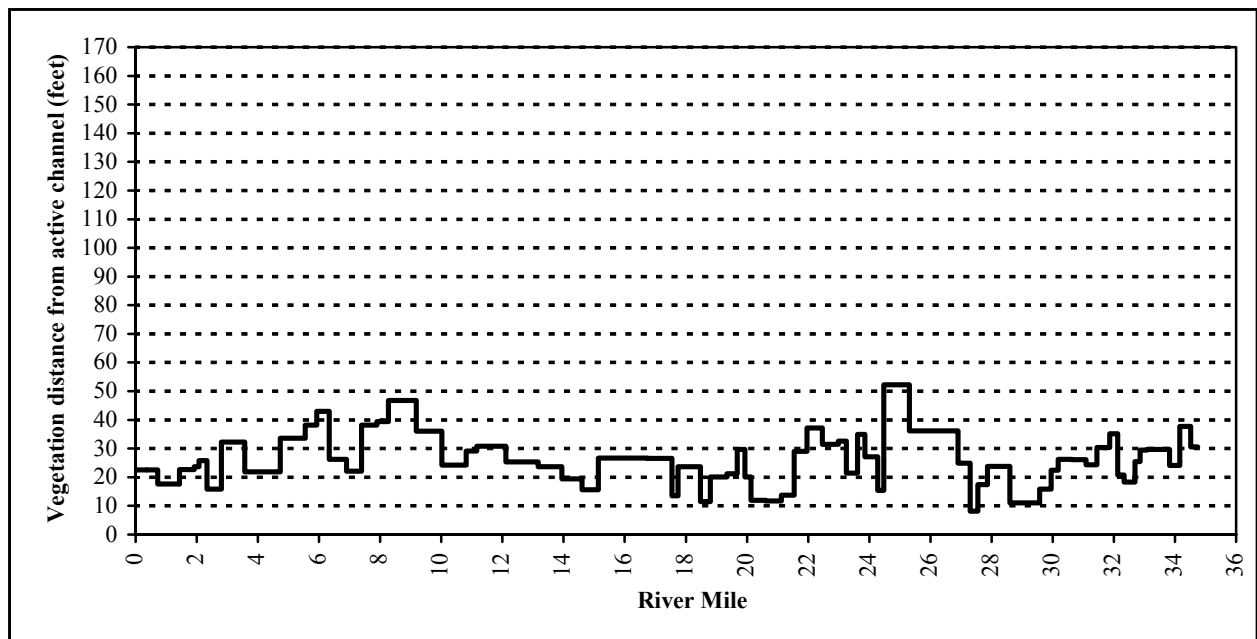
Figure 14. Longitudinal variation in the distance between the primary shade-producing vegetation and the active (bankfull) channel, lower South Fork Coquille River, September 2001. Values shown are means for each of 67 study segments of the river.

Tree to Channel Distance (Feet). Channel offsets for primary shade-producing vegetation were measured at the bank ends of multiple equally spaced cross-sectional transects within each study segment of the mainstem South Fork and within each of the five intensively measured tributary reaches in the Dement Creek watershed. Mean values of these measured “tree to channel” distances were entered directly into the SHADOW database. Mean offset distances measured within study segments of the South Fork ranged from 8 to 52 feet (Figure 14), while those for the measured tributary reaches varied from 3 to 13 feet. Lacking better data, the following tree to channel distances were assumed for unmeasured tributary reaches: 4 feet for first-order channels, 5 feet for second-order channels, and 10 feet for third order channels. These values were based on those found at the measured tributary reaches and fall within ranges suggested as appropriate in the user’s manual for the SHADOW model (USFS 1993).

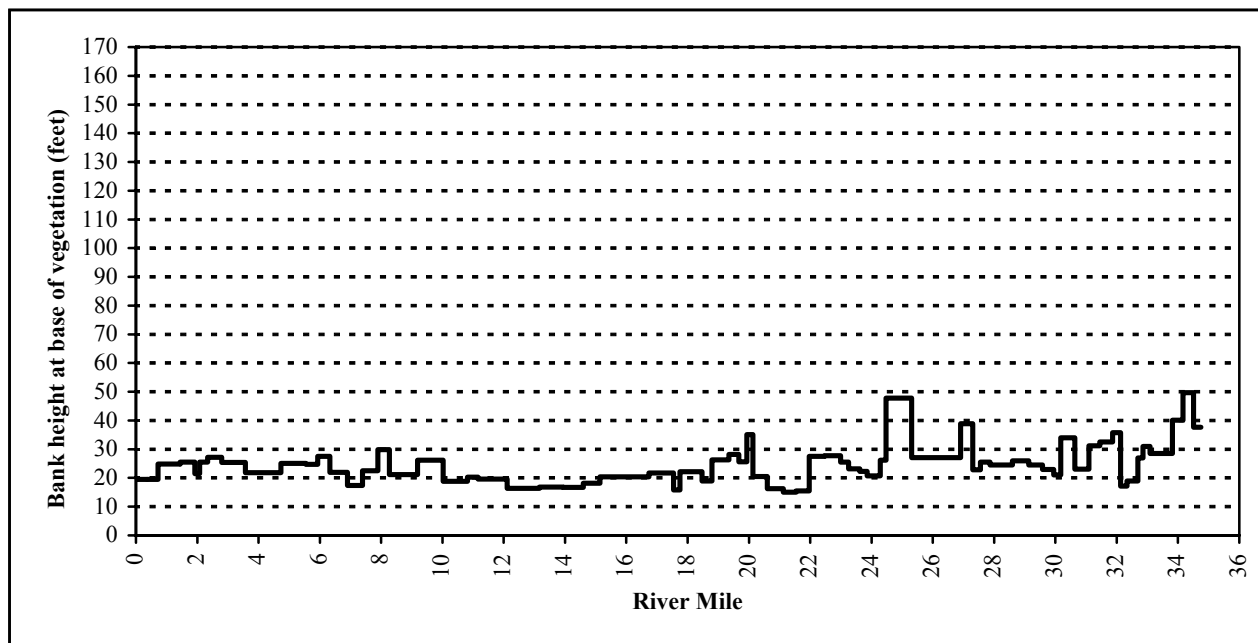
Figure 15. Longitudinal variation in bank height (relative to the low-flow water surface) at the base of primary shade-producing vegetation, lower South Fork Coquille River, September 2001. Values shown are means for each of 67 study segments of the river.

Tree to Channel Slope (Decimal Percent). Mean tree to channel slope was calculated from field measurements taken at the multiple cross-sections examined within each study segment on the mainstem and within each of the five intensively evaluated reaches in the Dement Creek watershed. Each calculated slope positioned shade-producing vegetation the appropriate height above the low flow water surface (Figure 15).

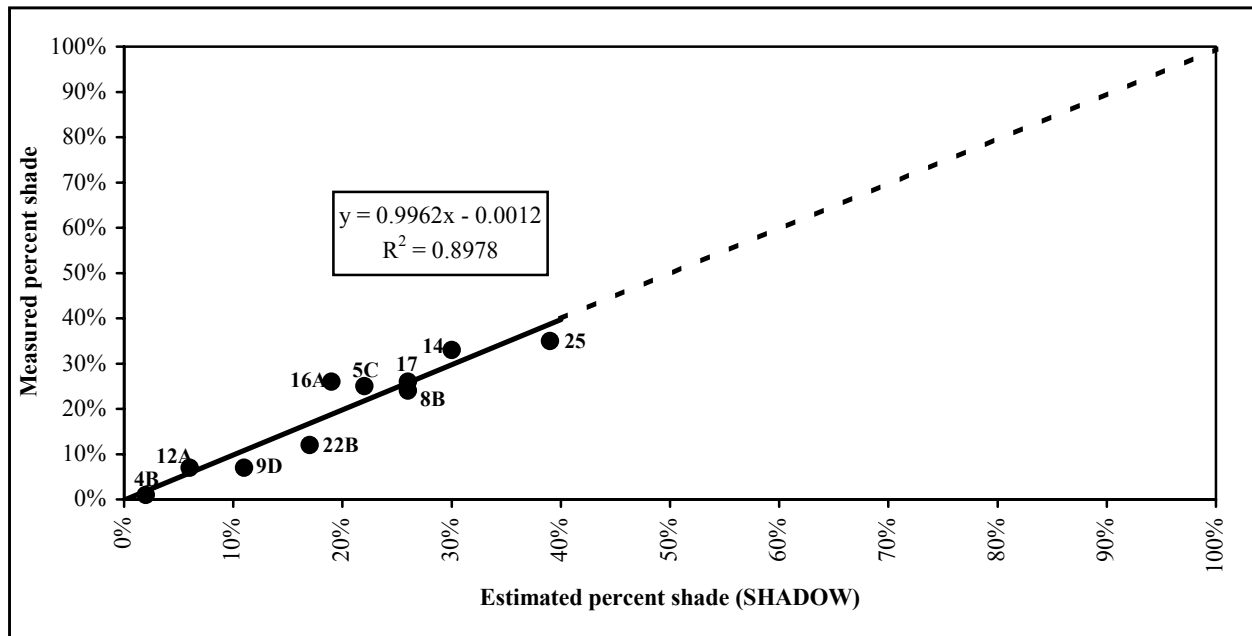
Figure 16. Unadjusted SHADOW (model) estimates of percent shade versus measured values for 10 sub-reaches of the lower South Fork Coquille R., Summer 2001.

The calibration effort showed that our initial SHADOW modeling provided predictions of stream shade levels that were biased toward a slight (<2 percent) over-estimation of the shade actually measured in the sampled channel segments (see Appendix Table J1). Regression-based equations developed to adjust (calibrate) raw output from the SHADOW model to account for small apparent biases in our initial shade estimates are given in Figures 16 and 17. Figure 16 gives the equation we used to adjust raw SHADOW-based estimates of percent shade for sub-reaches of the mainstem and shows how well it fits our calibration data for the 10 mainstem sub-

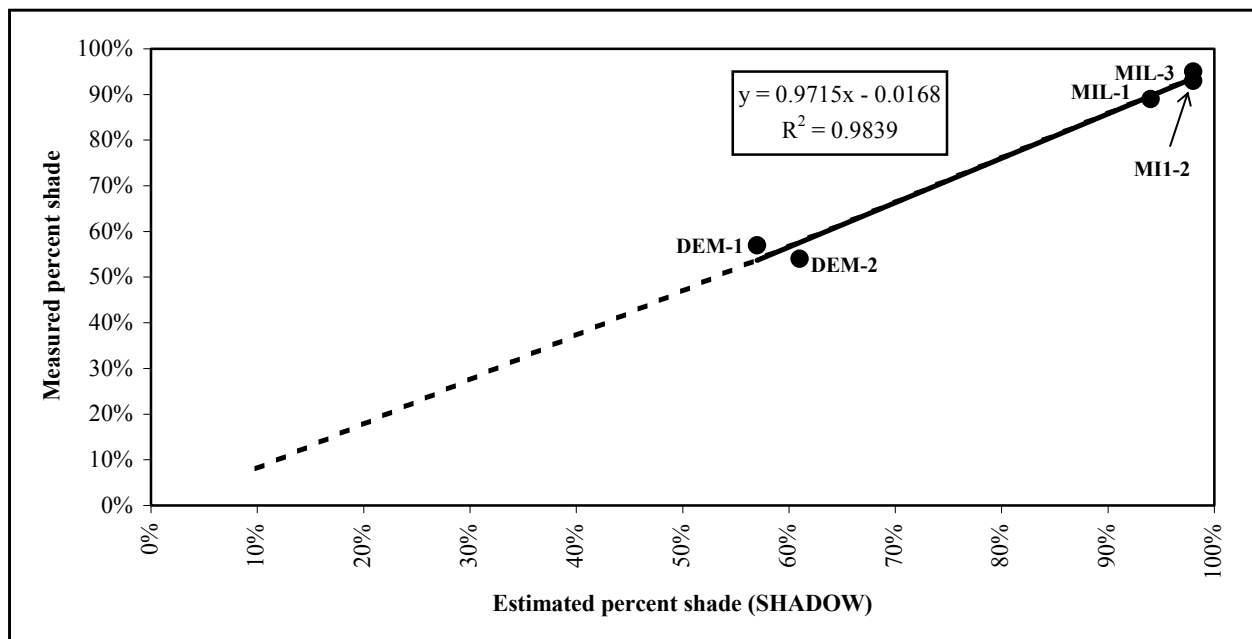
Figure 17. Unadjusted SHADOW (model) estimates of percent shade versus measured values for five reaches of tributaries to the lower South Fork Coquille R., Summer 2001.

reaches sampled. Figure 17 provides the equation used to adjust raw model-based estimates of percent shade for reaches in the tributary watersheds and indicates how well it fits our calibration data for the 5 tributary reaches sampled.

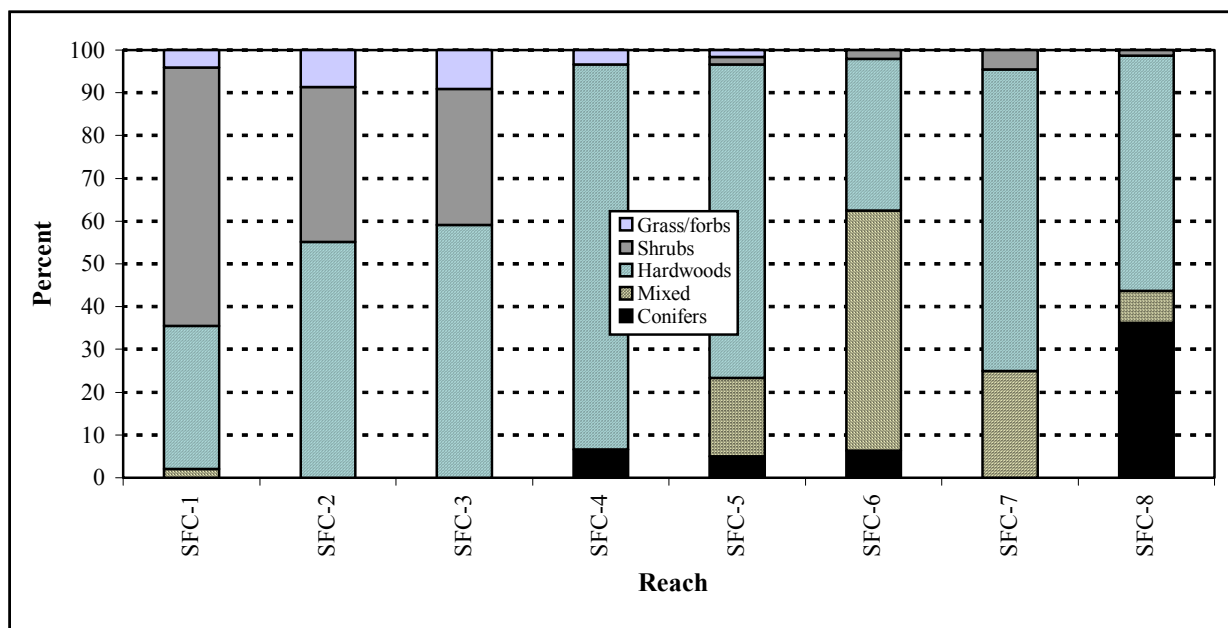
Figure 18. Percent of transect sites dominated by each of five classes of riparian vegetation, by reach, lower South Fork Coquille R., Summer 2001. See Appendix Table J6 for supporting data.

within the nearby North Fork Coquille River watershed. With the exception of the river reach surrounding Powers (SFC-7), riparian areas along the lower South Fork between the National Forest boundary and Rowland (i.e., in reaches SFC-6 and SFC-8) appear to have the potential for supporting mature stands of conifers or mixed tree stands strongly dominated by conifers. The Powers reach itself supports predominantly mixed tree stands strongly dominated by hardwoods, as does the river reach between Rowland and Gaylord (SFC-5). We consider mature stands of trees with something similar to the current balance of hardwoods and conifers to represent site potential vegetation along these two reaches. Riparian areas bordering the four study reaches of the South Fork below Gaylord (SFC-1 through SFC-4) are dominated by stands of hardwoods with very few conifers, wherever trees are present. Historical records (Benner 1991) combine with existing riparian communities in relatively least-disturbed areas suggest that these lower-most four reaches have the potential to support mature stands of mixed hardwoods that include Oregon ash, big-leaf maple, Oregon myrtle, red alder and pockets of black cottonwood.

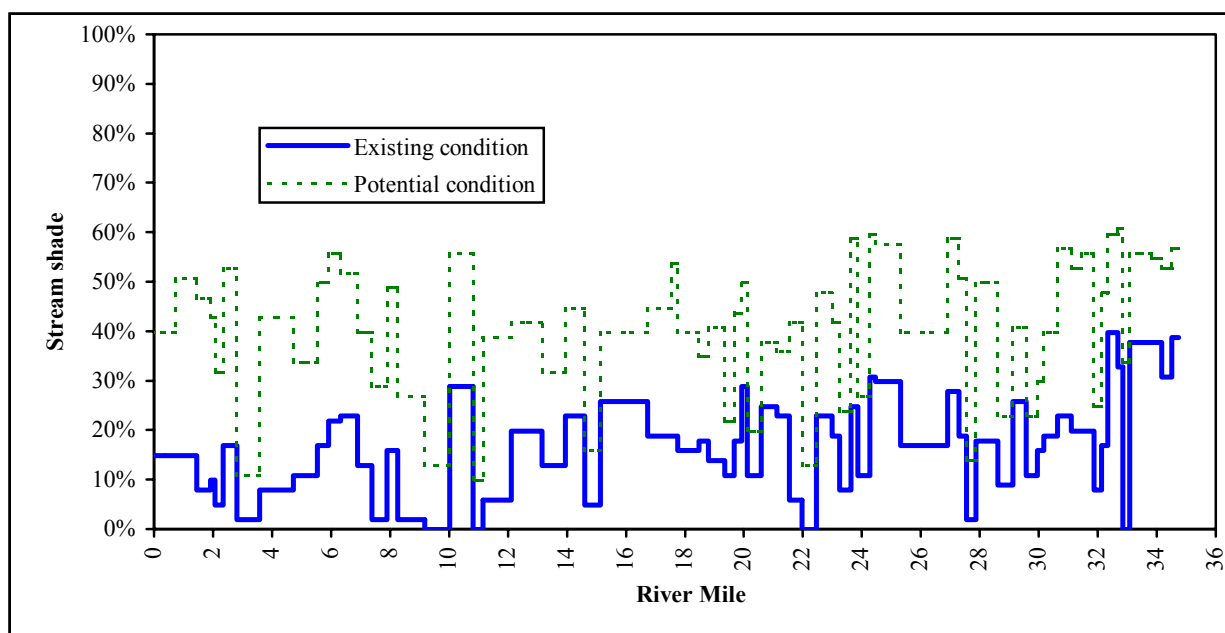
Figure 19. Estimated levels of existing and potential stream shade, versus River Mile, for the lower South Fork Coquille River, Oregon.

Results of our SHADOW modeling reflect that both existing and potential levels of stream shading vary considerably within the study area. For the mainstem South Fork, where both existing and potential shade levels were generally lower than those of the tributary streams, our model-based estimates ranged from 0 to 40% for existing shade and from 10% to 61% for potential shade (Figure 19). Estimates of the scope for improving shade conditions within individual modeled segments of the mainstem varied between 9% and 39%.

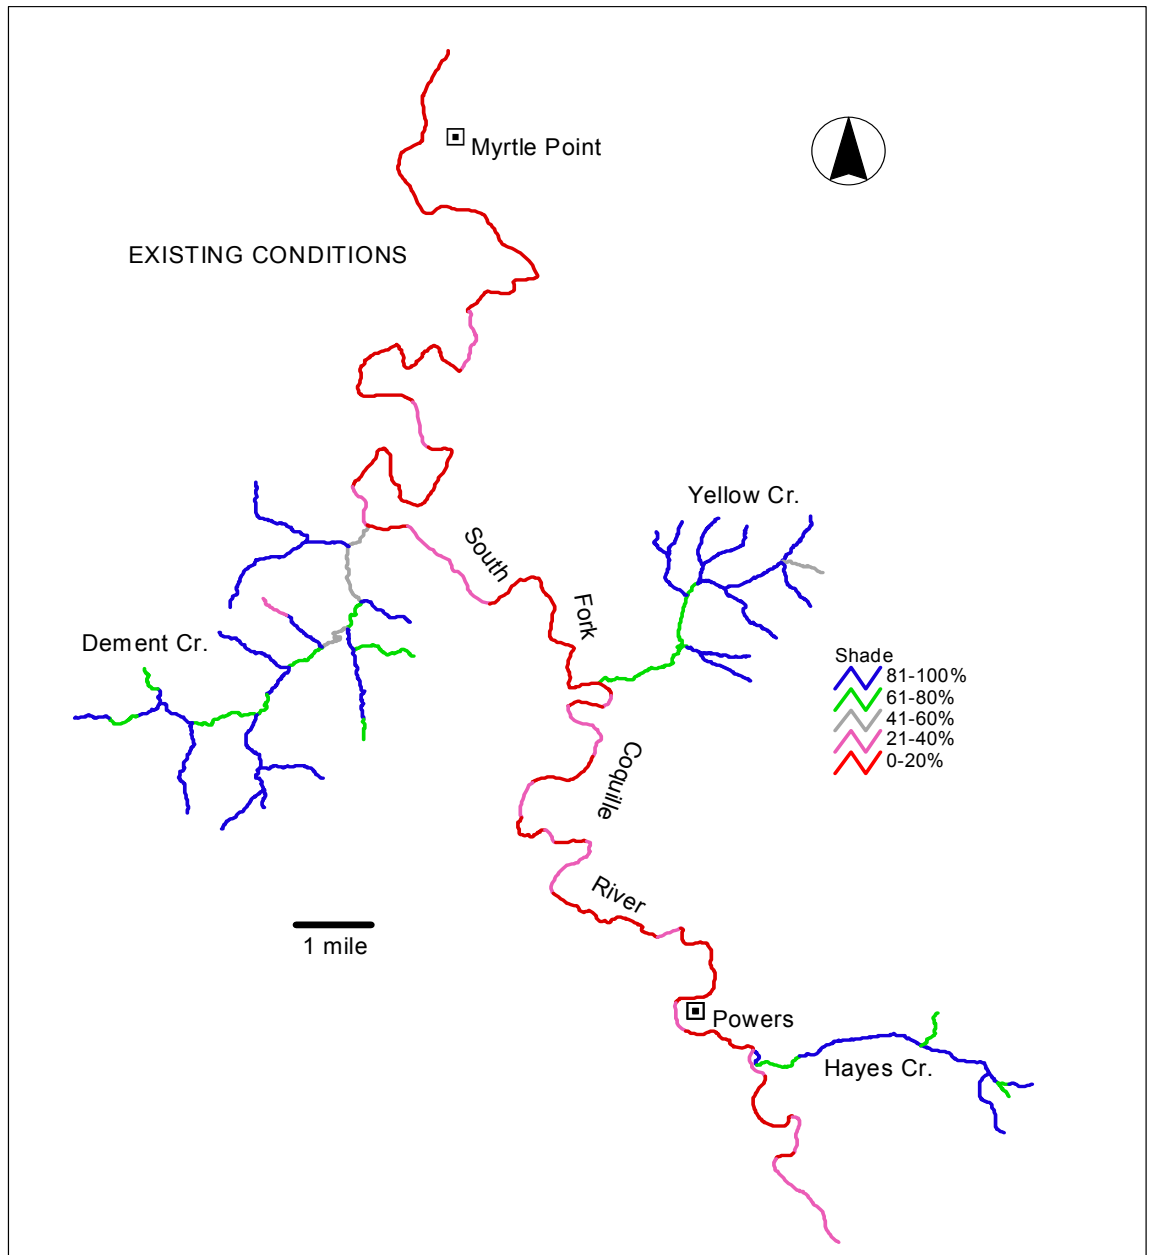
•
Figure 20. Spatial variation in existing stream shade within the lower South Fork study area.

Spatial patterns of variation in existing shade levels, potential shade levels, and scopes for improvement in shade levels within the study area are shown in Figures 20-22. Patterns evident in the figures include:

- Variable but low existing and potential shade levels along the mainstem South Fork.
- More variable but generally higher levels of existing shade along streams in the three tributary watersheds than along the mainstem. Estimated levels of existing shade varied from 22% to 95% among the 86 tributary reaches modeled.

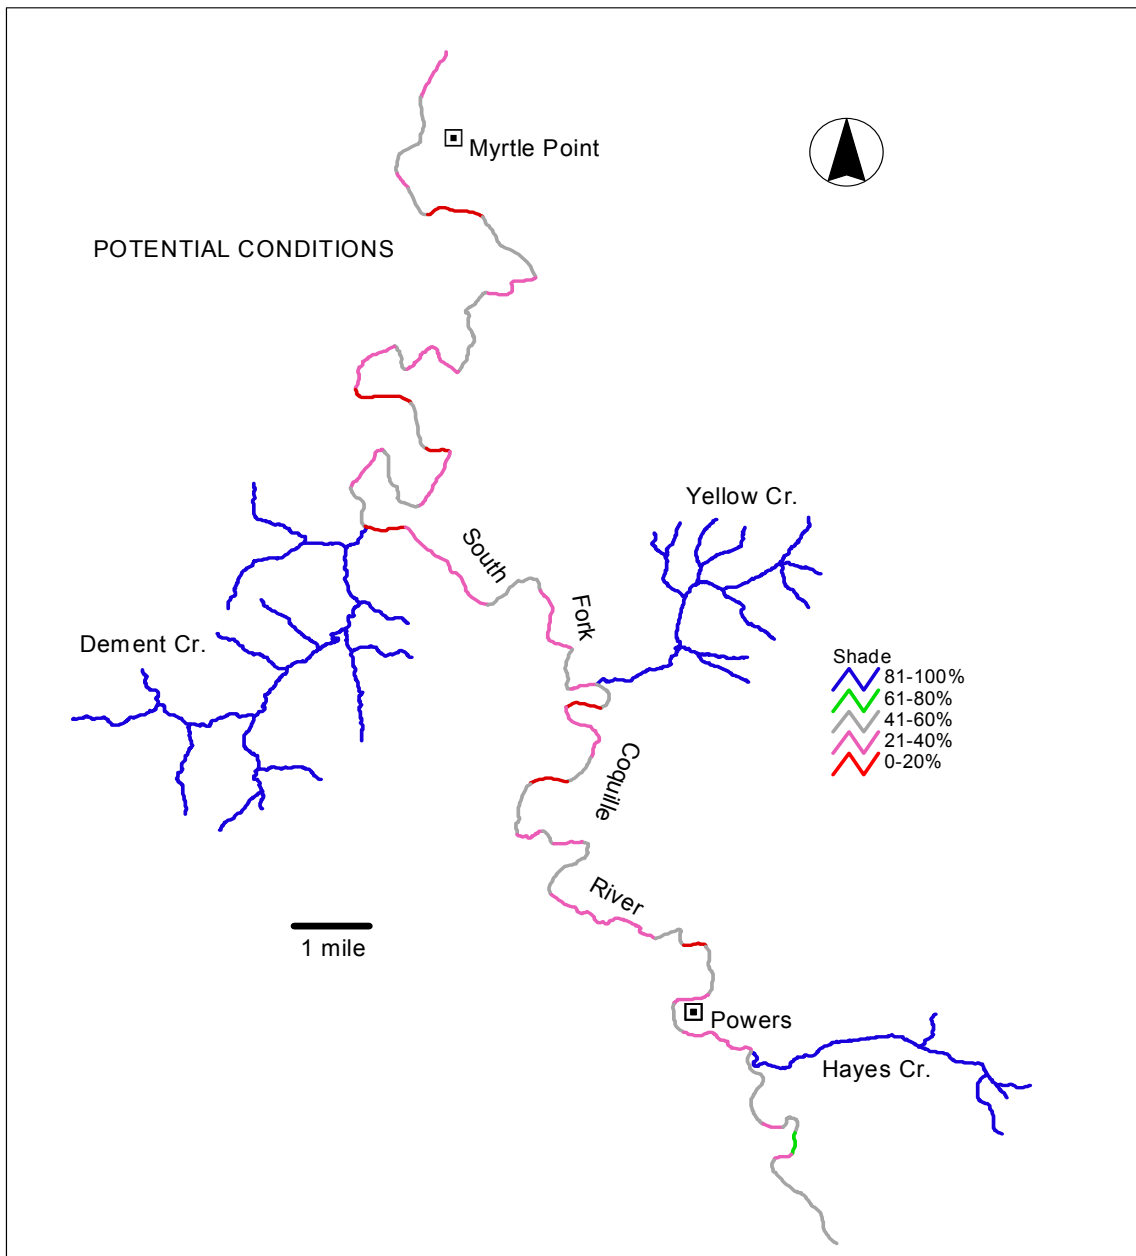
Figure 21. Spatial variation in stream shade potential within the lower South Fork study area.

- Consistently high shade potentials along all of the tributary streams. Estimated shade potentials varied from 86% to 95% among the 86 tributary reaches modeled.

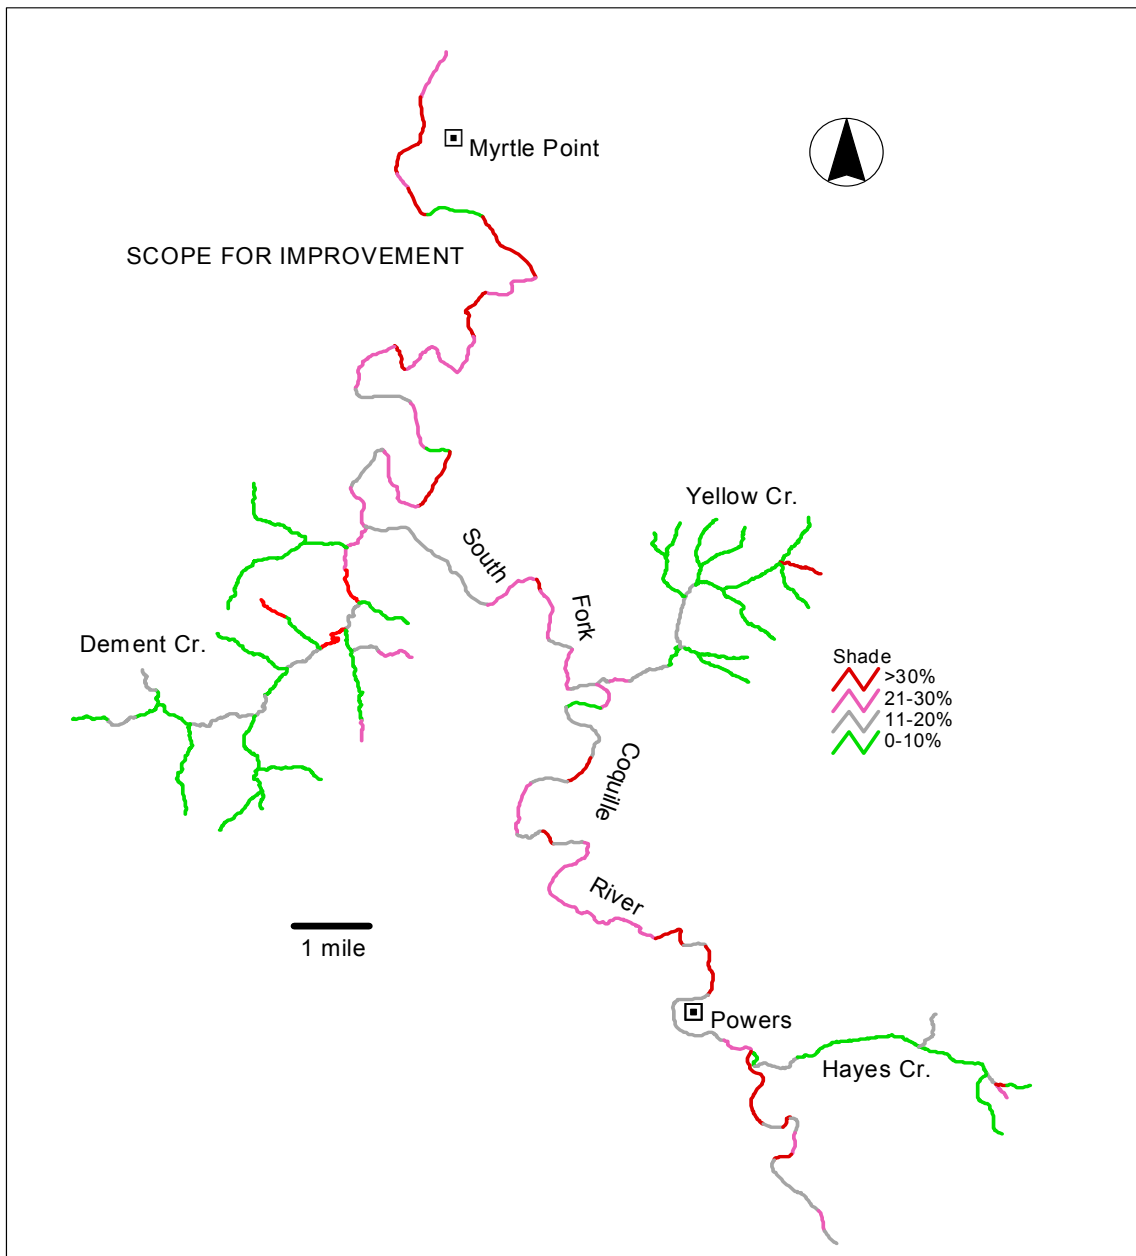
Figure 22. Spatial variation in scopes for improvement in stream shading within the lower South Fork study area.

- The presence of stream segments with significant scopes for improvement in shade conditions throughout most of the mainstem and at locations within each of the tributary watersheds. The greatest scope for improvement in the study area was an opportunity to increase stream shading by 73% along one of the modeled stream segments in a tributary system.

- The presence of more extensive opportunities for improving shade conditions in the Dement Creek system than in the other two tributary watersheds.
- The presence of multiple east-west trending segments of the lower South Fork that have very low shade potentials related to high natural exposure to mid-summer sun.
