South Fork Coquille Watershed Action Plan

Coquille Watershed Association

December 2, 2014

**Prepared by the South Fork Coquille Technical Advisory
Committee**

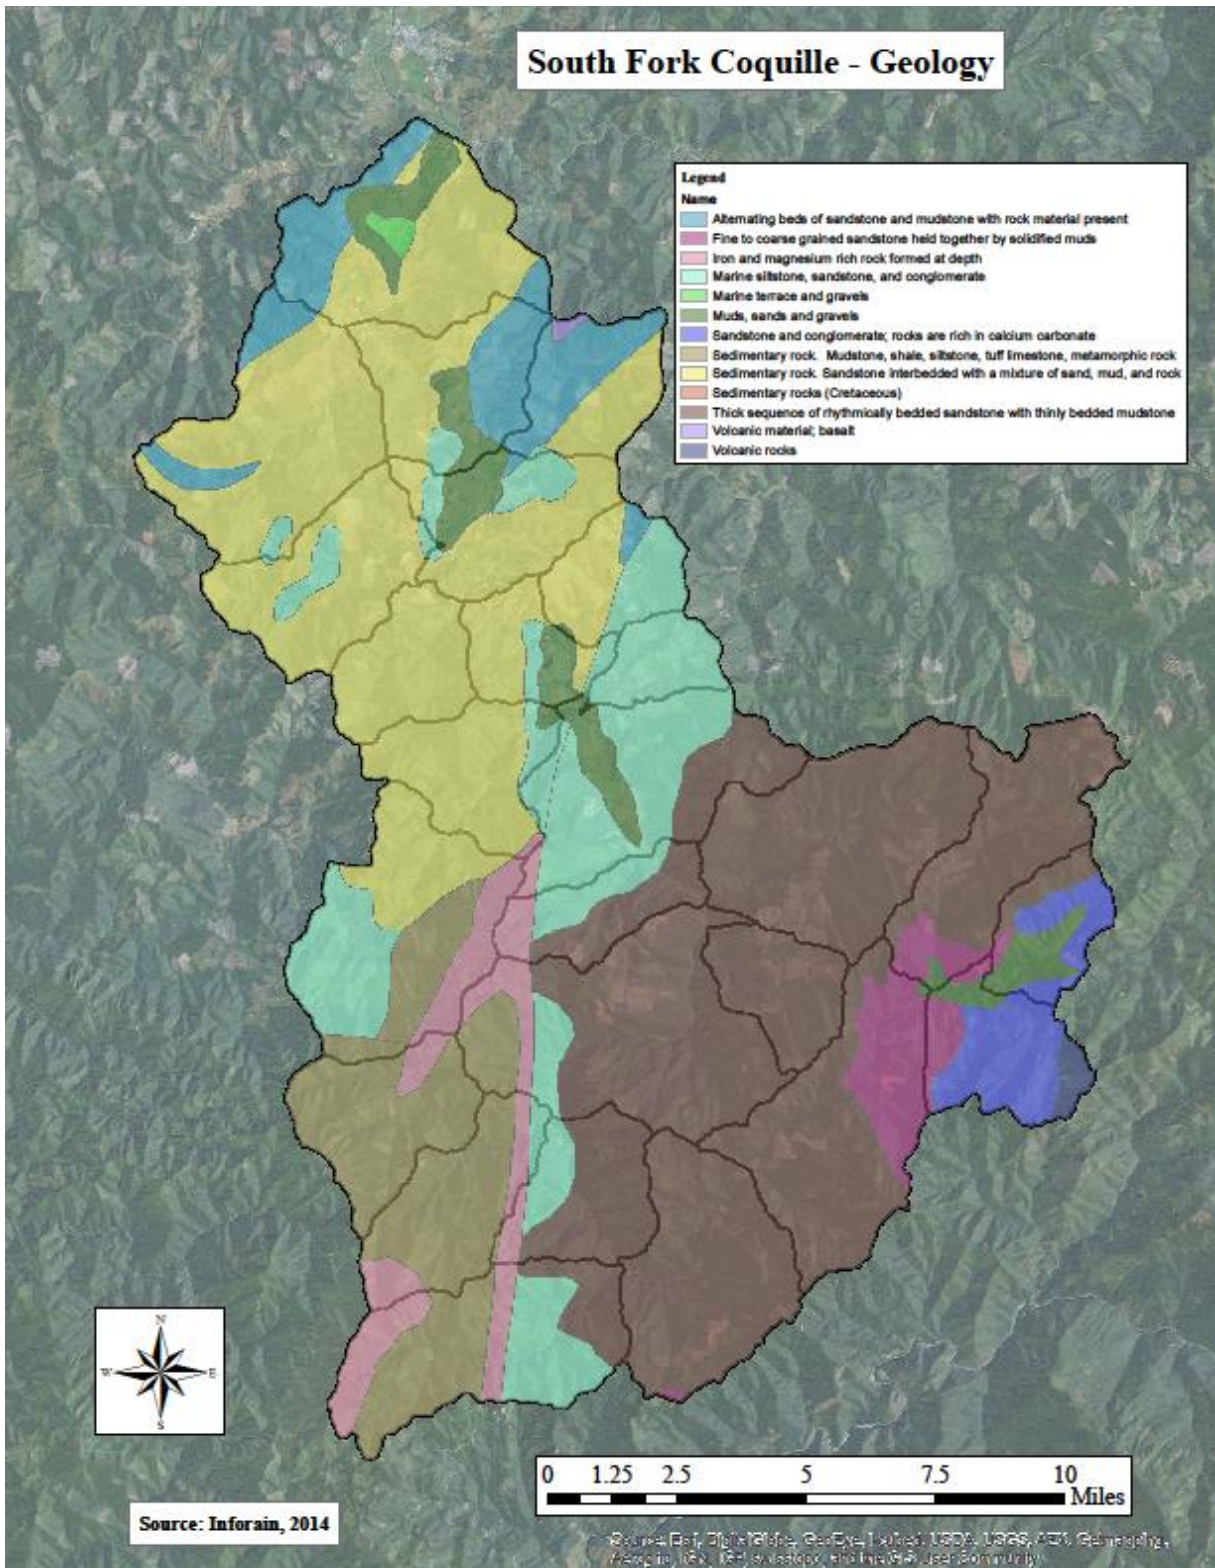
Figure 1- 2. Geology of the South Fork Coquille Watershed (Walker and MacLeod, 1991).

The headwaters of the South Fork Coquille River lie in the northwestern corner of the Klamath Mountain Province, which is active due to the climate and tectonic setting resulting from the convergence of the Juan de Fuca and North American plates (Florsheim and Williams, 1995). The remainder of the watershed lies in the southern part of the Coast Range Province, which consists of uplifted sedimentary and volcanic rocks (Florsheim and Williams, 1995). Due to fluctuating sea levels and continual uplifting and infilling the South Fork Coquille River has created alluvial sediment deposition and terraces such as the one that the city of Myrtle Point occupies. Both of these geologies produce fine grain sediments which are transported to stream channels. Descriptions of the geology of the watershed can be found in Figure 1-2. Erosion of the rugged hillslopes of the South Fork Coquille Watershed is the primary source of sediment (Florsheim and Williams, 1995).

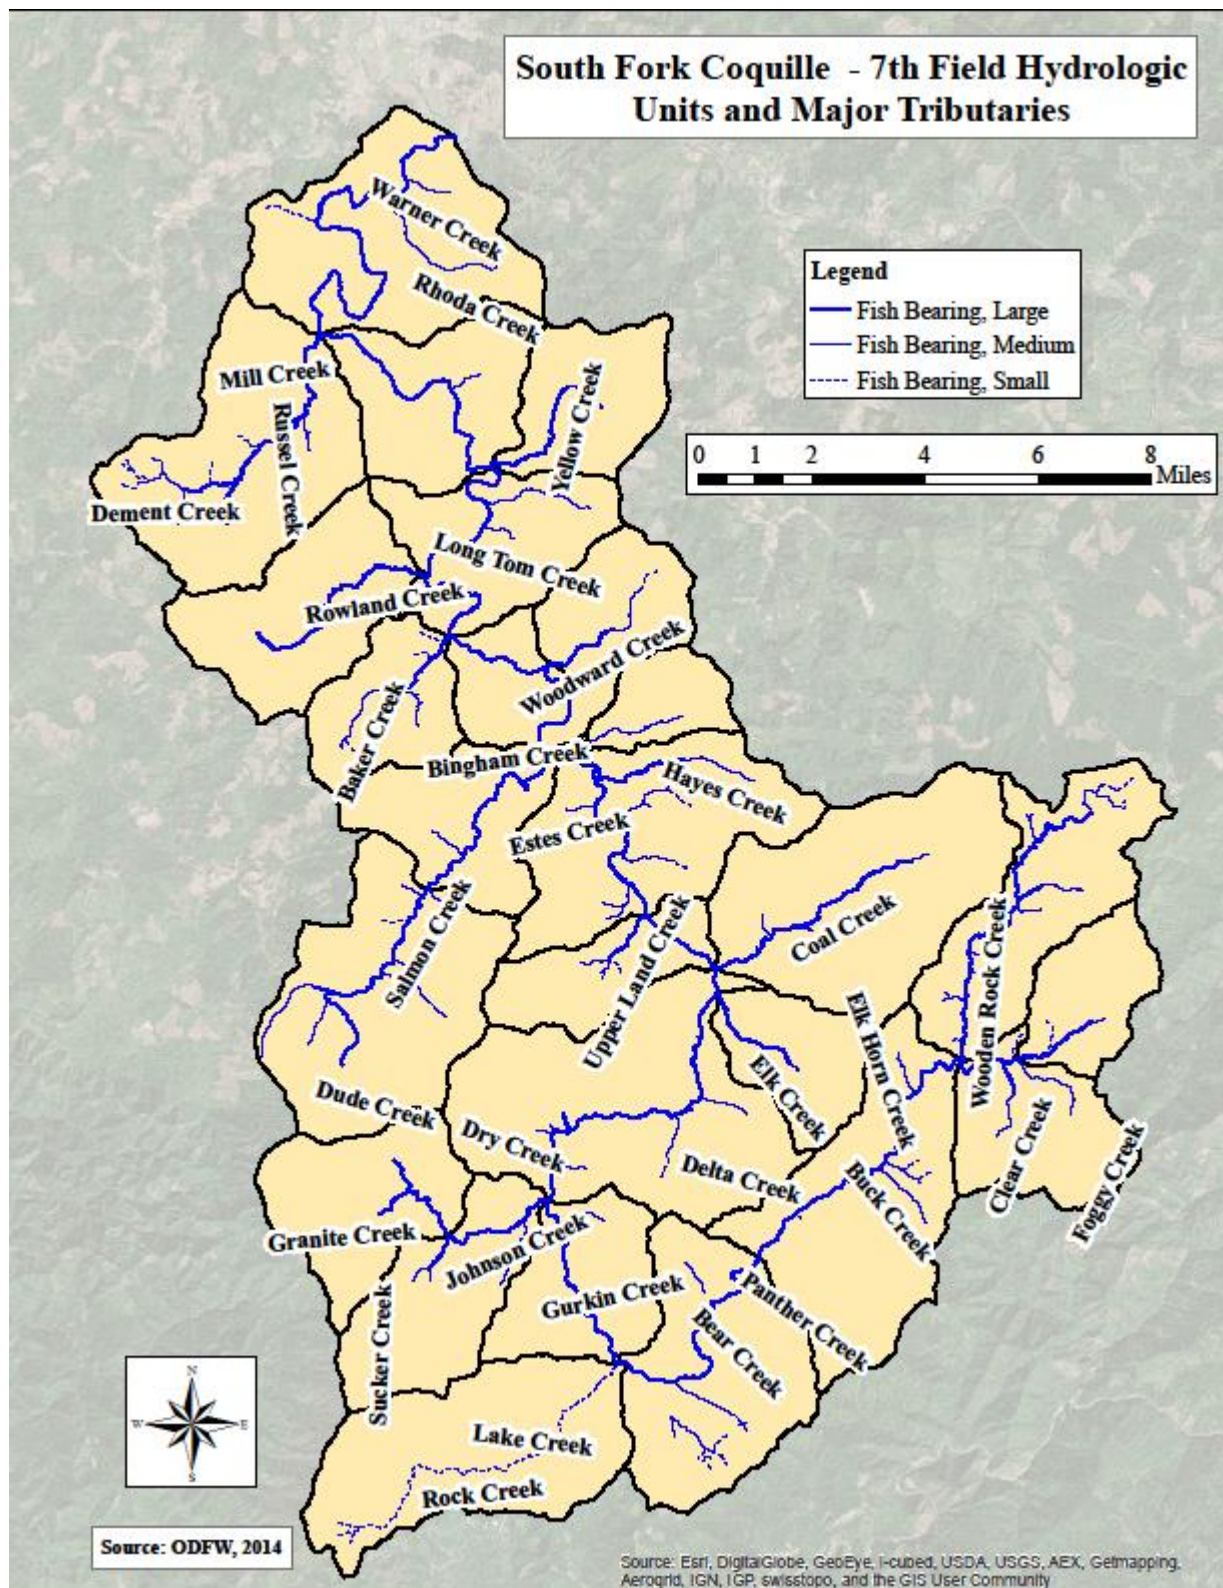
Figure 1- 4. Seventh field hydrologic units and major tributaries showing small, medium, and large fish bearing streams (OAR 629-635-0200).

The major tributaries to the South Fork Coquille River and their size according to OAR 629-635-0200 are located in Figure 1-4. These sizes relate to different streamside buffers required under the Oregon Forest Practices Act (see Section 1.4.c. for more information). The DEQ Fish Use Designations (Figure 1-5) and Salmon and Steelhead Spawning Use Map (Figure 1-6) are also included.

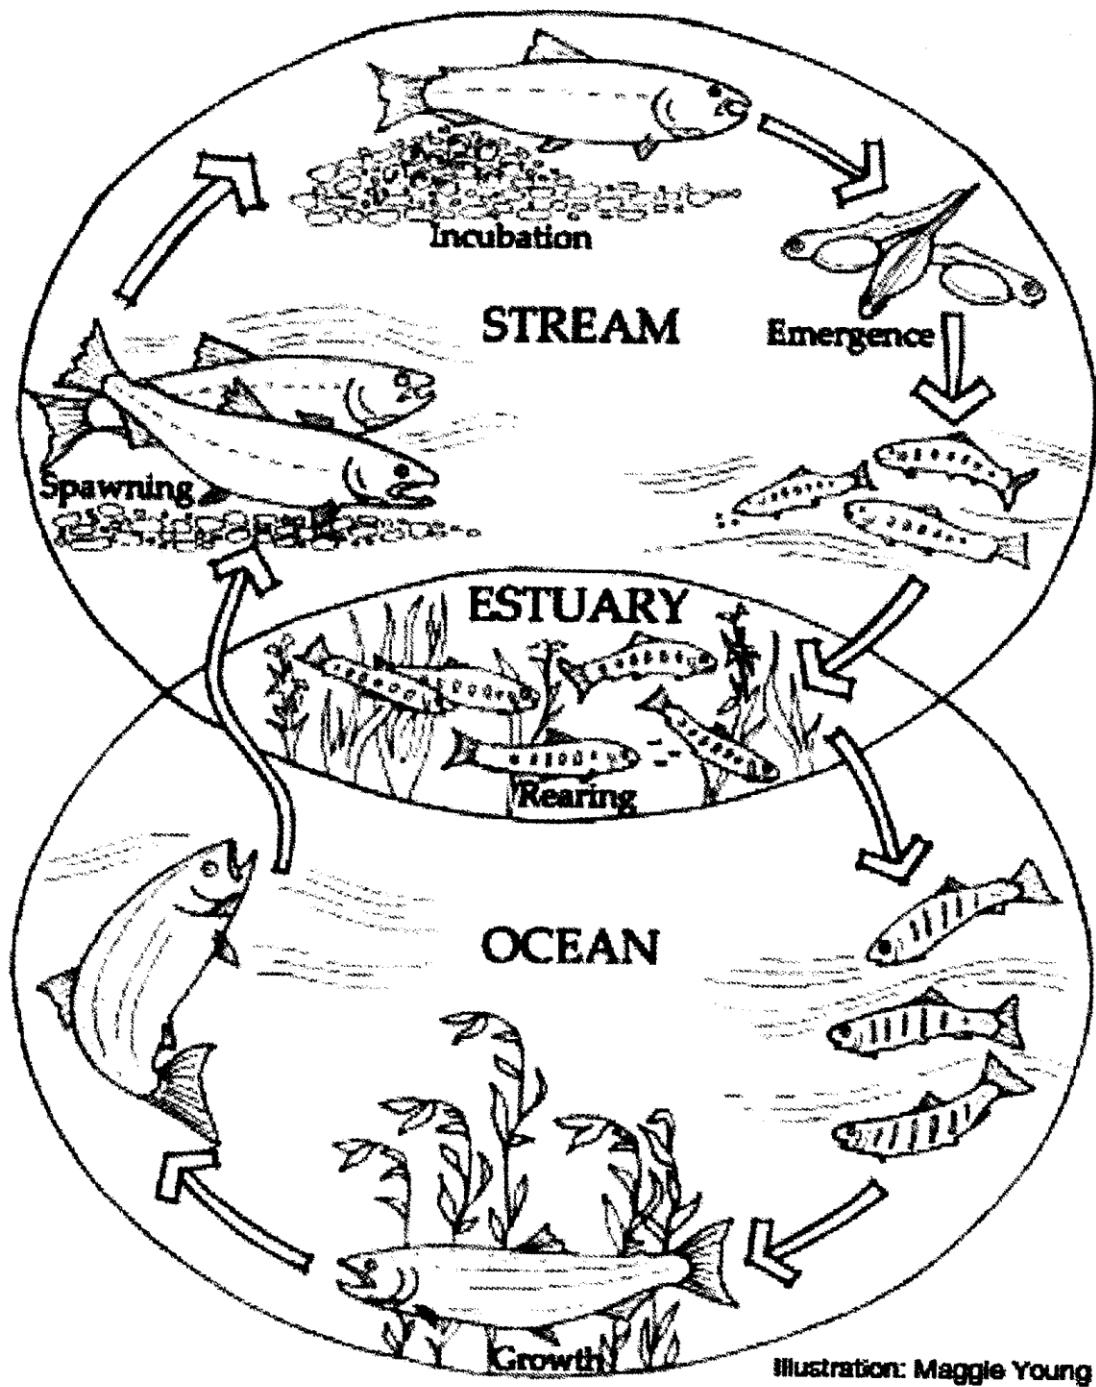
Figure 1- 7. Illustration of the salmon life cycle (Young, 2014).

Anadromous species within the Salmonidae family typically exhibit the same general life cycle (Figure 1-7) with differences in timing, habitat preference, and rearing length.

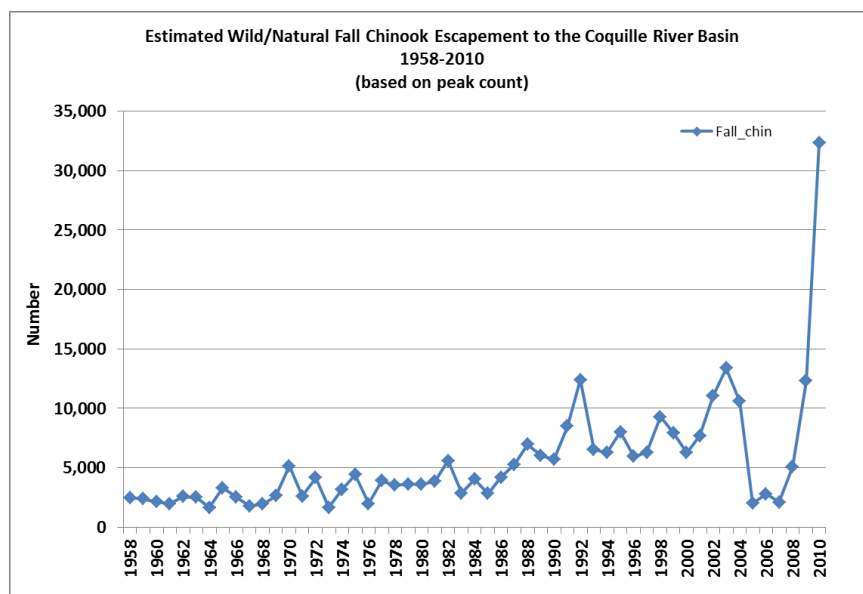
Figure 1- 9. ODFW wild/natural fall Chinook escapement in the Coquille River Subbasin from 1958-2010.

A Chinook hatchery program has been in effect since 1984 on the Coquille River to supplement runs. Bingham Creek, off the South Fork Coquille River near the city of Powers, is a hatchery release site for unfed fall Chinook fry. This program has been successful at supplementing the existing population. There has been significant increase in wild/natural fall Chinook Salmon escapement since 1958 (Figure 1-9).

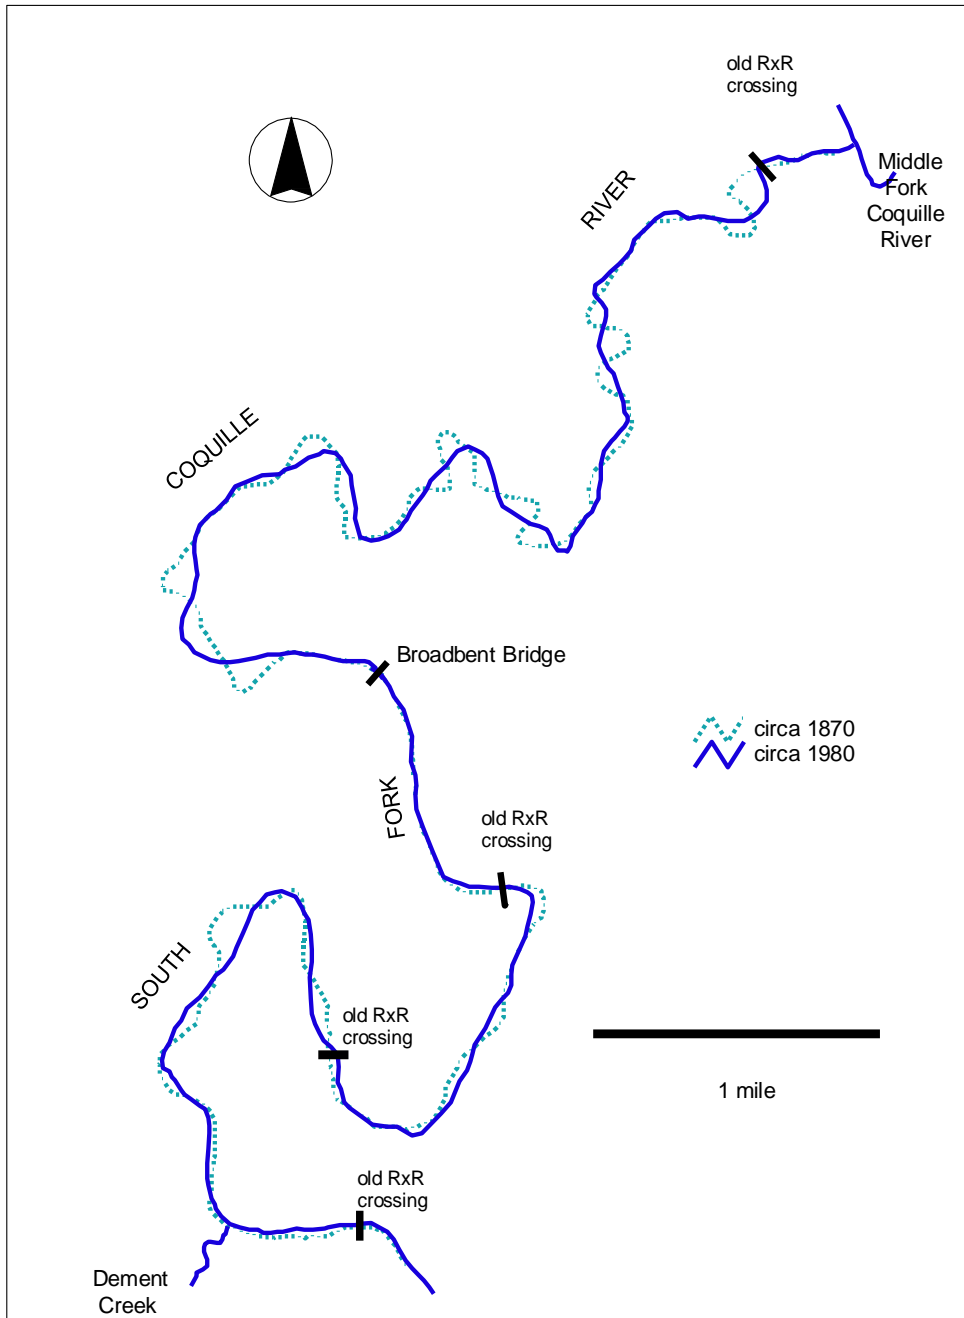
Figure 8. Changes in the alignment of the South Fork Coquille River between the Middle Fork and Dement (study reaches SFC-2 and SFC-3), 1870-1980. River positions given represent channel mid-lines.

Though little information in the form of channel topography is available to describe historical channel conditions, a recreation of the planform of the 1870 channel for a short stretch of the South Fork Coquille upstream of its confluence with the Middle Coquille suggests significant changes in the channel's meander pattern (Figure 2-1) (Florsheim and Williams, 1995 and Clearwater BioStudies, Inc., 2003). The reconstruction, based on General Land Office (GLO) surveys around 1870, suggests that the channel was in a very similar position to the current channel, but with increased sinuosity and meanders with higher amplitudes and shorter wavelengths. This tighter meander pattern was likely supported by a more robust riparian corridor that provided bank stability and hydraulic roughness, regulating shear stress during flood flows. Also, the changes in sediment inputs following land clearing and logging and channel modifications such as snagging (snagging is the act of mechanically removing large wood from the channel) and dredging that eventually degraded the channel had not disturbed the system at that time (Inter-Fluve, Inc., 2013).

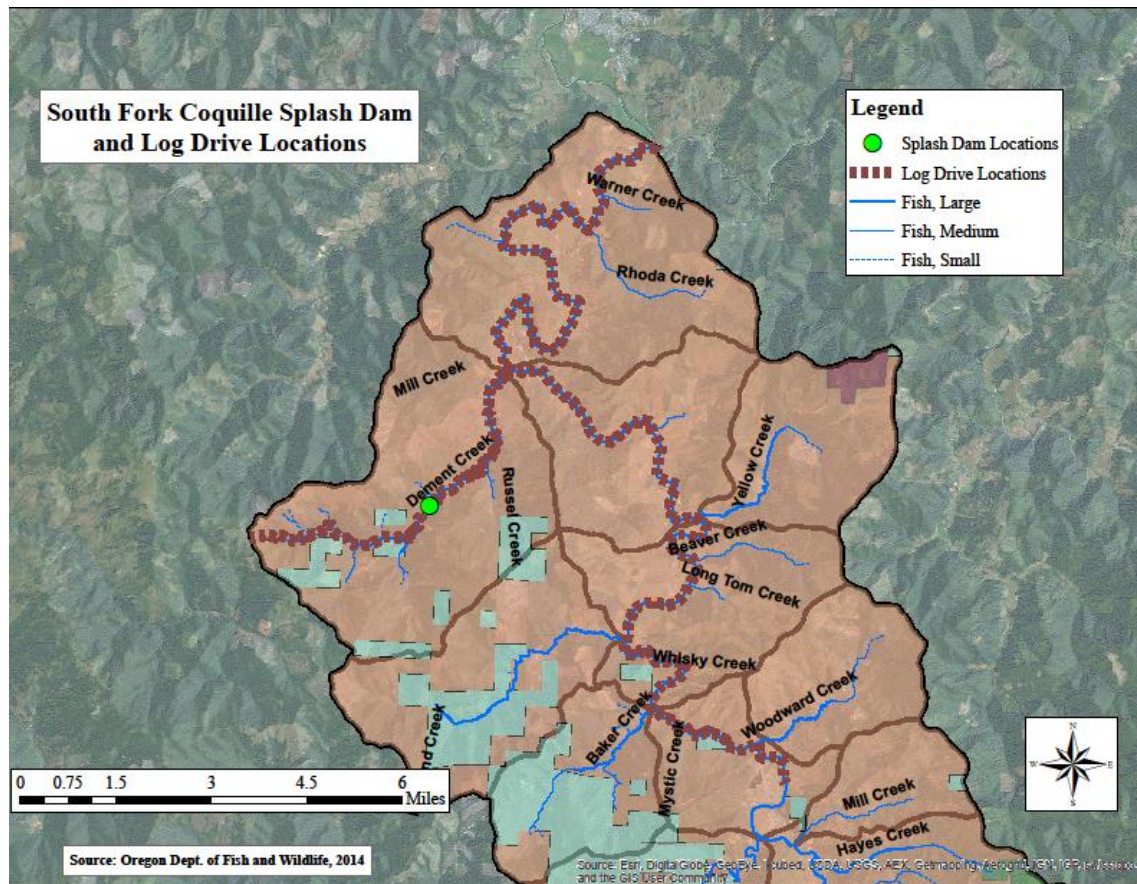
Figure 2- 2. Map of locations of splash dams and log drive channels within the South Fork Coquille River (Miller, 2010). Stream sizes are according to Oregon Administrative Rules.

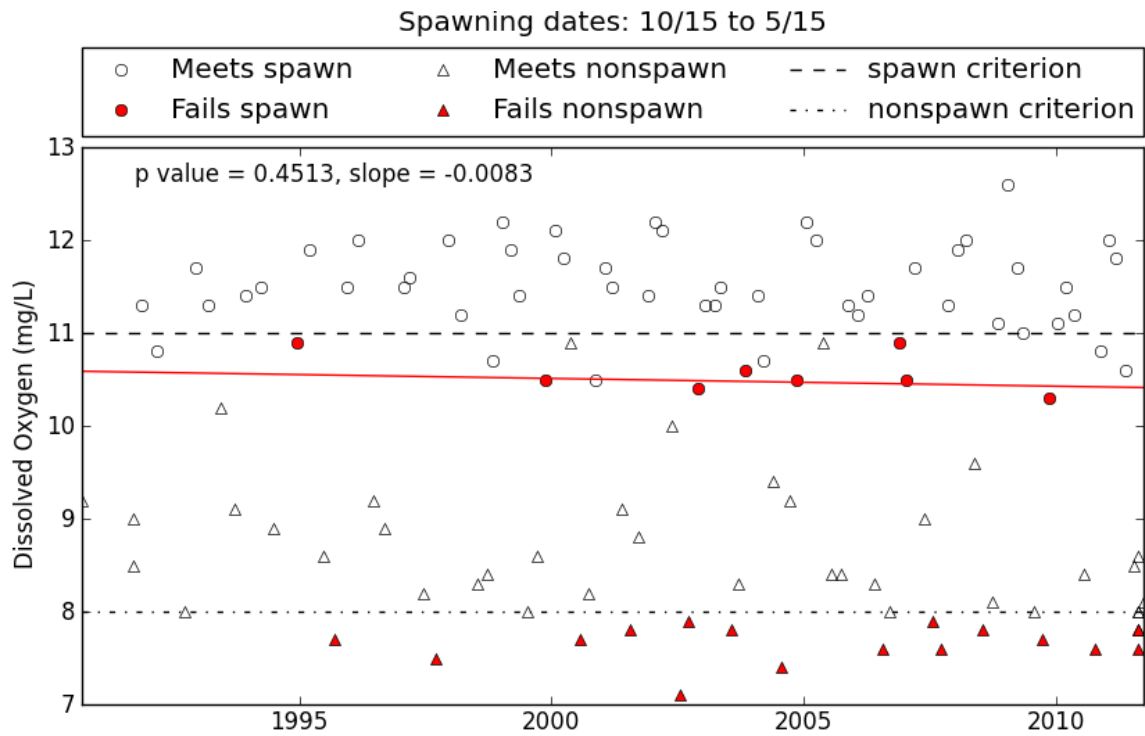
Figure 2- 7. South Fork Coquille River at Broadbent - dissolved oxygen (DEQ, 2014).

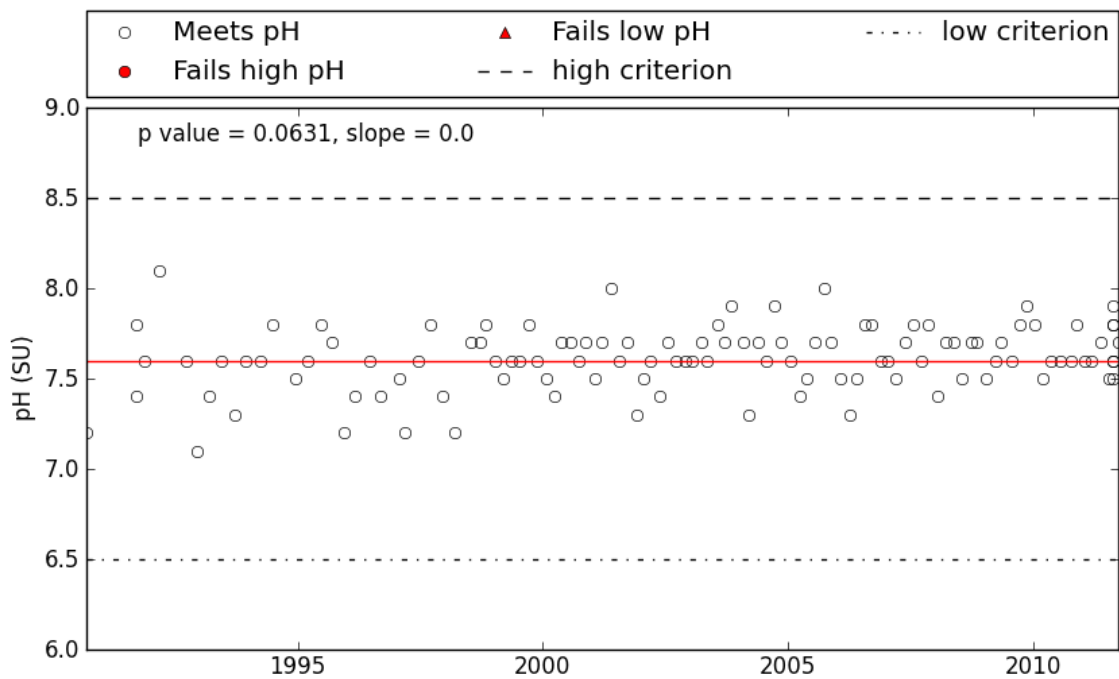
Figure 2- 8. South Fork Coquille River at Broadbent – pH (DEQ, 2014).

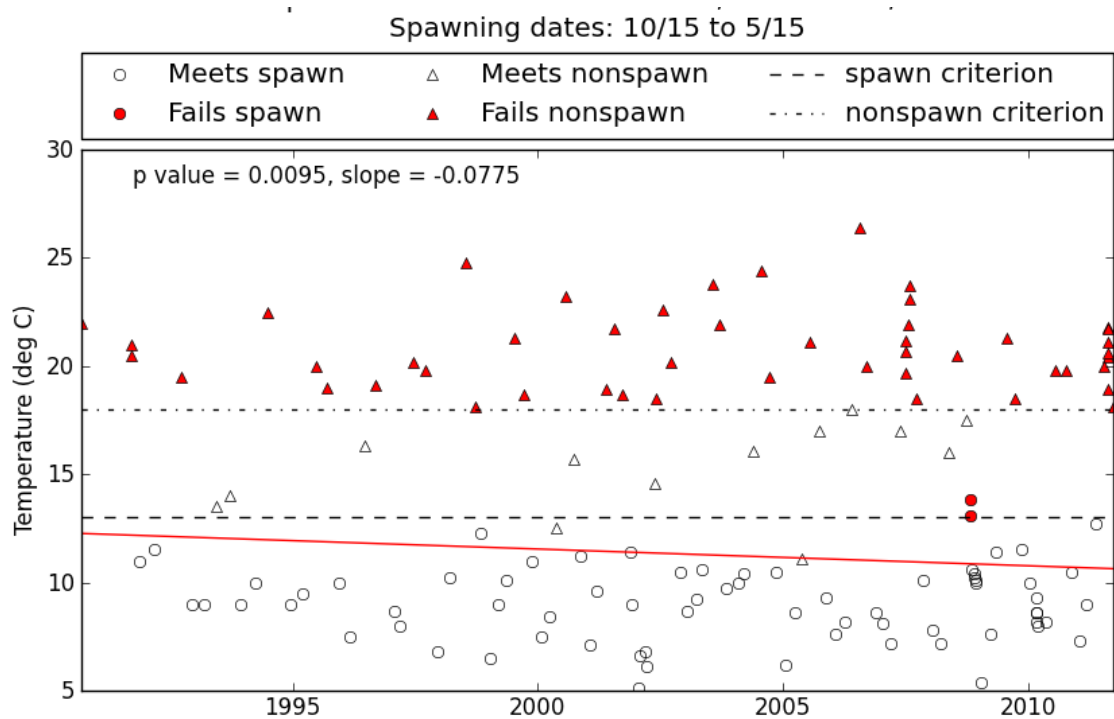
Figure 2- 9. South Fork Coquille River at Broadbent - temperature (DEQ, 2014).

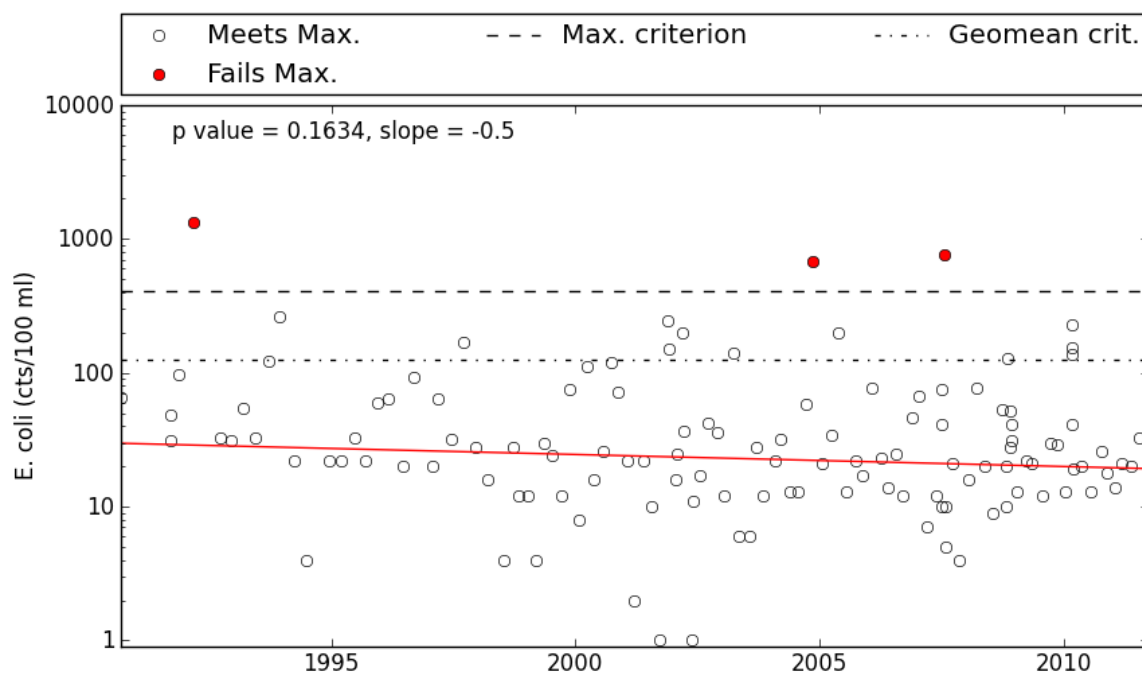
Figure 2- 10. South Fork Coquille River at Broadbent - bacteria (DEQ, 2014).

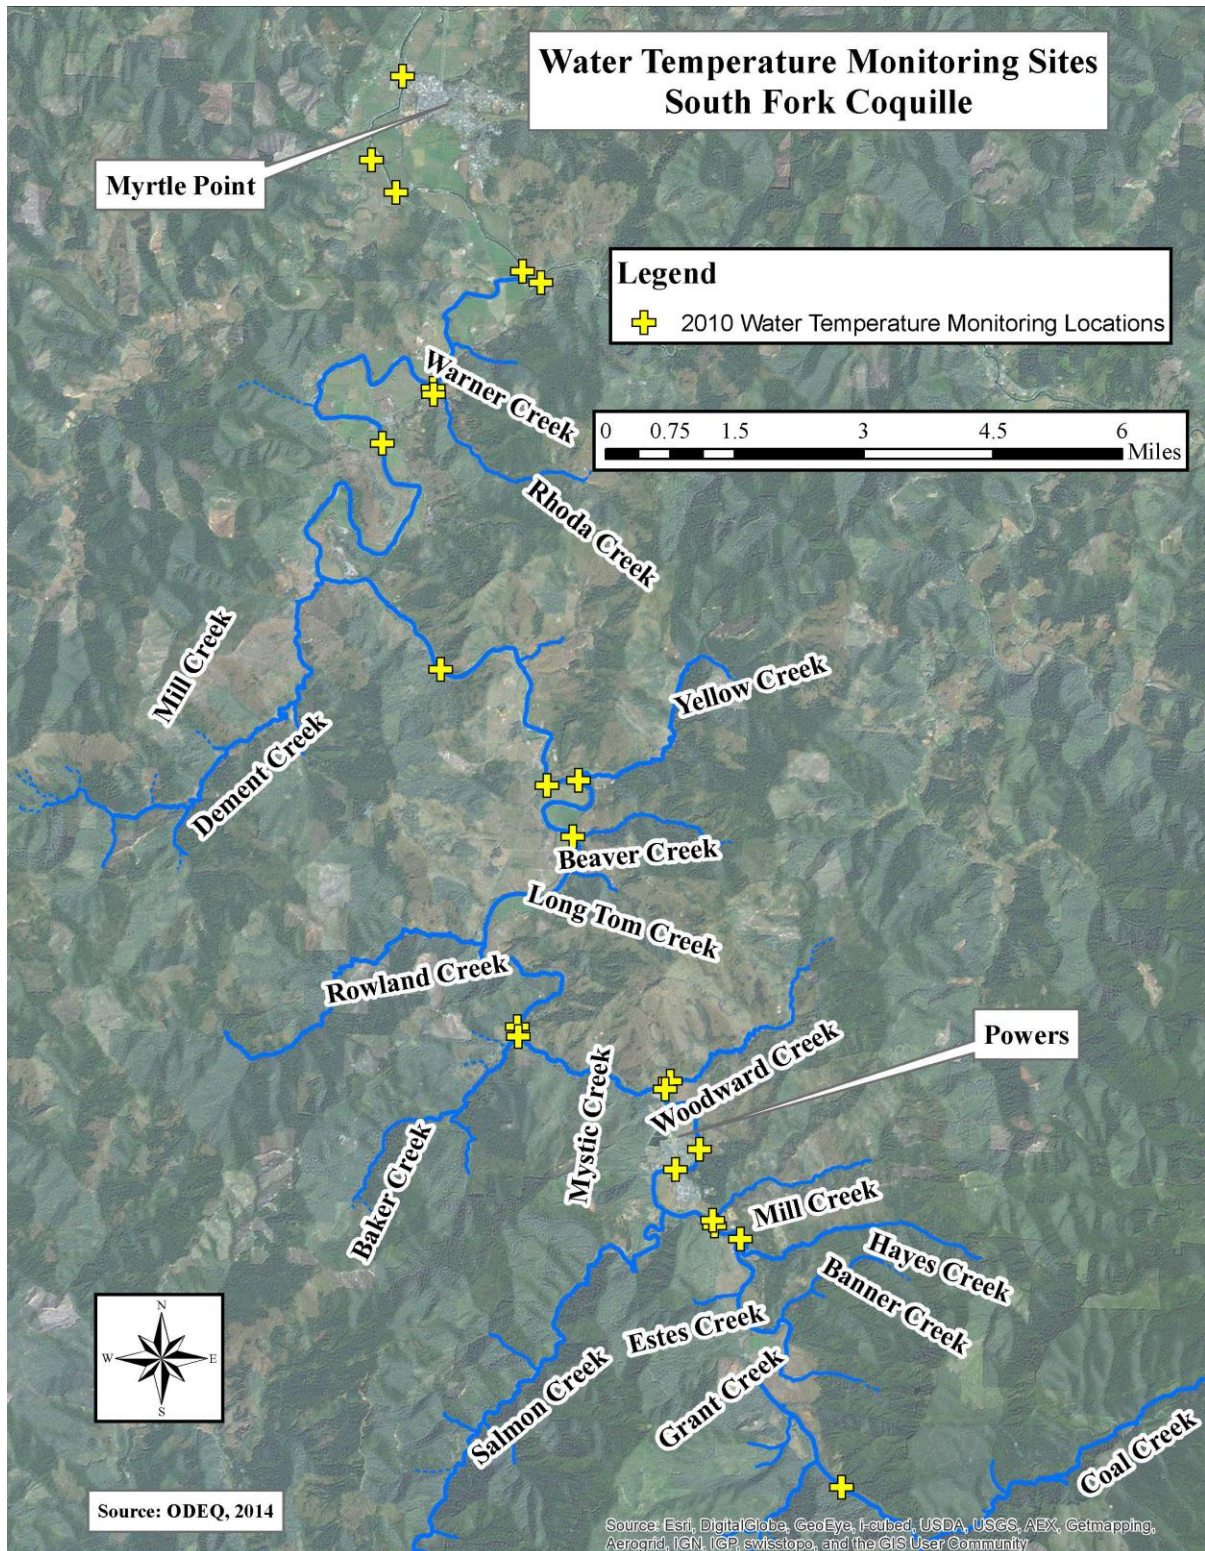
Figure 2- 11. South Fork Coquille River mainstem and tributary 2010 temperature monitoring sites.

Figure 2-11 shows the water temperature monitoring sites and Tables 2-9 and 2-10 show the metrics derived by DEQ from these temperature data.

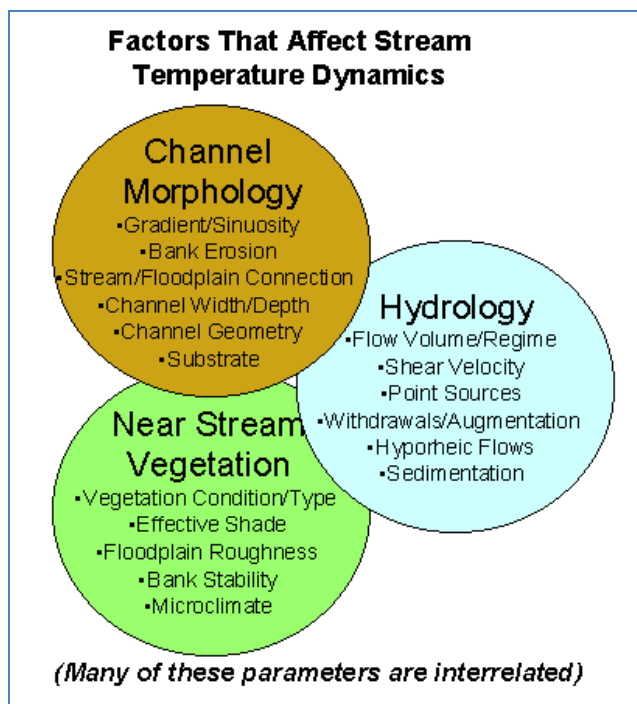
Anthropogenic activities that affect stream temperature can be grouped as near stream land cover (vegetation), channel morphology and hydrology. Many of these stream parameters are interrelated (i.e., the condition of one may impact one or more of the other parameters). Stream temperature dynamics are influenced by the transfer of heat from the air, heat from the streambed (bedrock conducts more heat than gravels), evaporation (liquid becoming vaporized), and both long and short wave radiation (solar energy).

Figure 2- 12. Factors that affect stream temperature dynamics (Boyd and Kasper, 2003).

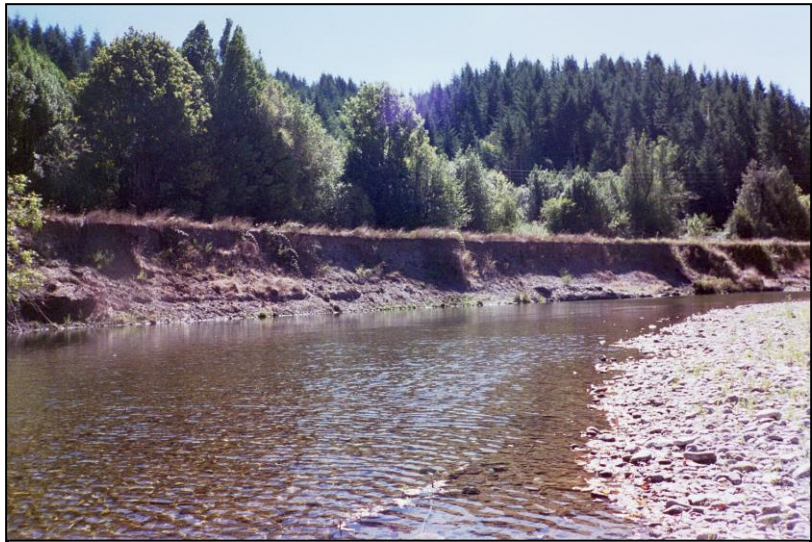
warm in a downstream direction as they become wider and streamside vegetation is less effective at shading the surface of the water. Also, the cooling influences of ground water inflow and the impact of smaller tributaries have less of an impact downstream as a stream becomes larger because the cool water is a smaller percentage of the total stream flow. Greater reach volumes are associated with a reduction in stream sensitivity to natural and human sources of heat. Heat energy delivered by sunlight hitting the surface of the water is a primary cause of stream heating (Figure 2-13). As the channel widens more surface area is available to intercept heat energy. Riparian shade is a primary mechanism for preventing the delivery of the sun's heat energy to the water column.

Figure 2- 13. Lack of riparian vegetation and widening of the stream channel (Clearwater BioStudies, Inc., 2003).

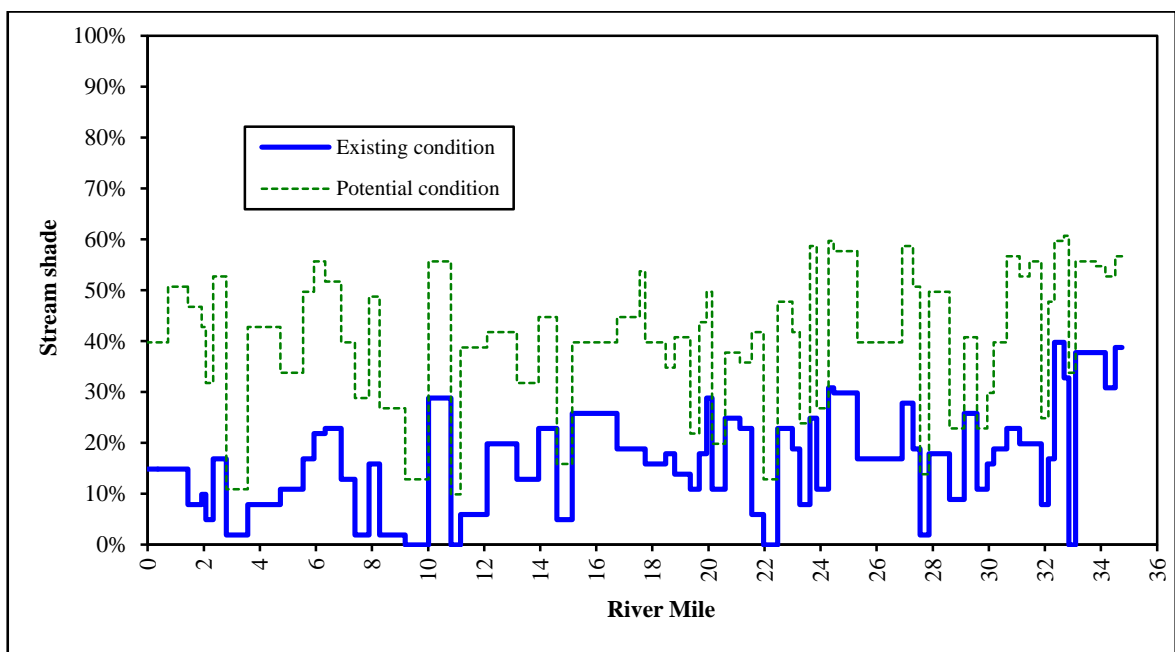
Results of our SHADOW modeling reflect that both existing and potential levels of stream shading vary considerably within the study area. For the mainstem South Fork, where both existing and potential shade levels were generally lower than those of the tributary streams, our model-based estimates ranged from 0 to 40% for existing shade and from 10% to 61% for potential shade (Figure 2-14). Estimates of the scope for improving shade conditions within individual modeled segments of the mainstem varied between 9% and 39% (see Section 5.1.d. - Stream Shading and Riparian Restoration to Improve Shading).

Figure 2- 14. Estimated levels of existing and potential stream shade, versus river mile, for the lower South Fork Coquille River, Oregon (Figure 19 in Clearwater BioStudies, Inc., 2003).

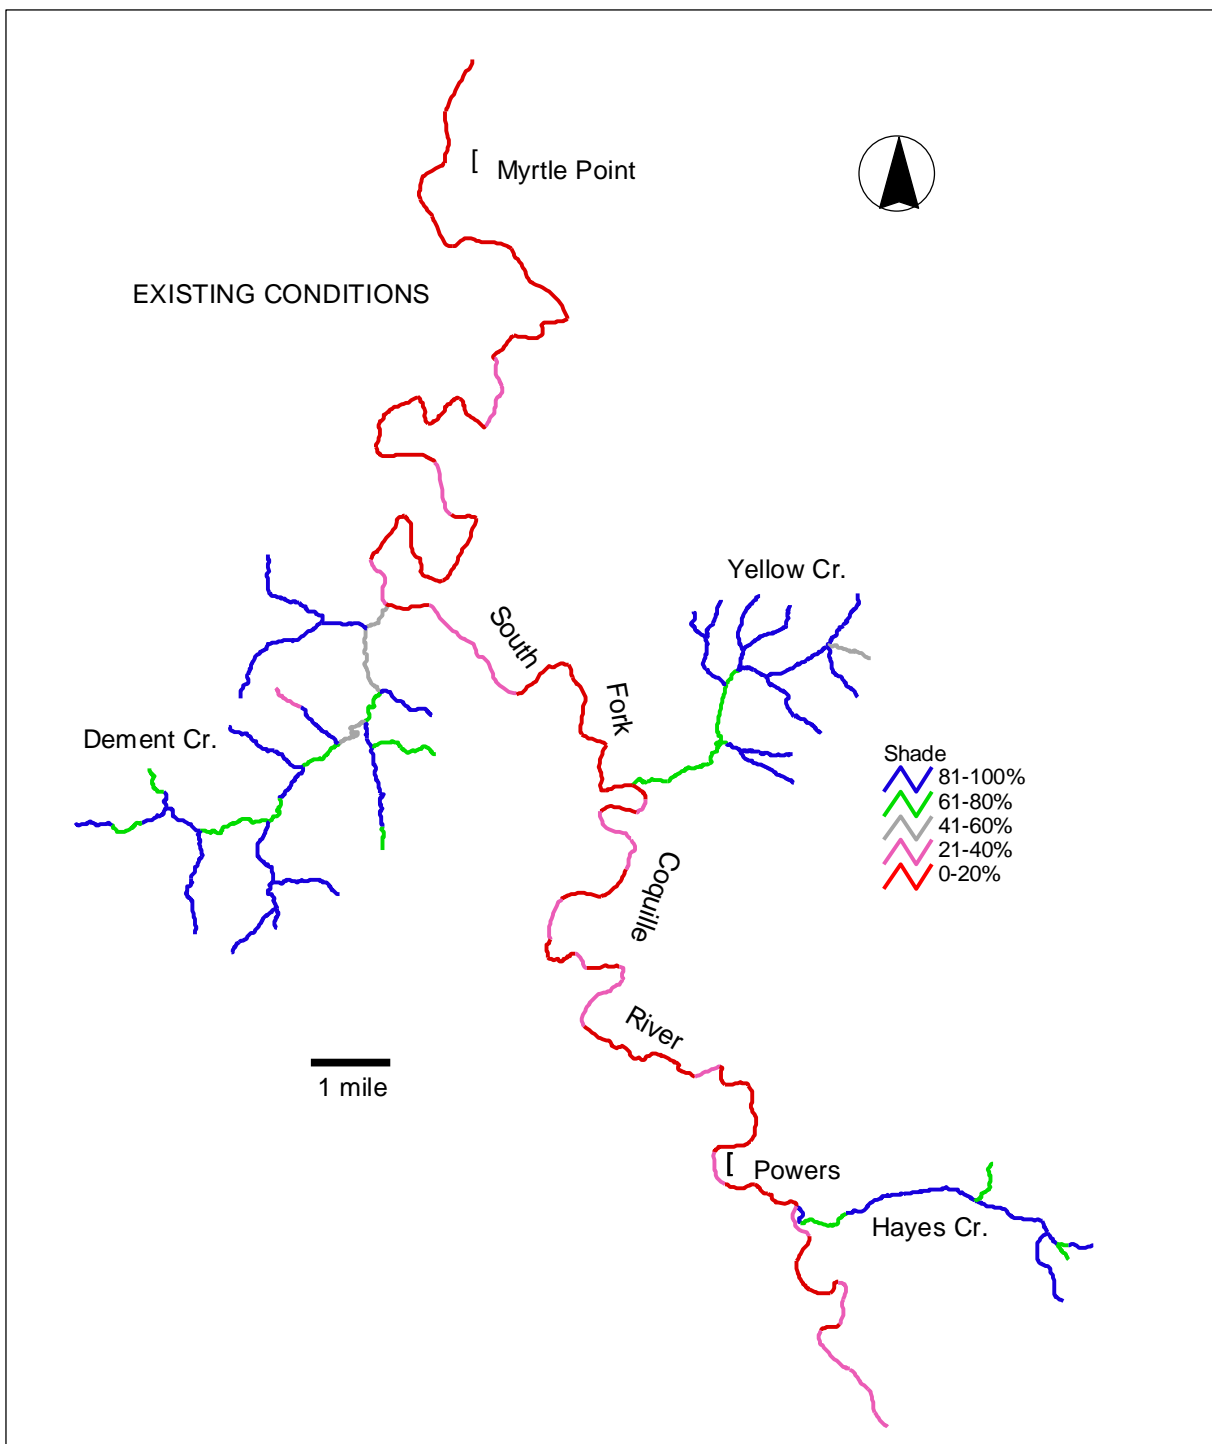
- Variable but low existing and potential shade levels along the mainstem South Fork Coquille.
- More variable but generally higher levels of existing shade along streams in the three tributary watersheds than along the mainstem South Fork Coquille. Estimated levels of existing shade varied from 22% to 95% among the 86 tributary reaches modeled.
- Consistently high shade potentials along all of the tributary streams. Estimated shade potentials varied from 86% to 95% among the 86 tributary reaches modeled.
- The presence of multiple east-west trending segments of the lower South Fork that have very low shade potentials related to high natural exposure to mid-summer sun.

Figure 2- 15. Spatial variation in existing stream shade within the lower South Fork Coquille River study area (Figure 20 in Clearwater BioStudies, Inc., 2003).

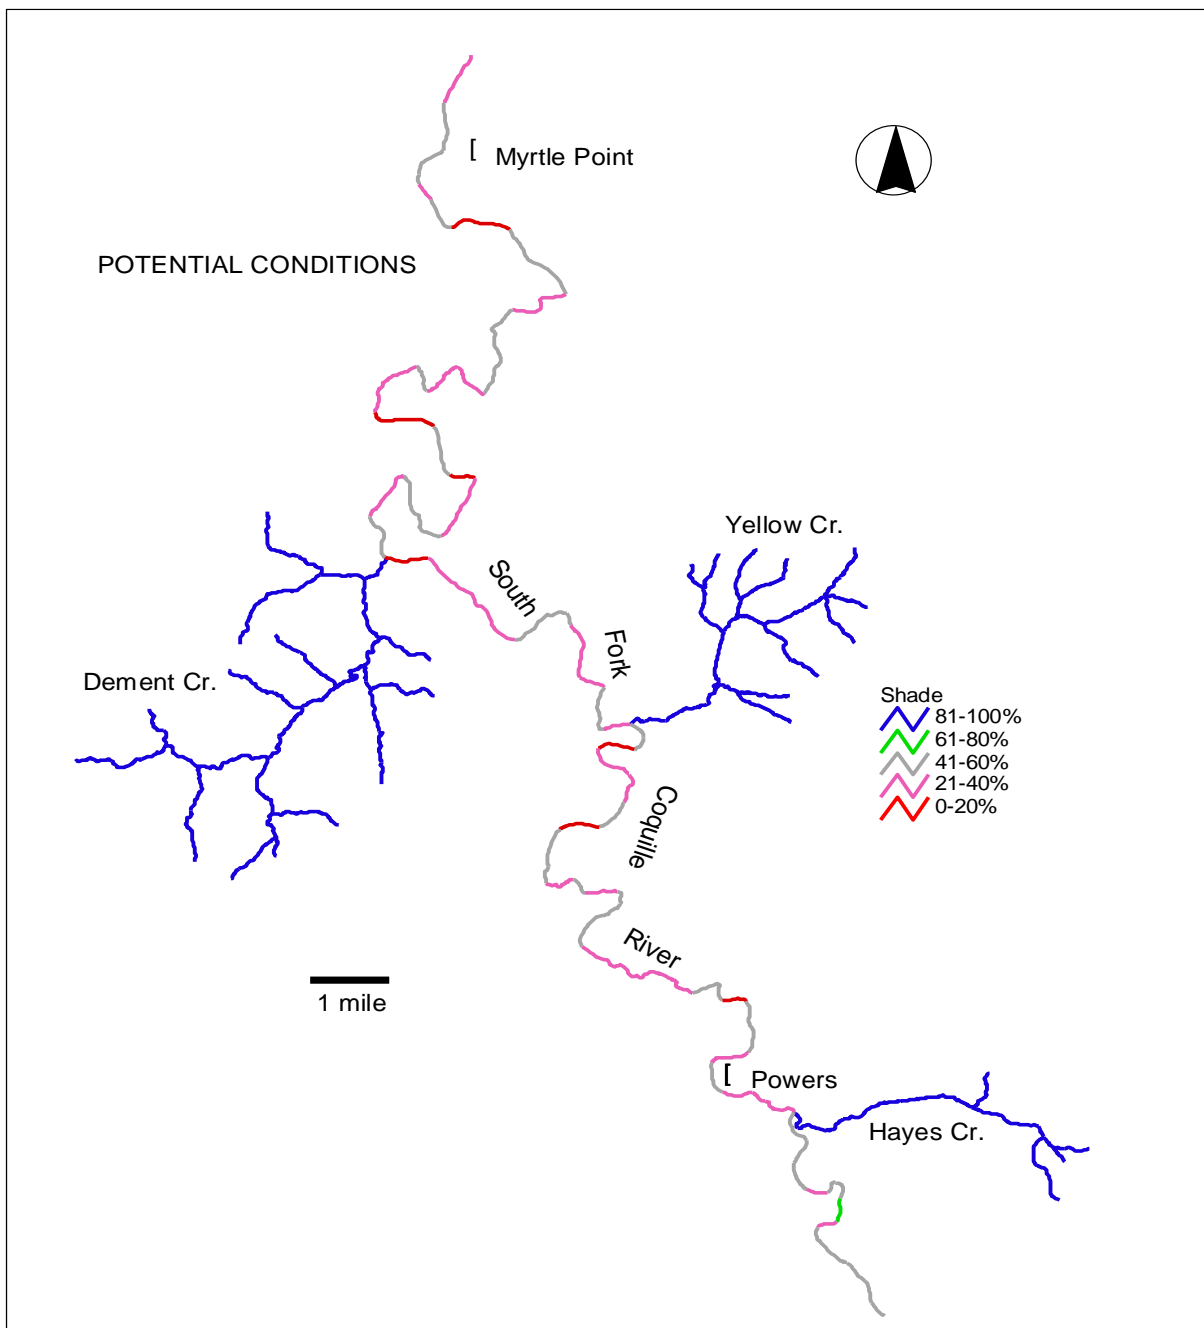
Figure 2- 16. Spatial variation in stream shade potential within the lower South Fork Coquille River study area (Figure 21 in Clearwater BioStudies, Inc., 2003).

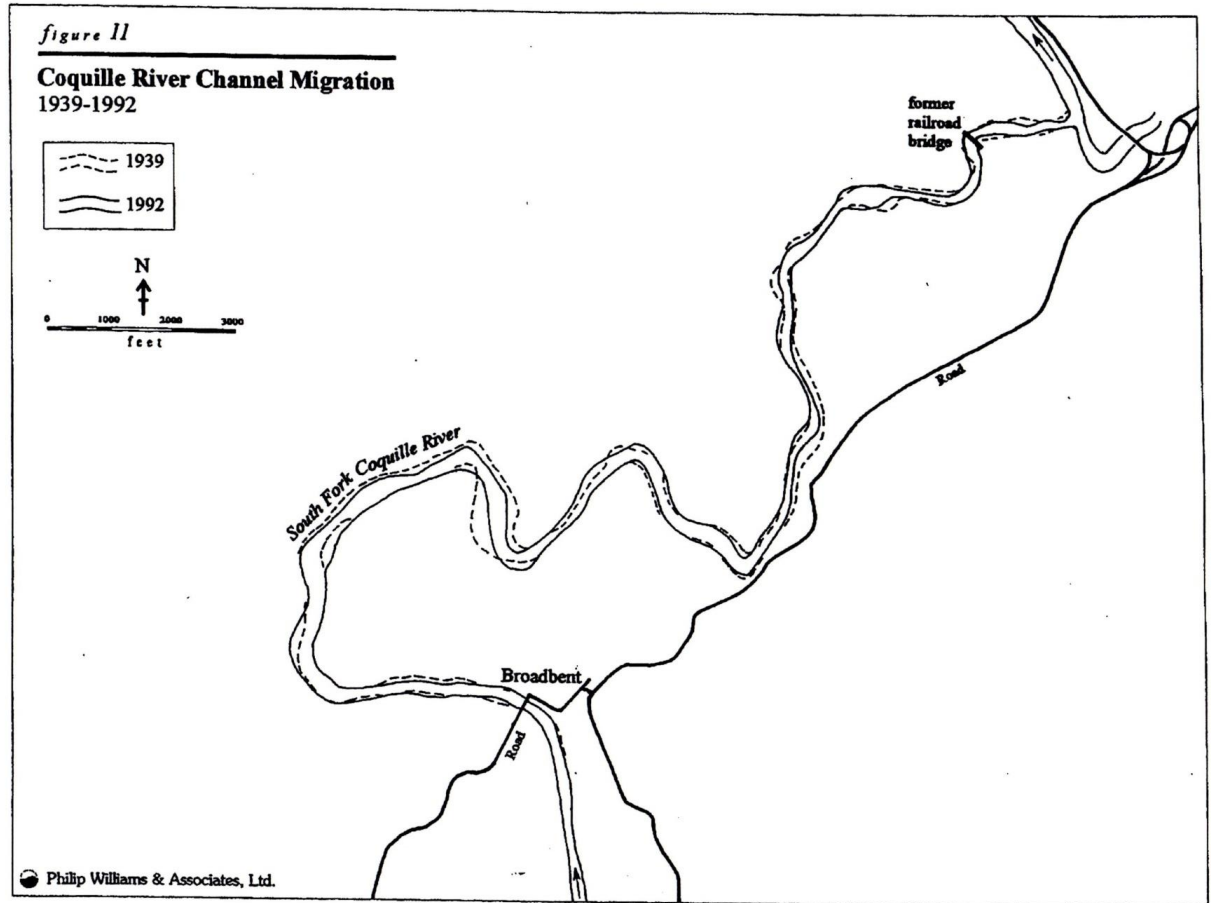
Figure 2- 19, Comparison of 1939 channel to 1992 channel (Florsheim and Williams, 1995).

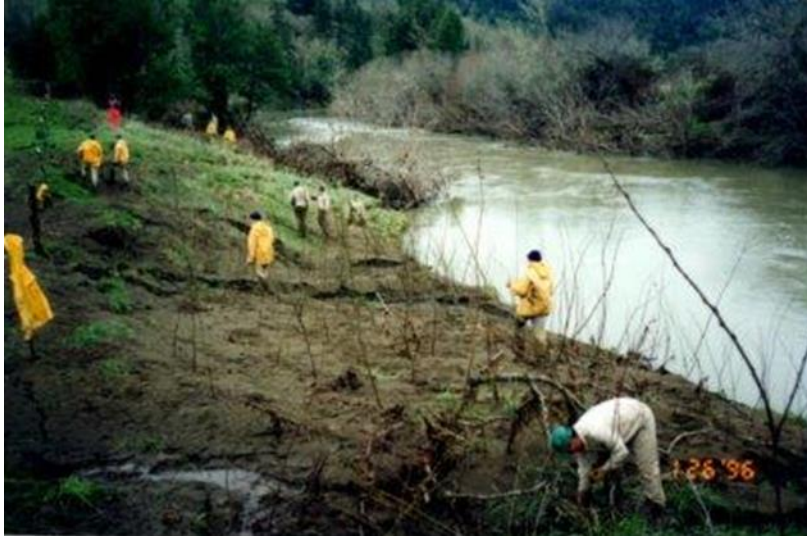
Figure 3- 4. Crew planting willows between the fence and S. Fork Coquille River.

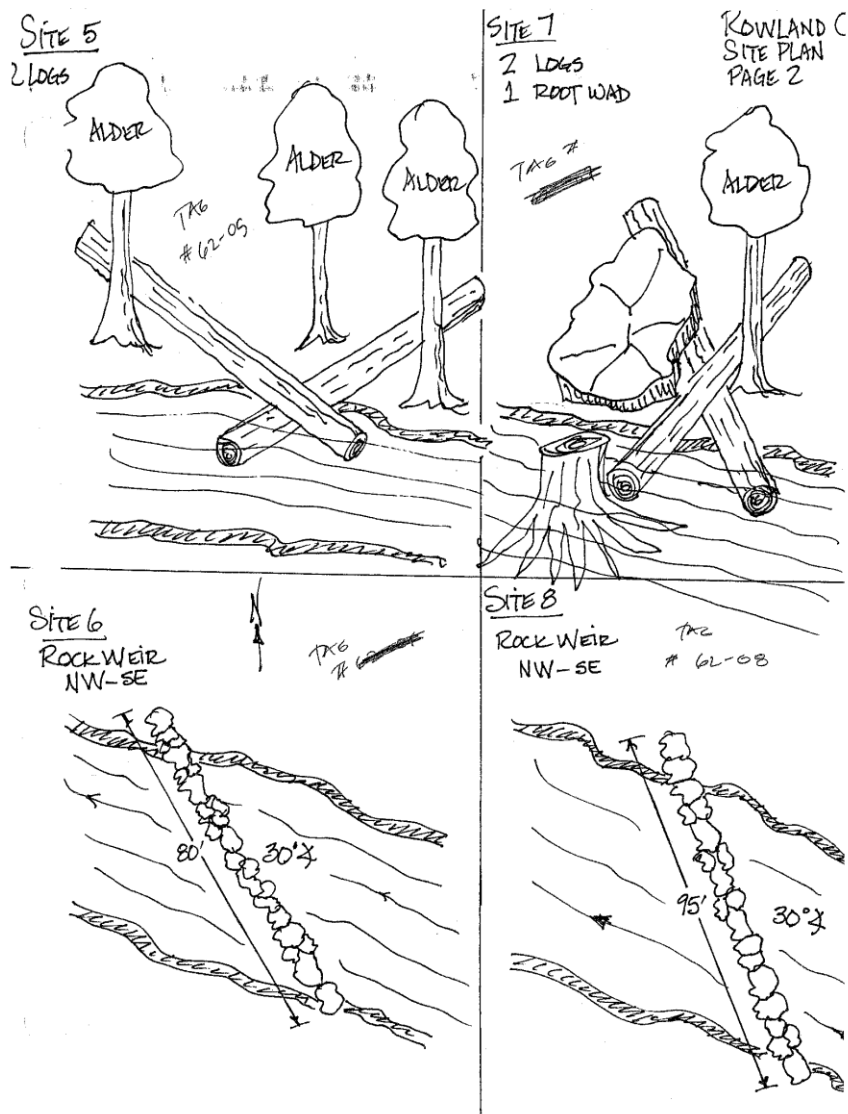
Figure 3- 6. Diagrams of log and weir structures on Rowland Creek.
