South Fork Coquille Watershed Action Plan

Coquille Watershed Association

December 2, 2014

**Prepared by the South Fork Coquille Technical Advisory
Committee**

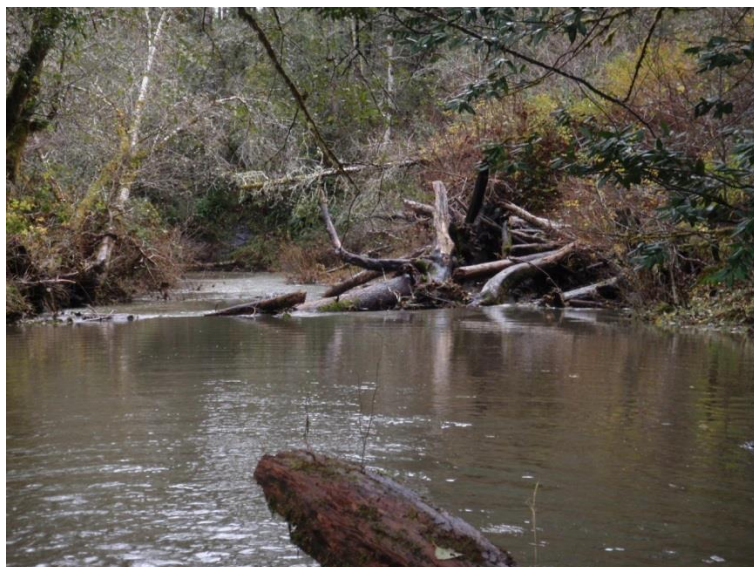
Figure 3- 7. Rowland Creek wood placement site in Fall 2012.

The 2000 monitoring visit found all 25 log structures intact. The structures had recruited some additional wood, formed deep pools for summer refugia, retained spawning gravels, and created backwater areas for winter rearing habitat. CWA and ODFW staff briefly visited the site in Fall 2012 (Figure 3-7). Some of the placement sites have moved/shifted, while others are contributing significantly to aquatic habitat complexity in Rowland Creek. A more thorough evaluation of this project is needed.

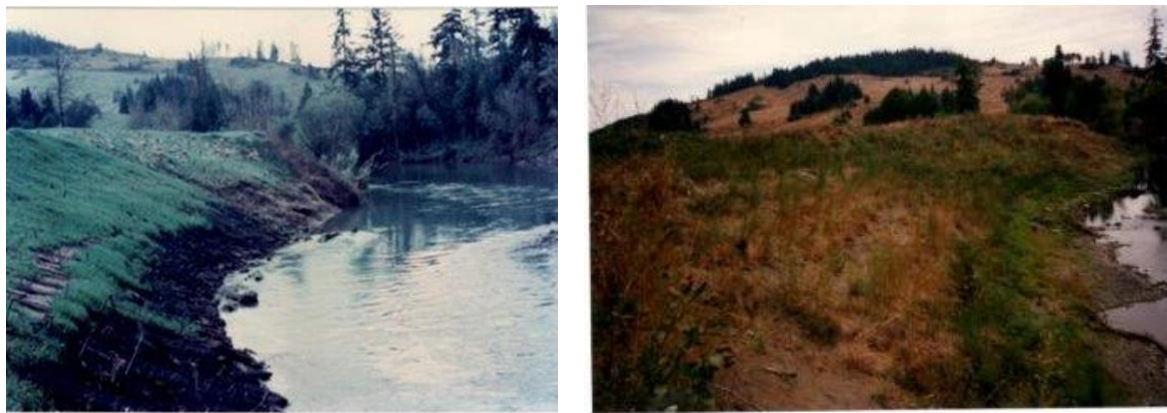
Figure 3- 10. Site photos shortly after completion of bank stabilization project at Isenhart Wash.

After one flood season there were no blowouts of the main slope, although some minor erosion did occur. There was approximately 60-70% willow survival with moderate competition from invasive vegetation. Willows provided approximately 60% shrub cover, with 40% grass cover on the slope.

In 2004, the project was considered partially successful. The slope had some erosion that needed to be addressed. The fence was intact and functioning, the willow plantings had survived, and planted trees were indistinguishable from relict, native trees.

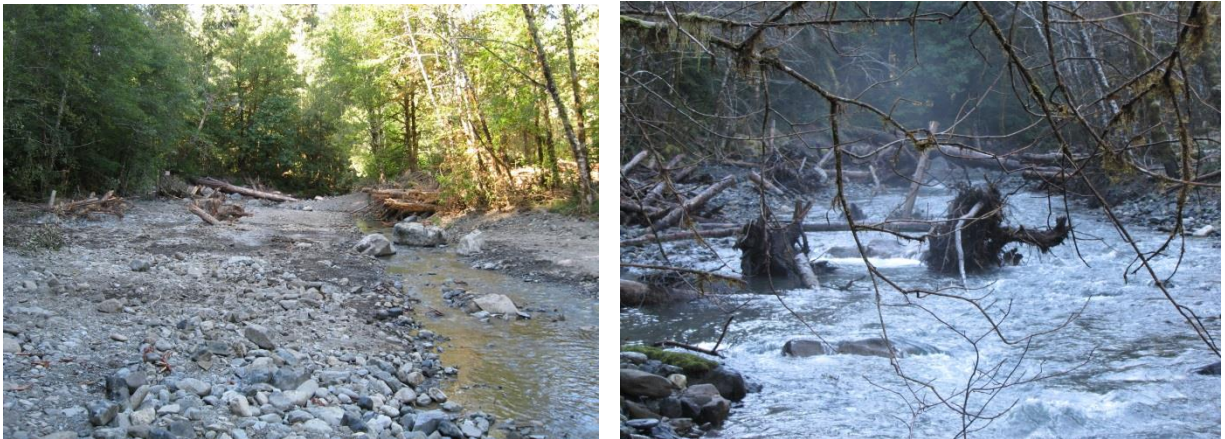
Figure 3- 13. Rock Creek project immediately post-implementation (left photo). Rock Creek project during winter flows 2010 (right photo).

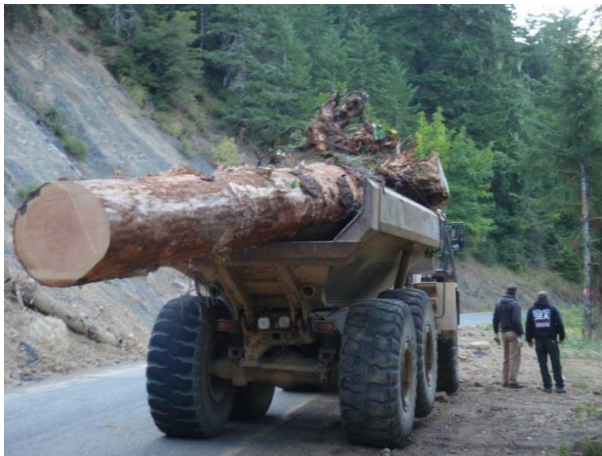
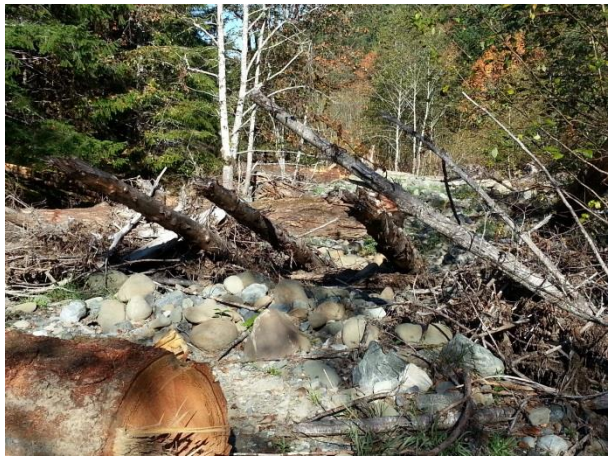
Figure 3- 14. Upslope hazard tree with rootwad moved via 4x4 dump truck during 2012 for the S.F. Coquille at Daphne Grove Campground restoration project. Location of hazard trees limited movement of whole trees.

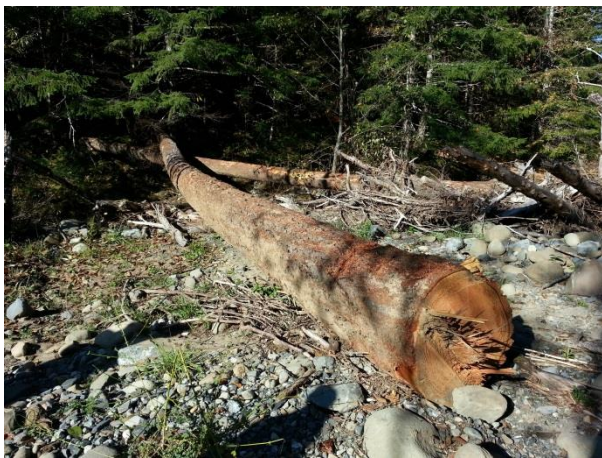
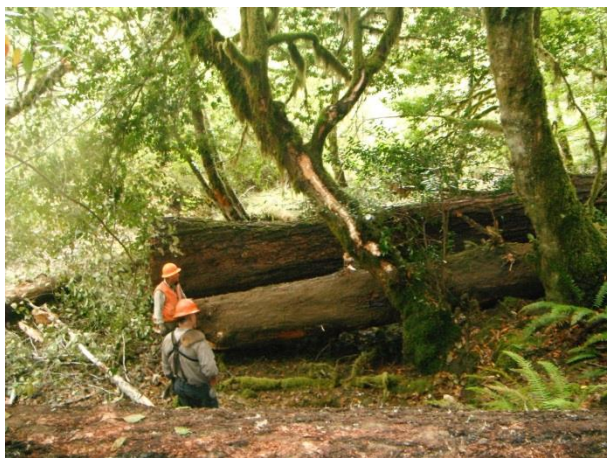
Figure 3- 15. Smaller cut logs buried on gravel bar in rake formation during 2012. Structure is designed to accumulate wood in the South Fork Coquille River at Daphne Grove Campground.

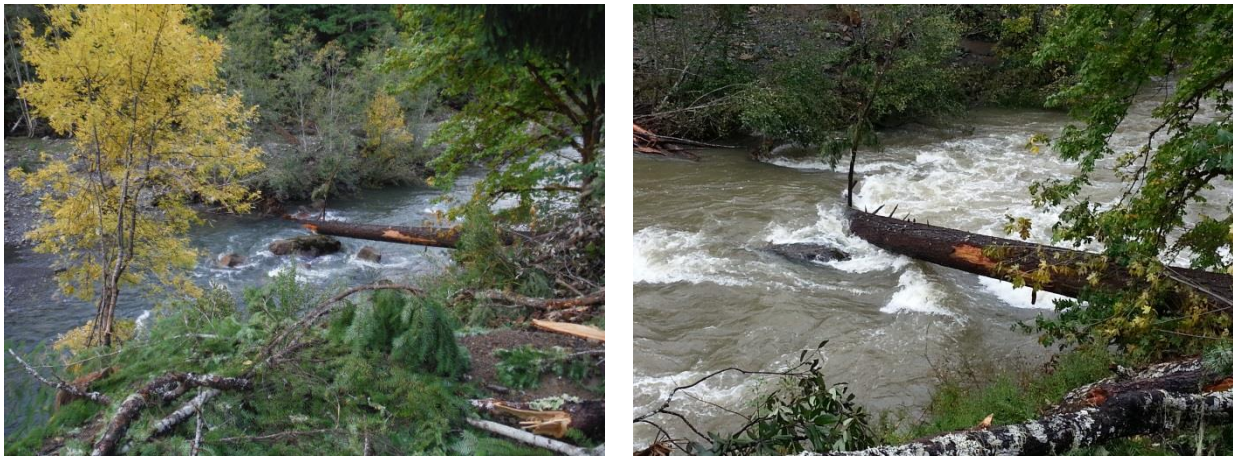
Figure 3- 16. Log placement on Road 33 side, in main flow of S.F. Coquille at Daphne Grove Campground. Picture taken immediately after placement in September 2013 (left photo). Log placement on the South Fork Coquille at Daphne Grove Campground during October 2013 high water (right photo).

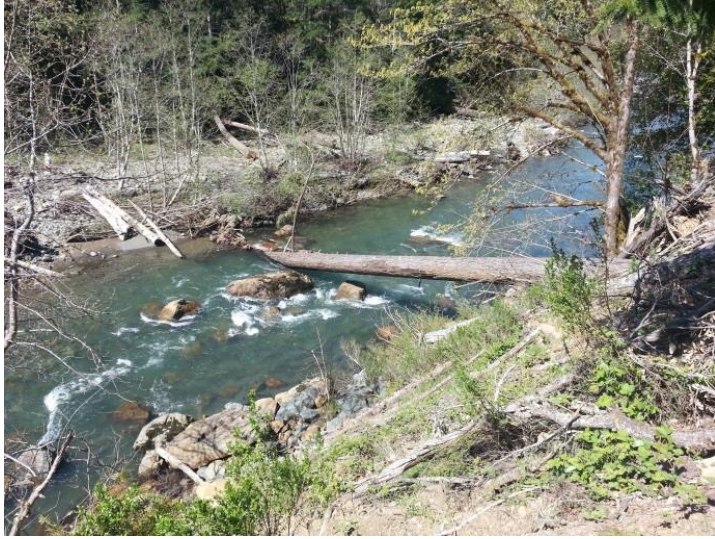
Figure 3- 17. Log placement on South Fork Coquille River at Daphne Grove Campground in early spring flow, April 2014.

Since this project was very recently implemented, it is difficult to measure overall project results. Wood placements did interact with winter flows but have not trapped a great deal of material as of yet (Figure 3-17). It might be several years before tangible results are realized. Project managers are confident that slowing flows and providing winter refugia objectives have been met. The original Whole Watershed Restoration Initiative (WWRI) grant application acknowledged that it may take 5-10 years for some of the objectives to be met (CWA, 2011). It does not appear that significant sediment sorting is occurring in the side channel. None of the project logs have left the site, so the project has been successful in that regard. Managers will continue to monitor this wood placement project, hoping to improve on subsequent projects.

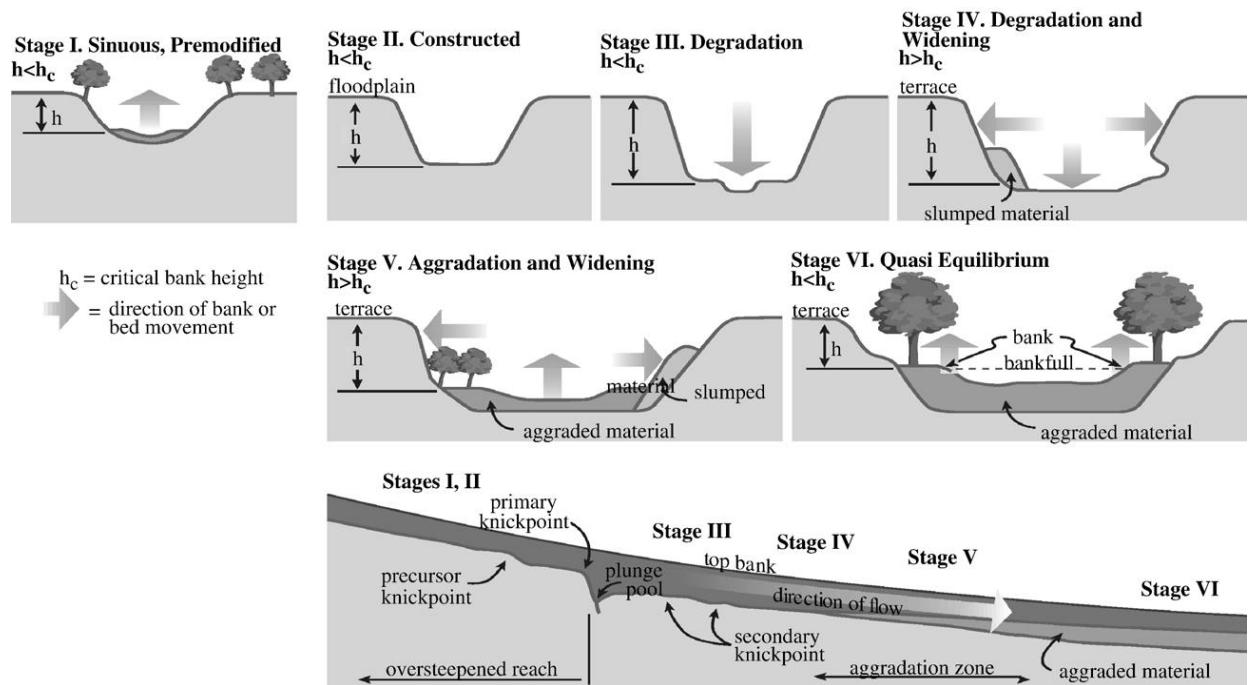
Figure 4- 1. Stages of evolution (Figure 7 in Simon and Rinaldi, 2006; modified from Simon and Hupp, 1986).

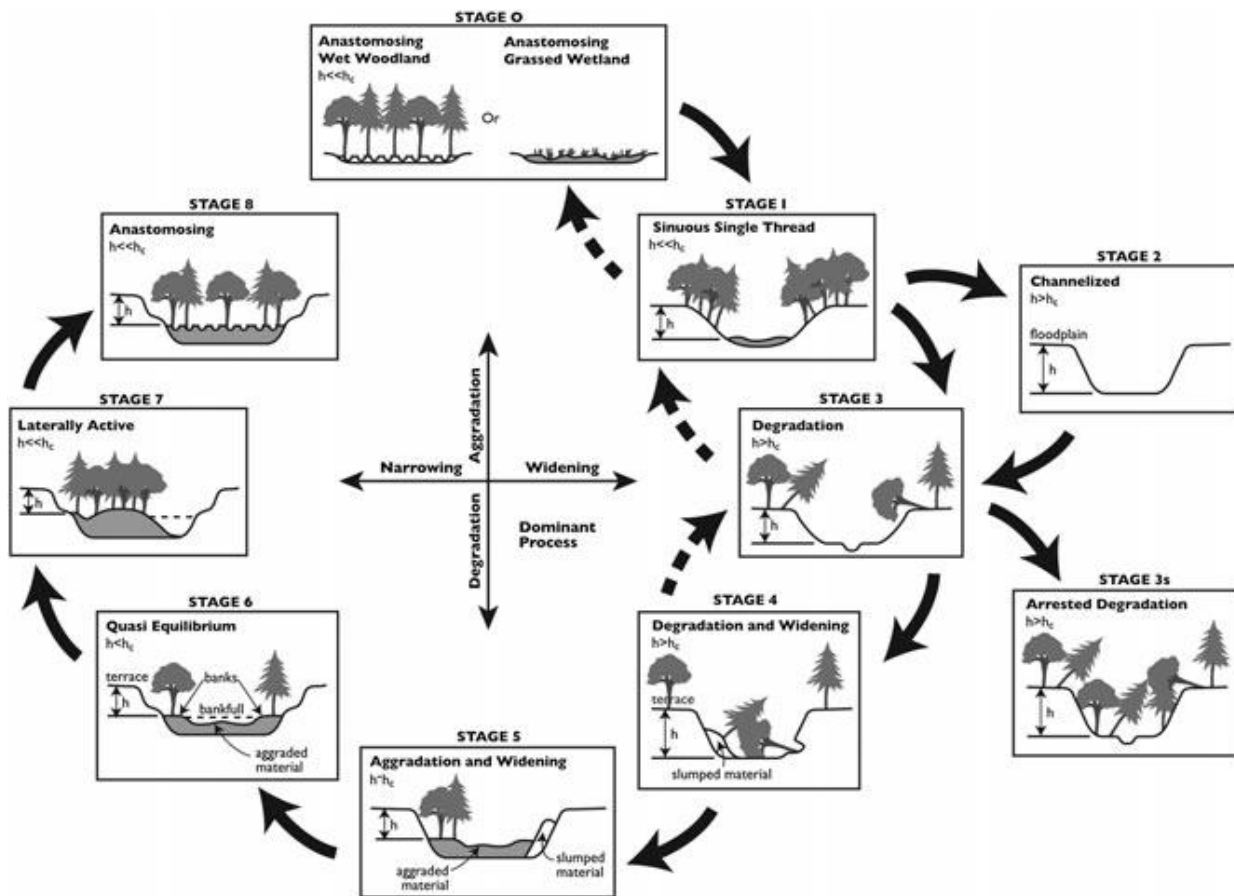
Figure 4- 3. Stream evolution model based on Simon and Rinaldi (2006) and Figure 4-2 inserting a pre-disturbance stage (Stage 0) and two late-stage evolution stages (Stages 7 and 8) (Figure 4 in Cluer and Thorne, 2013).

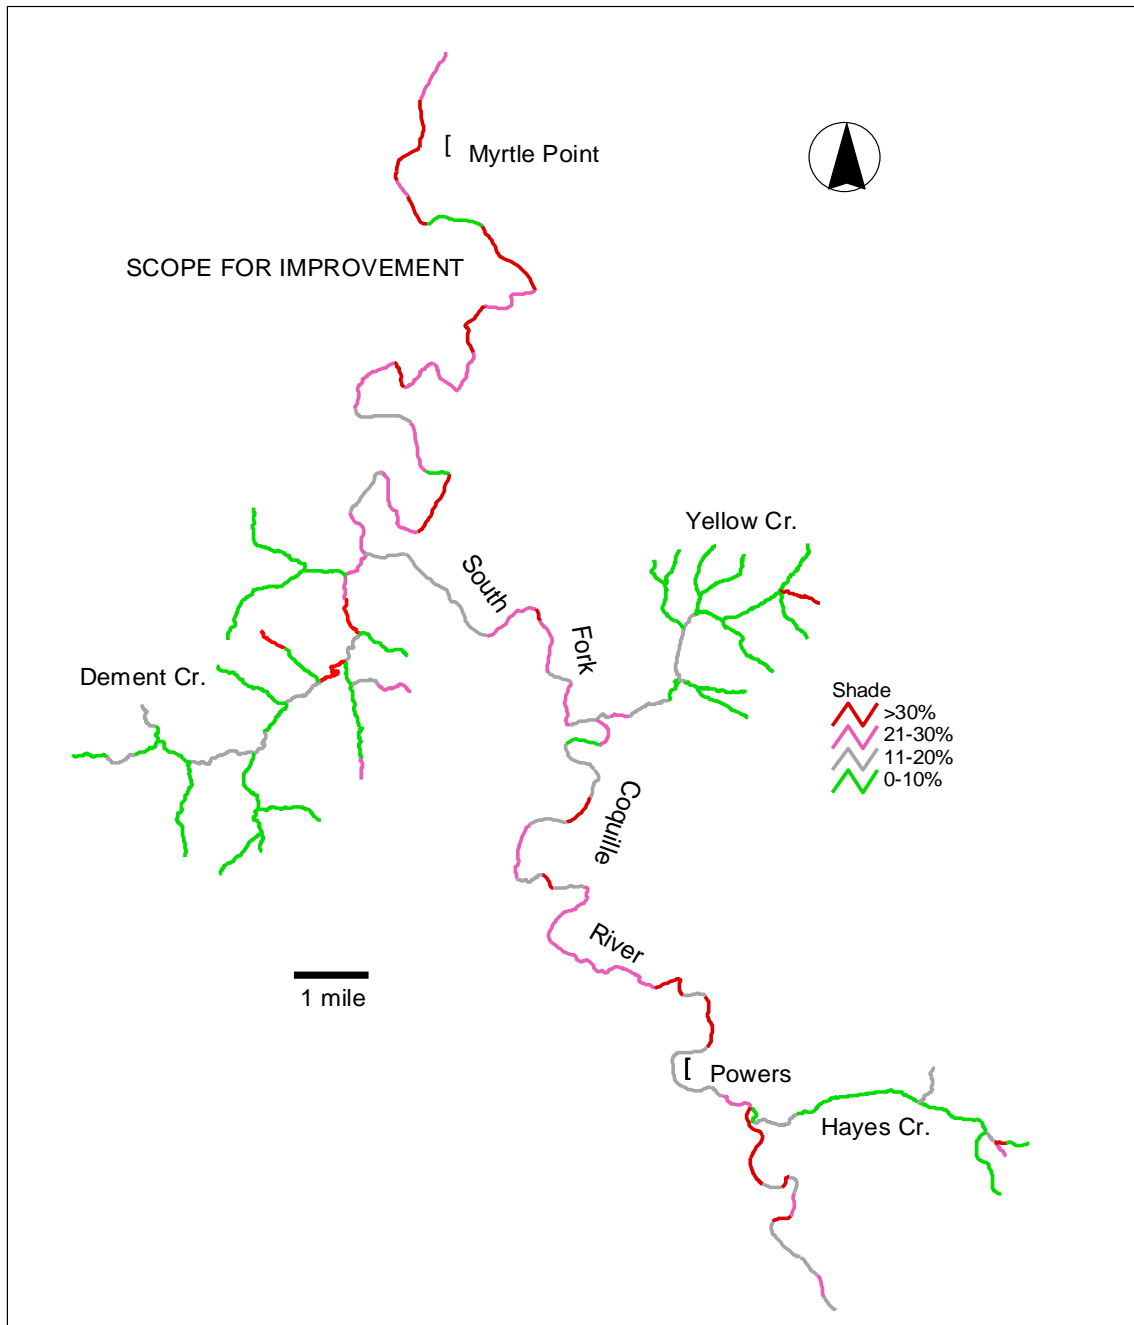
Figure 5- 1. Spatial variation in scope for improvement in stream shading within the lower South Fork Coquille River study area (Figure 22 in Clearwater BioStudies, Inc., 2003).

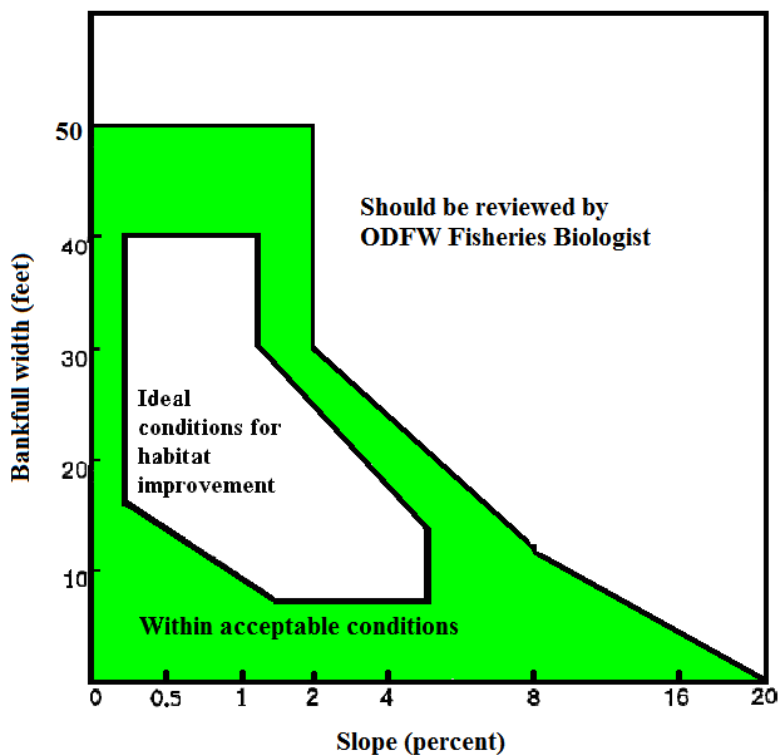
Figure 6- 1. Stream slope and bankfull width which, taken together make for ideal, acceptable, or requires additional review of the large wood placement design that is based on literature review and ODFW fish biologist experience (ODFW, 2010).

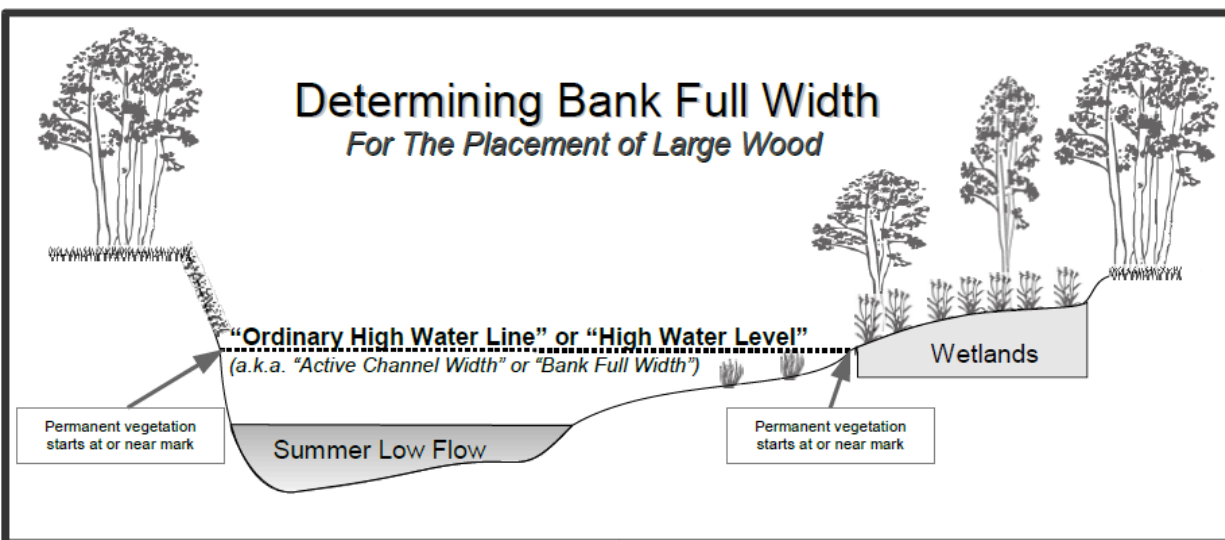
Figure 6- 2. Cross section of a stream with normal and bankfull flow levels indicated. Area above bank full would be considered floodplain (ODFW, 2010).

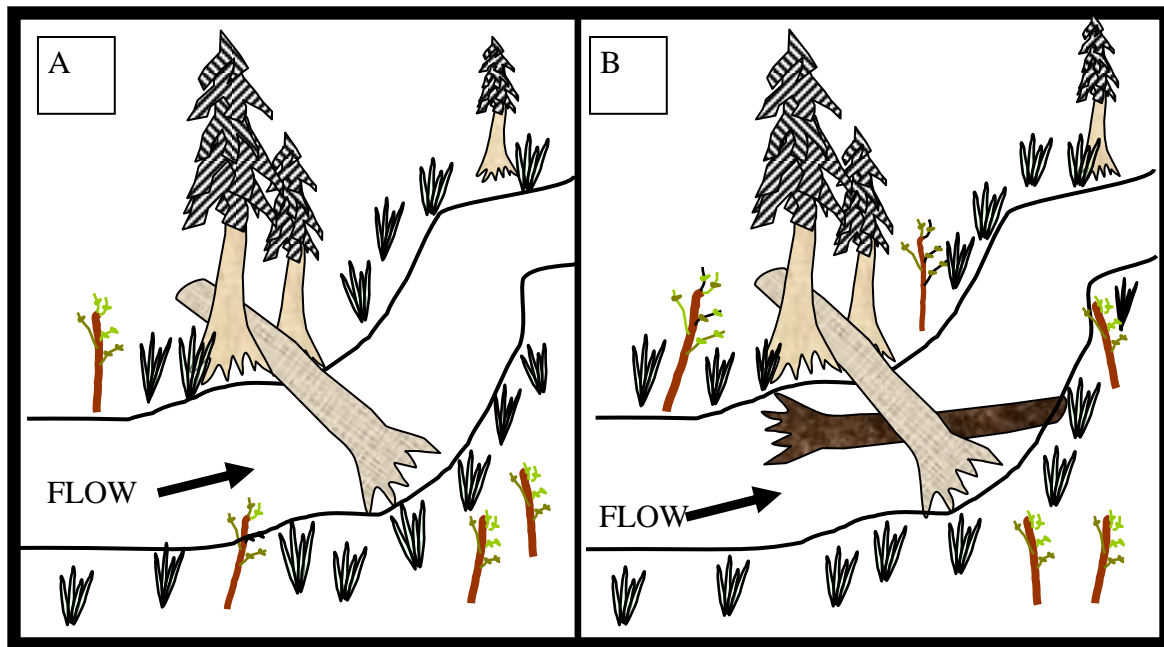
Figure 6- 3. Panel A is single log placed between two standing trees to create a pivot and lock point. Panel B is an X pattern where the weight of the top log pins the bottom log to reduce the movement. Not shown is coarse wood (CW) or limbs that will create better habitat (ODFW, 2010).

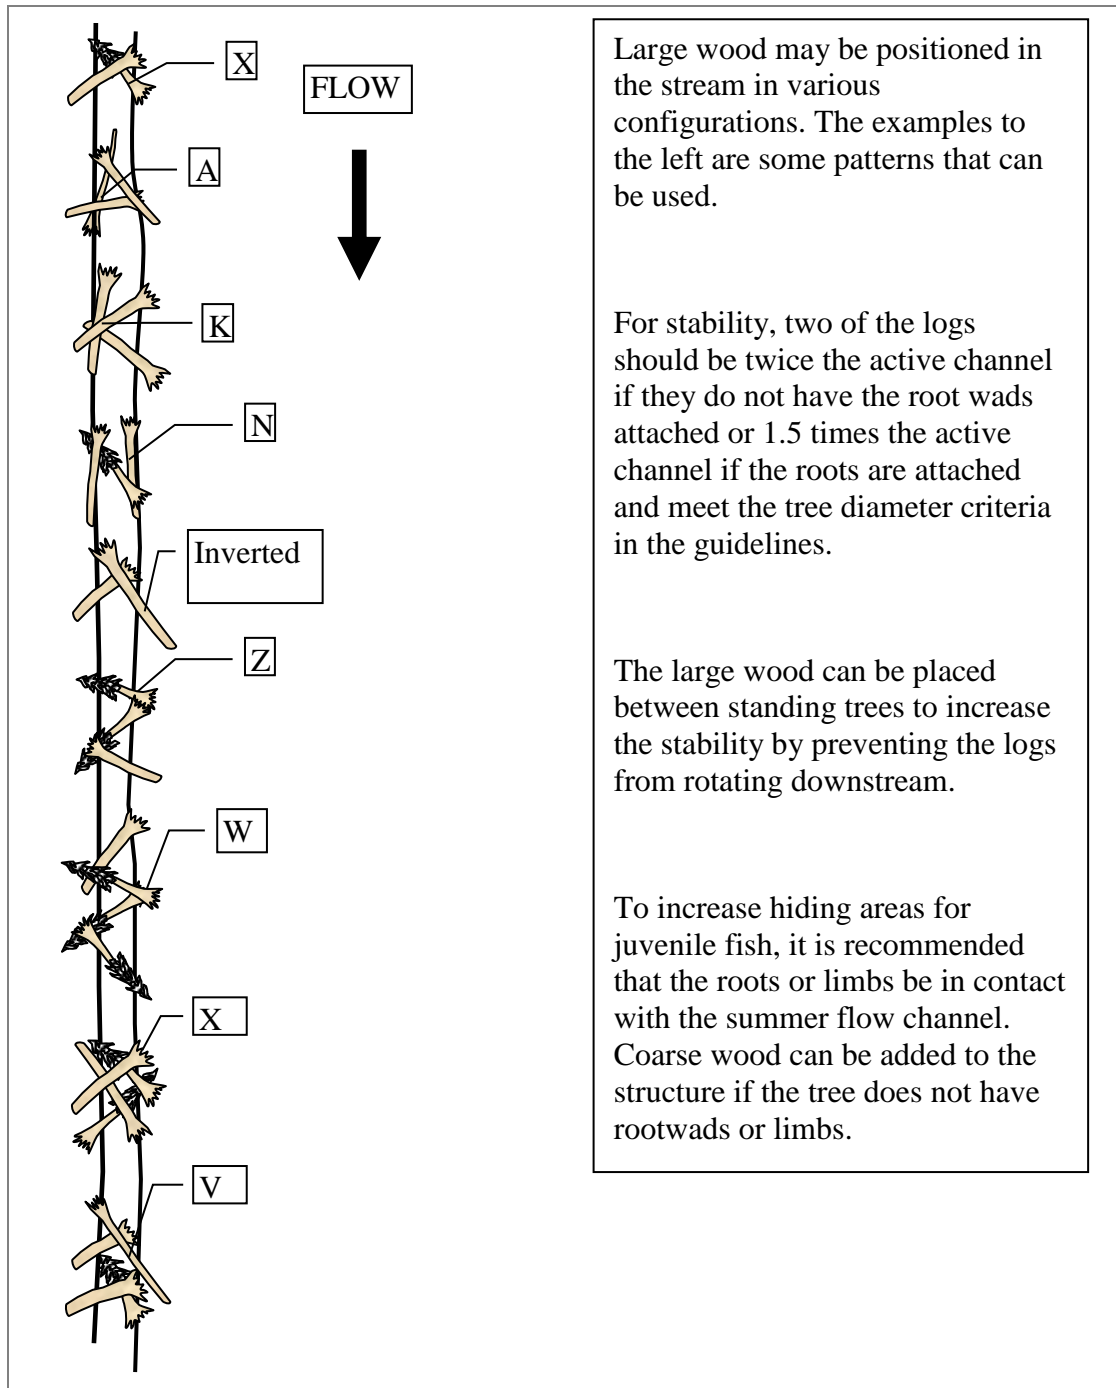
Large wood may be positioned in the stream in various configurations. The examples to the left are some patterns that can be used.

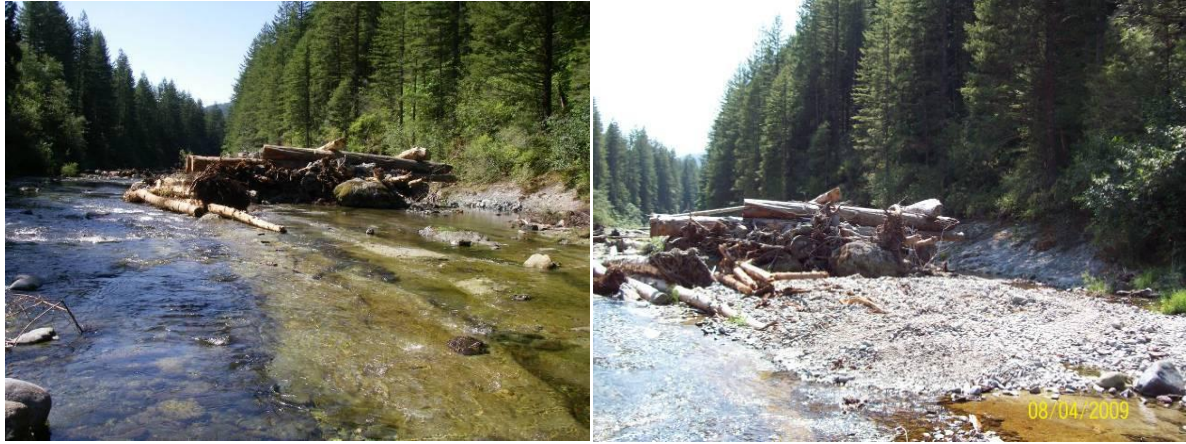
Figure 6- 5. Significant gravel accumulation one year after construction of a river log jam. (Left) post-construction. (Right) one year after construction (Washougal River, WA, Tony Meyer as cited in Cramer, 2012).

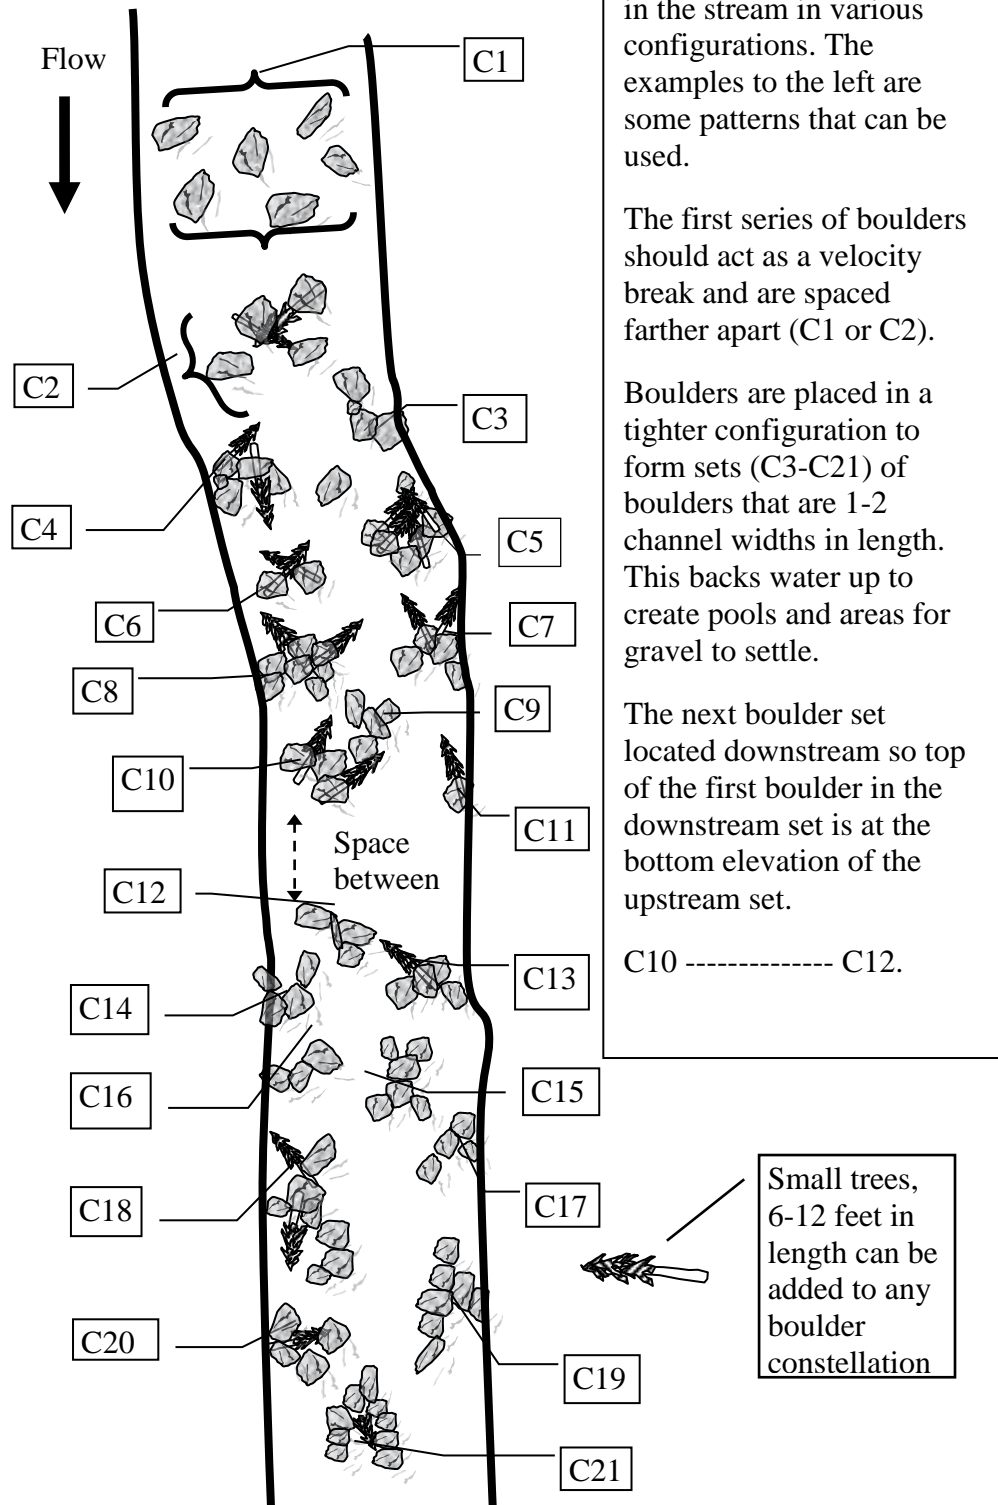
Boulder Constellations

Figure 6- 6. Examples of boulder constellations that can be used to slow the water down to collect gravel. Each constellation may have their orientation changed to meet the site-specific requirements. For clarity of the illustration, the boulder constellations are spaced further apart than what will be used in the habitat restoration project (ODFW, 2010).

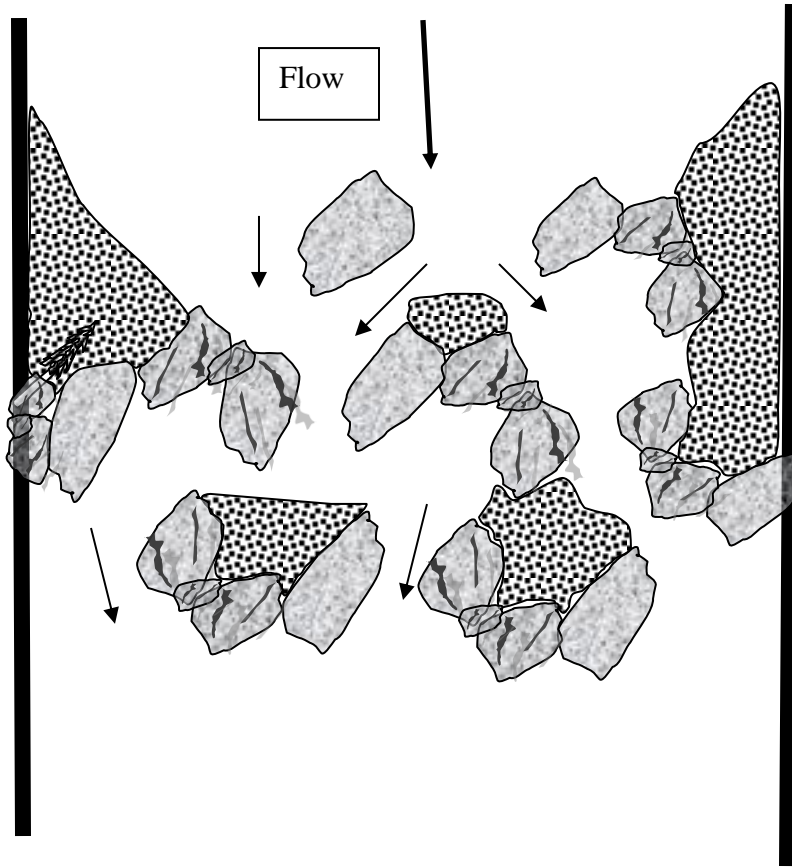
Figure 6- 7. Accumulation of bed load material above boulder constellations with gaps to allow fish passage for all life stages at all flows (ODFW, 2010).

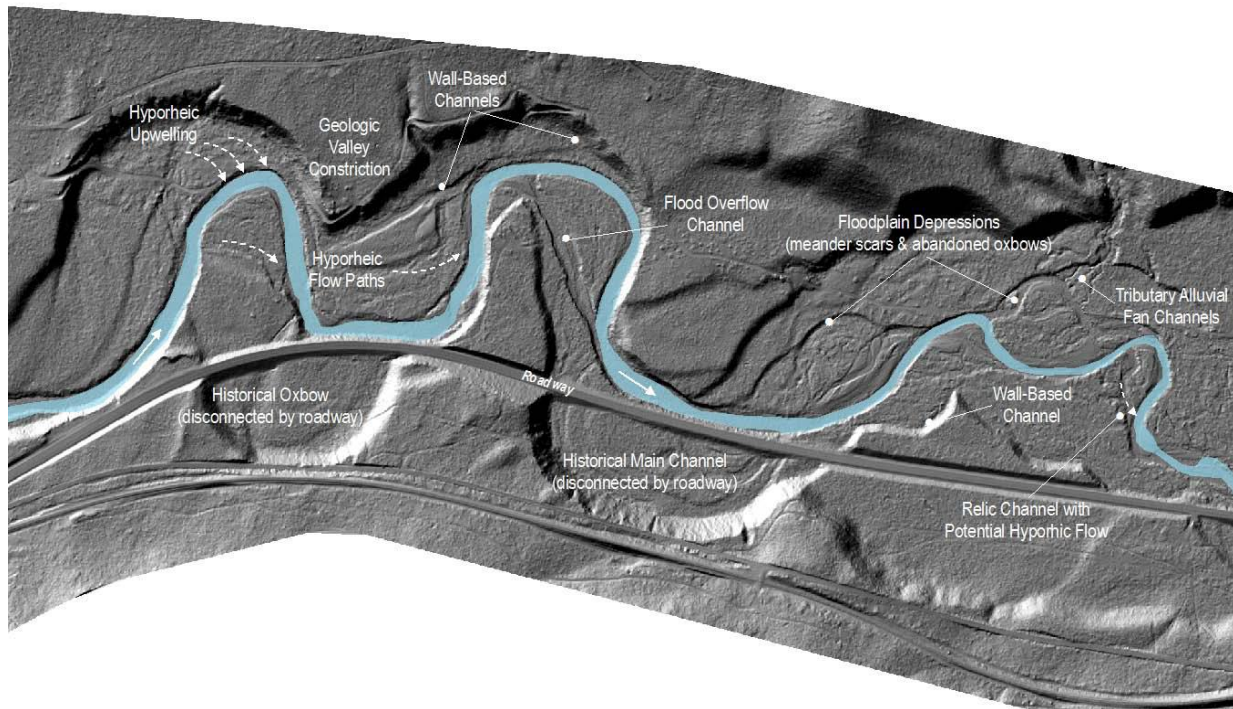
Figure 6- 8. Hill shaded relief map showing geomorphic features that may indicate the potential for side channel projects (Cramer, 2012).

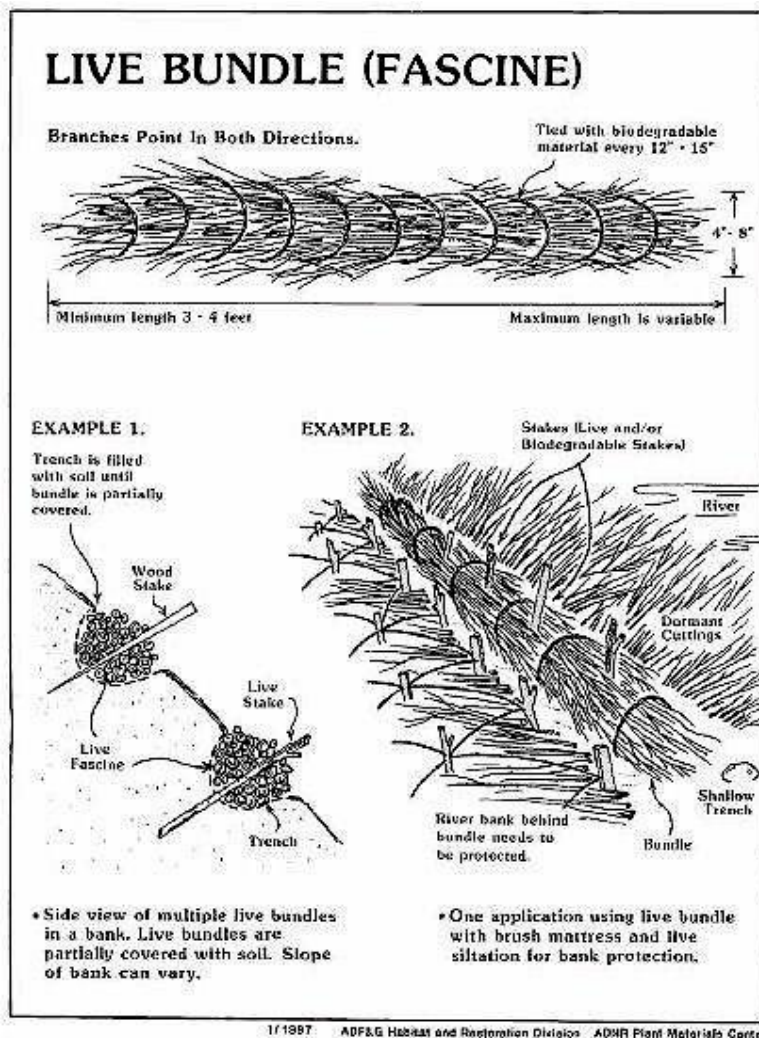
Figure 6- 9. Examples of live bundle (fascine) techniques (ADFG, 2005).

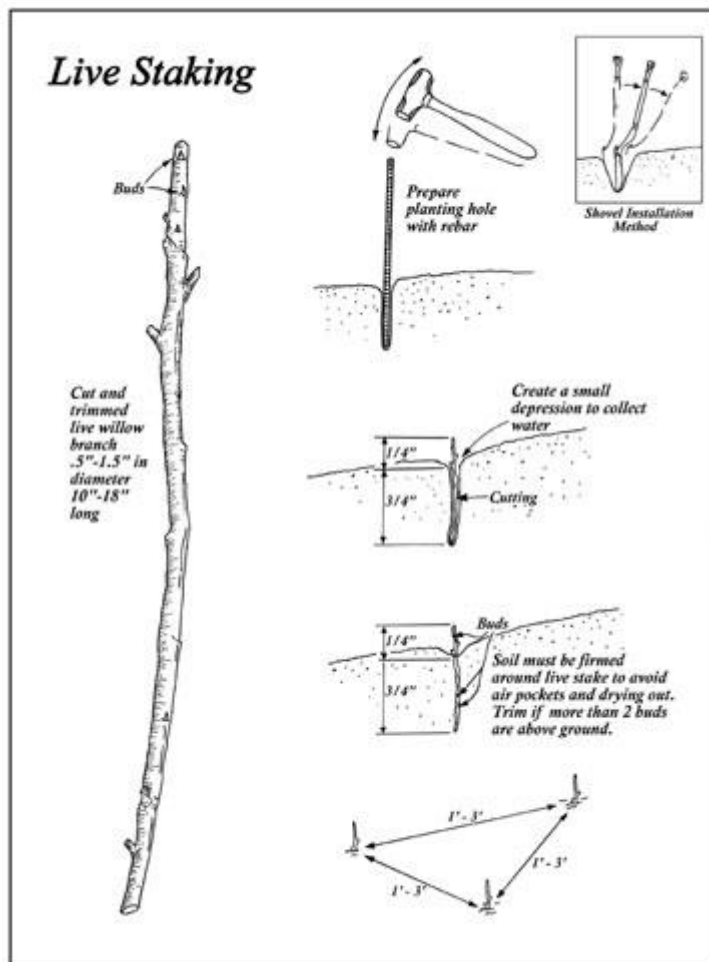
Figure 6- 10. Live staking technique (ADFG, 2005).

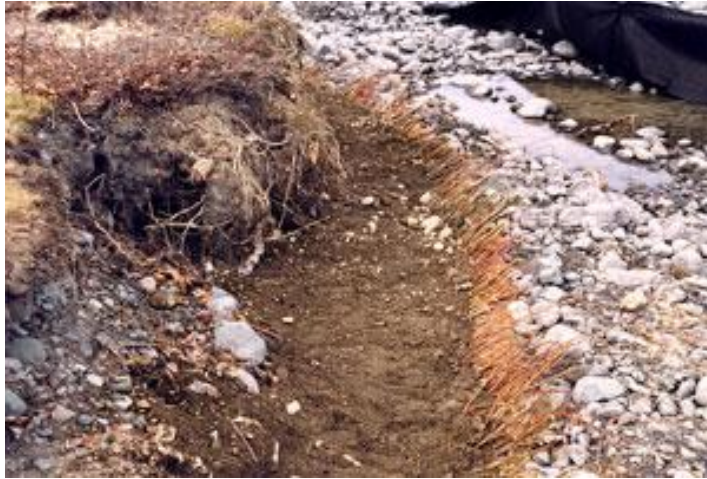
Figure 6- 12. Live siltation during construction (ADFG, 2005).

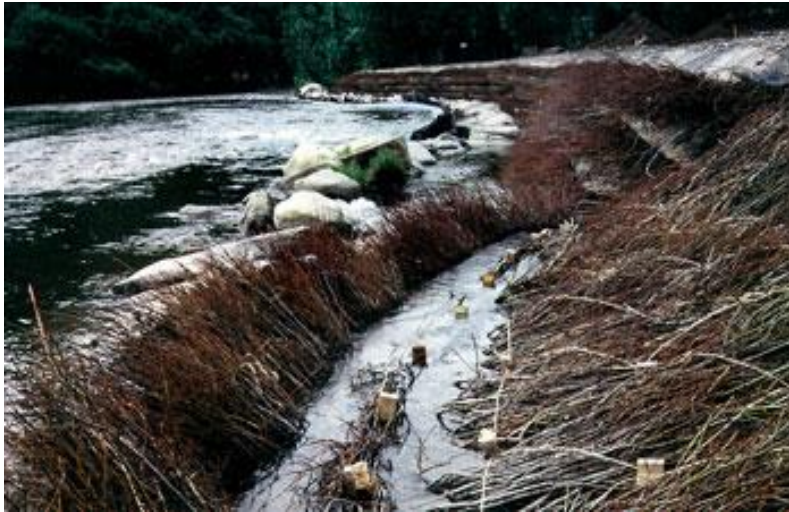
Figure 6- 13. Brush mat and live siltation constructed in Alaska in 1994. Bundles were used to provide a transition between the two techniques (ADFG, 2005).

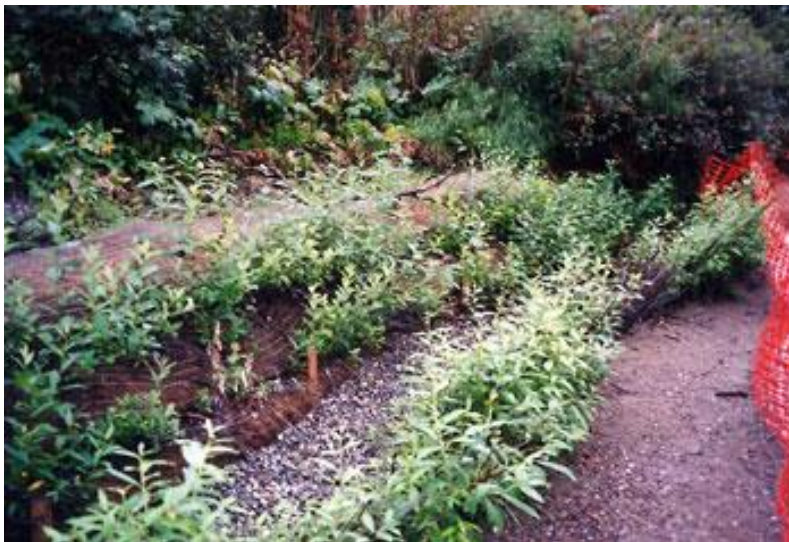
Figure 6- 14. Live siltation and brush layering at the Little Susitna River, Alaska (ADFG, 2005).

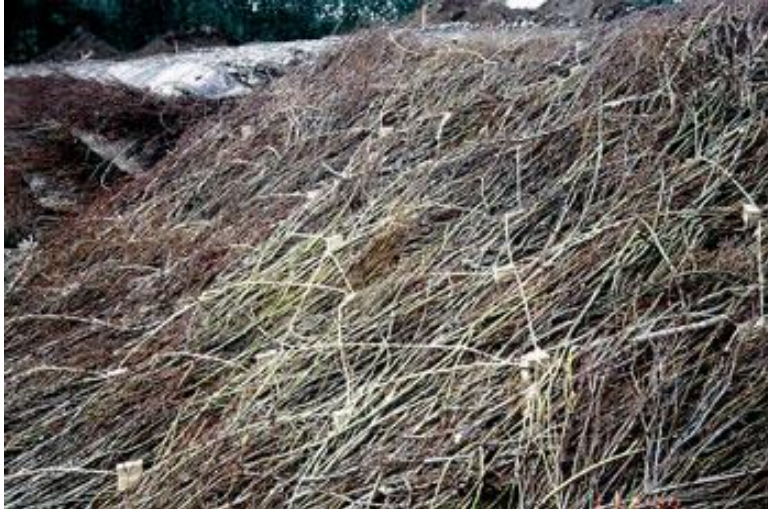
Figure 6- 15. A brush mat - note the crisscross pattern of the jute used to anchor the mat to the bank (ADFG, 2005).

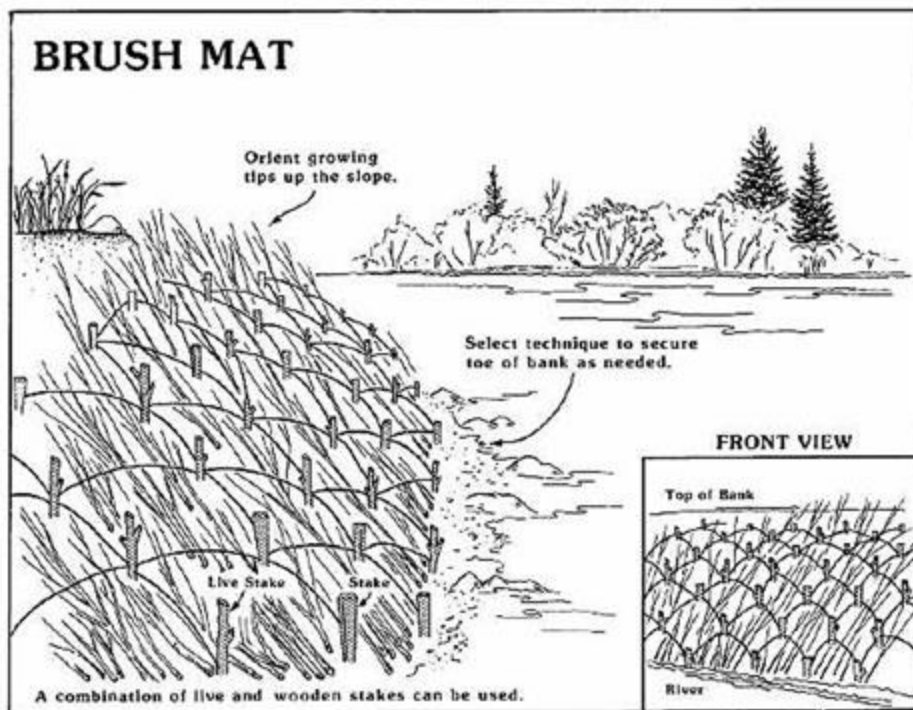
Figure 6- 16. Example of brush mat stabilization technique (ADFG, 2005).

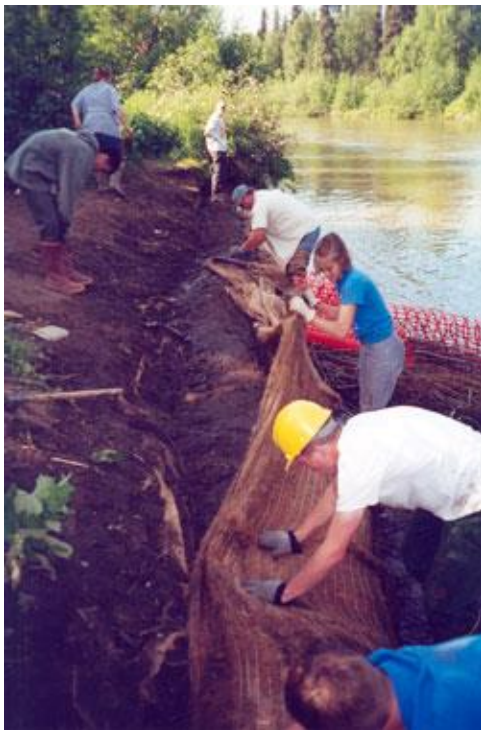
Figure 6- 18. Installation of brush layering, Little Susitna River, Alaska (Youth Restoration Corp from ADFG, 2005).

- Prepare a bench, which corresponds to the bank depth necessary to stabilize the slope, either through excavation or building up the slope, so that it angles slightly down and into the bank (Figure 6-18). It is important to note the upstream and downstream riparian species and slope height and angle when designing a brush layer project. Specifications should represent the local native environment as much as possible. If the surrounding area has been greatly impacted, observation further upstream and downstream may be necessary. Place fifteen dormant branches on the bench per foot or ten rooted cuttings per foot, slightly crisscrossed (see Hedge Brush Layering/Brush Layering section). A mixture of dormant cuttings and rooted plants may be used. The cut or rooted ends are placed into the slope with the tips extending beyond the edge of the bench **no more than 1/4 of the total branch length** (Figure 6-19). Place 2 to 4 inches of soil on top of the branches, water and tamp into place.

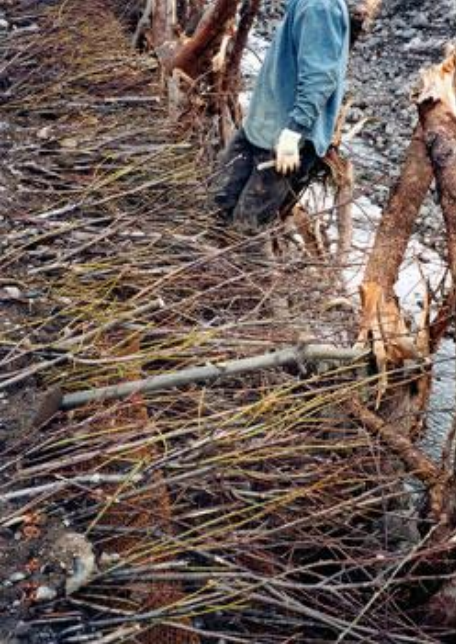
Figure 6- 19. Brushlayer installation prior to trimming, Centennial Park, Kenai River, Alaska (ADFG, 2005).

- Collection, storage and planting information are described in the Dormant Cuttings section of Riparian Planting. Different species of woody cuttings that root easily (see Plant Species Selection List, Shrubs and Trees) can be mixed in the layers (Figure 6-19); rooted plants can also be added to create a hedge-brush layer. Rooted plants may be planted throughout the growing season from spring through early fall. Dormant plants, if collected in the spring, should be planted late winter/early spring.

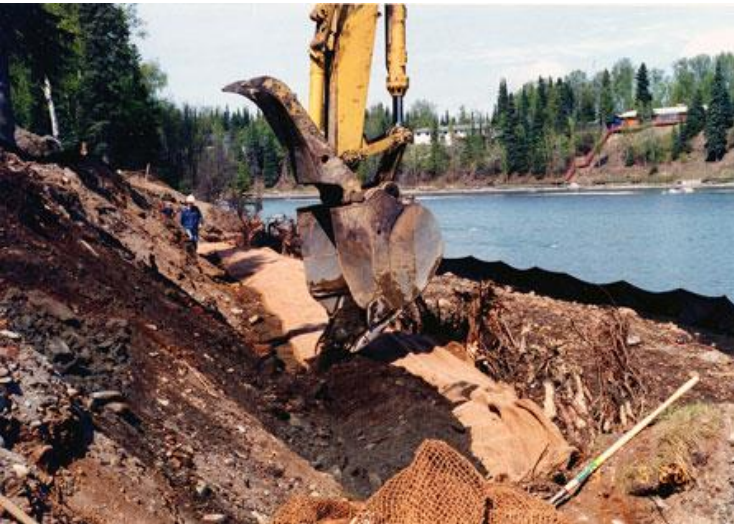
Figure 6- 20. Rootwad and brush layering bank stabilization, Centennial Park, Kenai River, Alaska (ADFG, 2005).

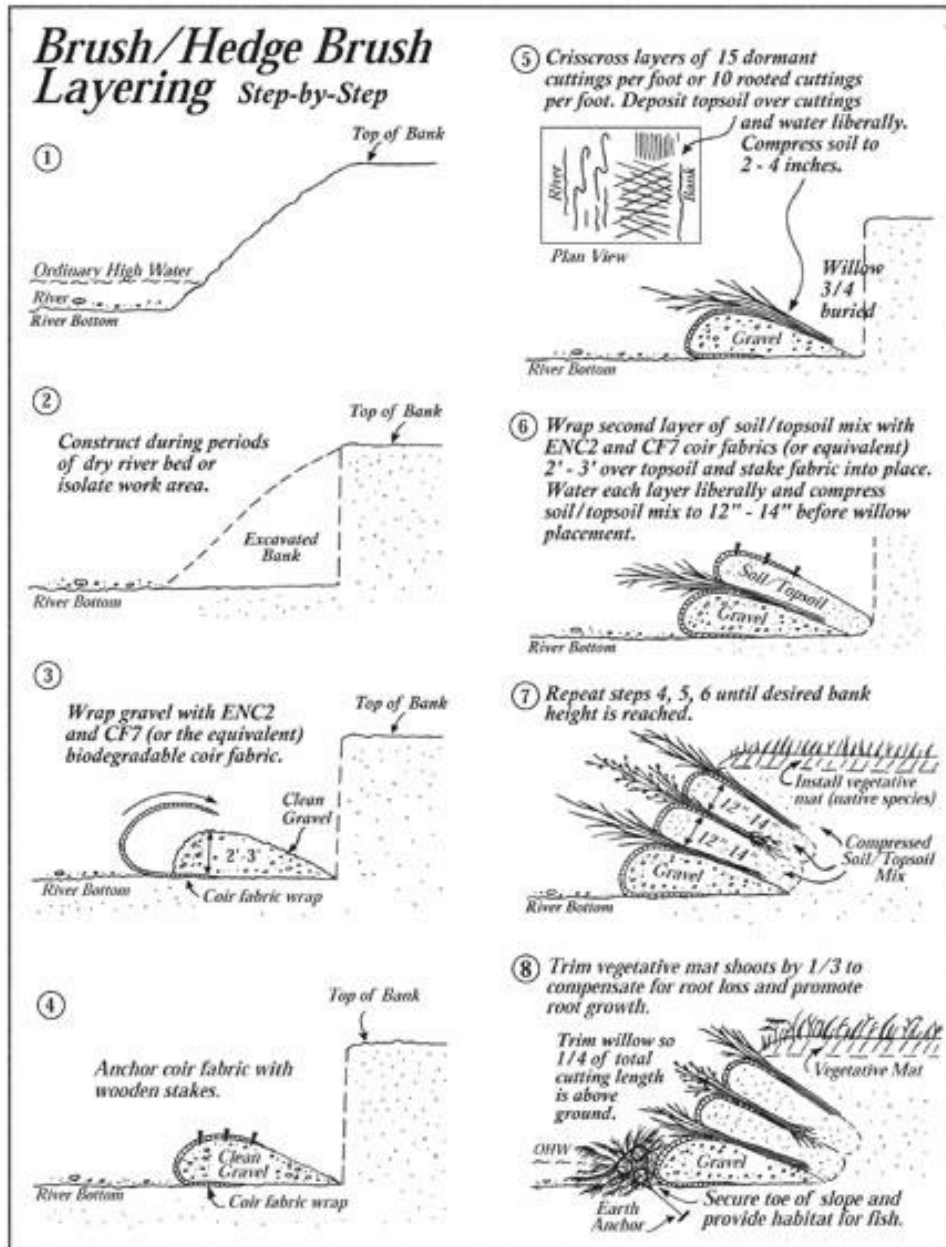
Figure 6- 21. Step-by-step guide to brush layering (ADFG, 2005).

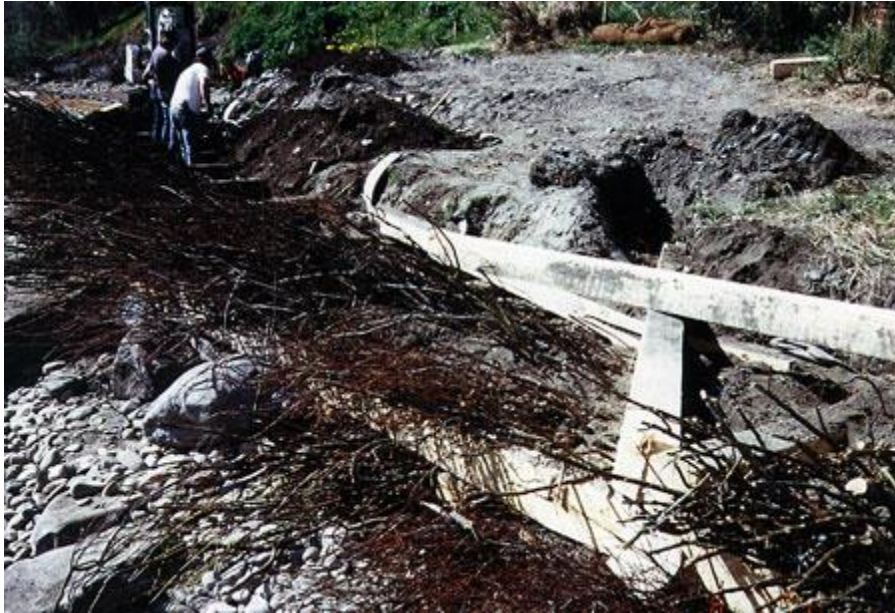
Figure 6- 23. Vegetated cribbing project under construction. Note cross timbers. Project located on the Kenai River, Alaska (ADFG, 2005).
