South Fork Coquille Watershed Action Plan

Coquille Watershed Association

December 2, 2014

**Prepared by the South Fork Coquille Technical Advisory
Committee**

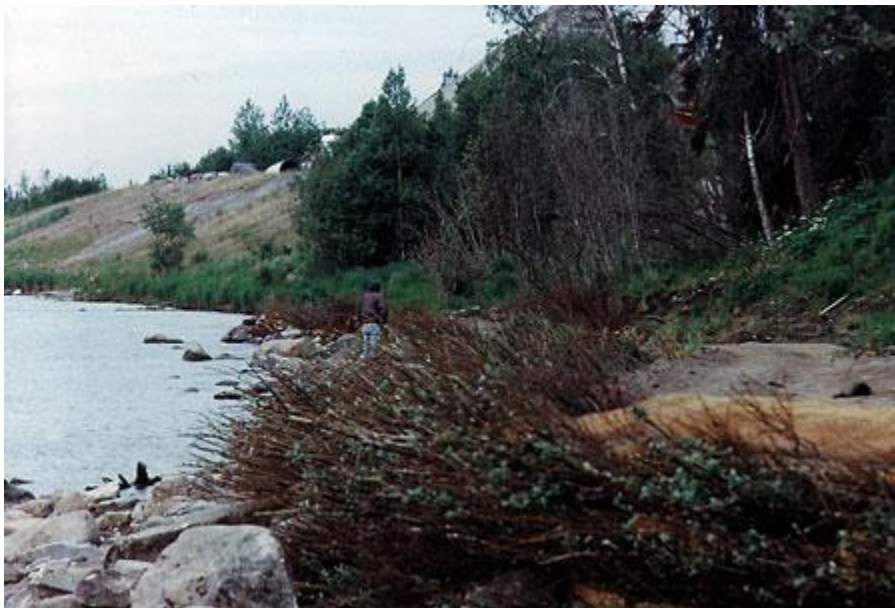
Figure 6- 24. Vegetated cribbing three weeks after installation (ADFG, 2005).

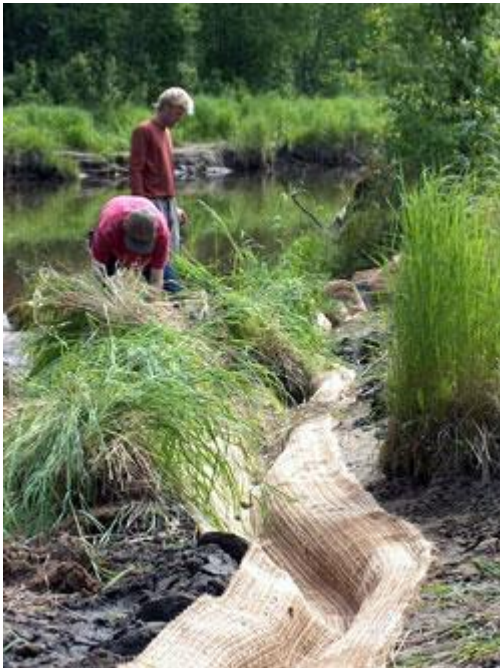
Figure 6- 25. Grass roll installation, mouth of Willow Creek, Alaska (ADFG, 2005).

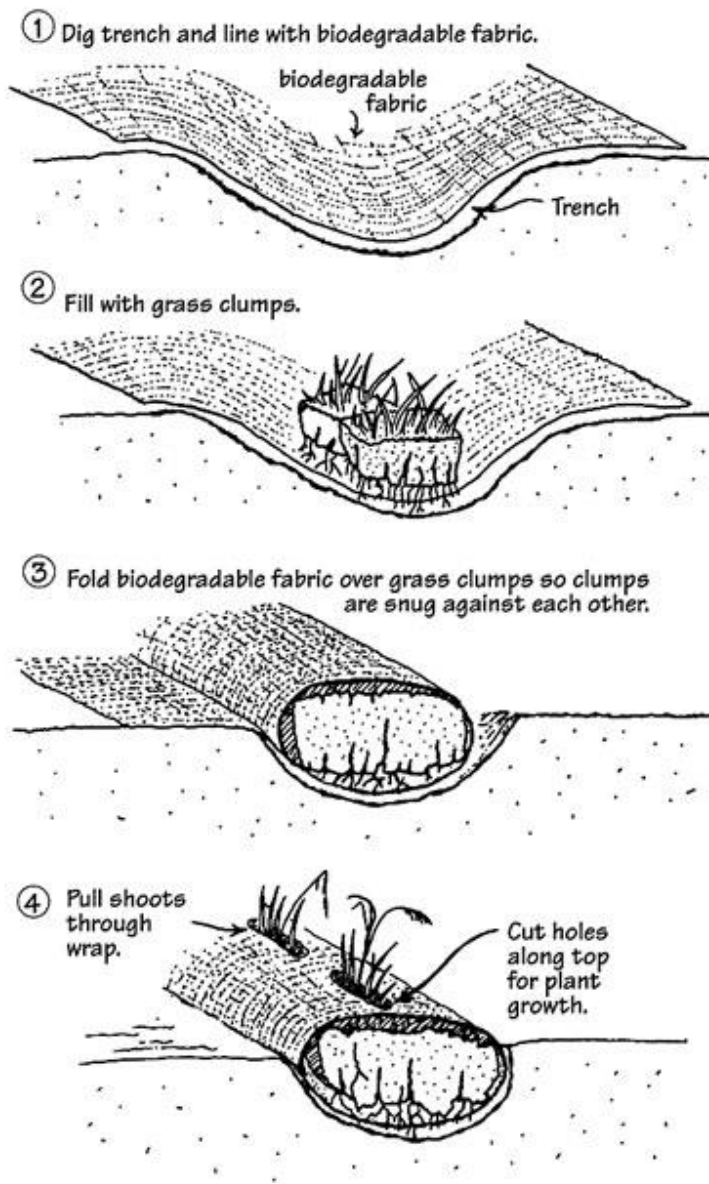
Figure 6- 27. Step-by-step guide to grass roll construction (ADFG, 2005).

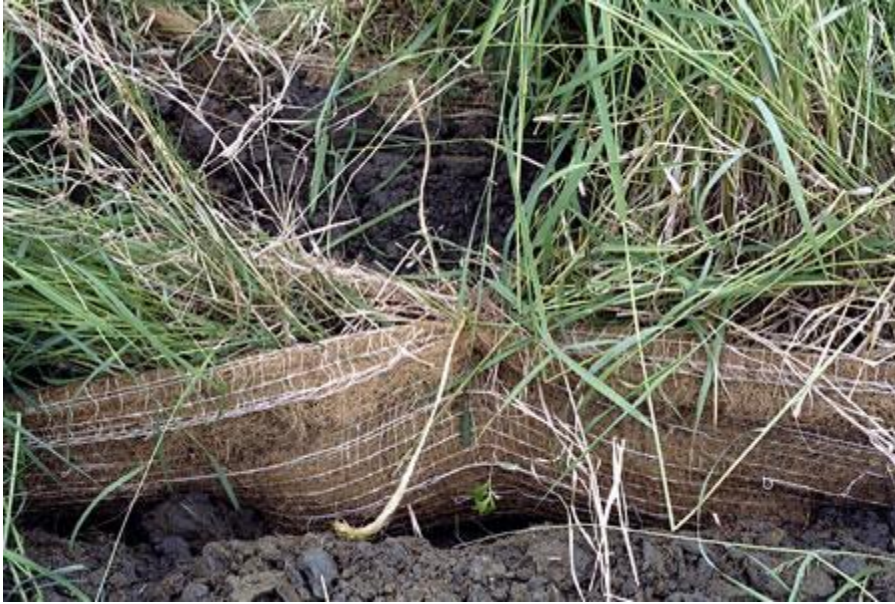
Figure 6- 28. Grass roll installation at the mouth of Willow Creek, Alaska (ADFG, 2005).

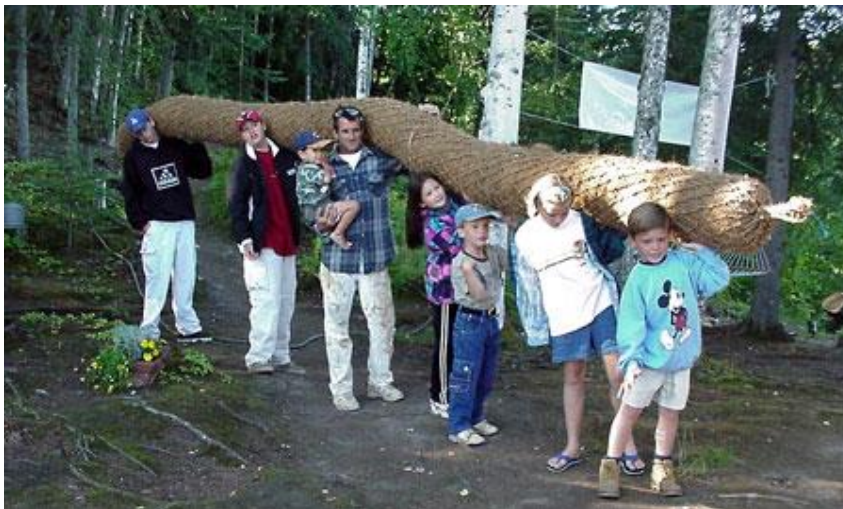
Figure 6- 29. Sherman family moving coir log to site at Big Lake, Alaska (ADFG, 2005).

Coir logs are constructed of interwoven coconut fibers that are bound together with biodegradable netting. Commercially produced coir logs come in various lengths and diameters (Figure 6-29). The product needs to be selected specifically for the site. Fiber logs composed of other sturdy biodegradable materials may function equally as well.

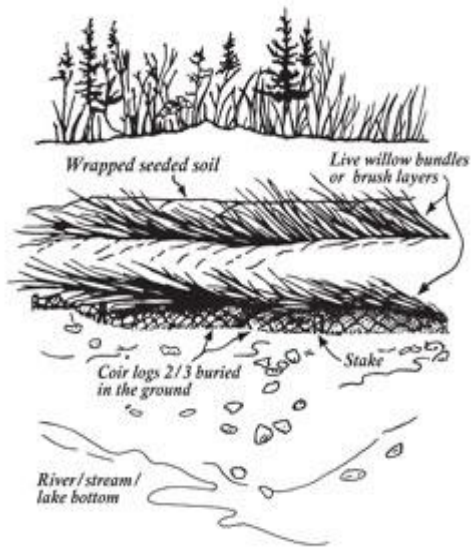
Figure 6- 30. Coir log location in proximity to water's edge (ADFG, 2005).

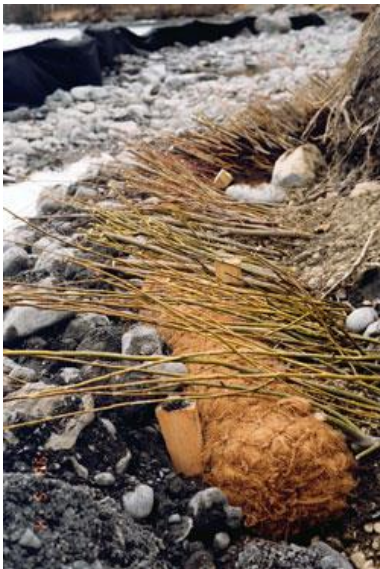
Figure 6- 31. Installation of coir log toe protection, Eagle River, Alaska (ADFG, 2005).

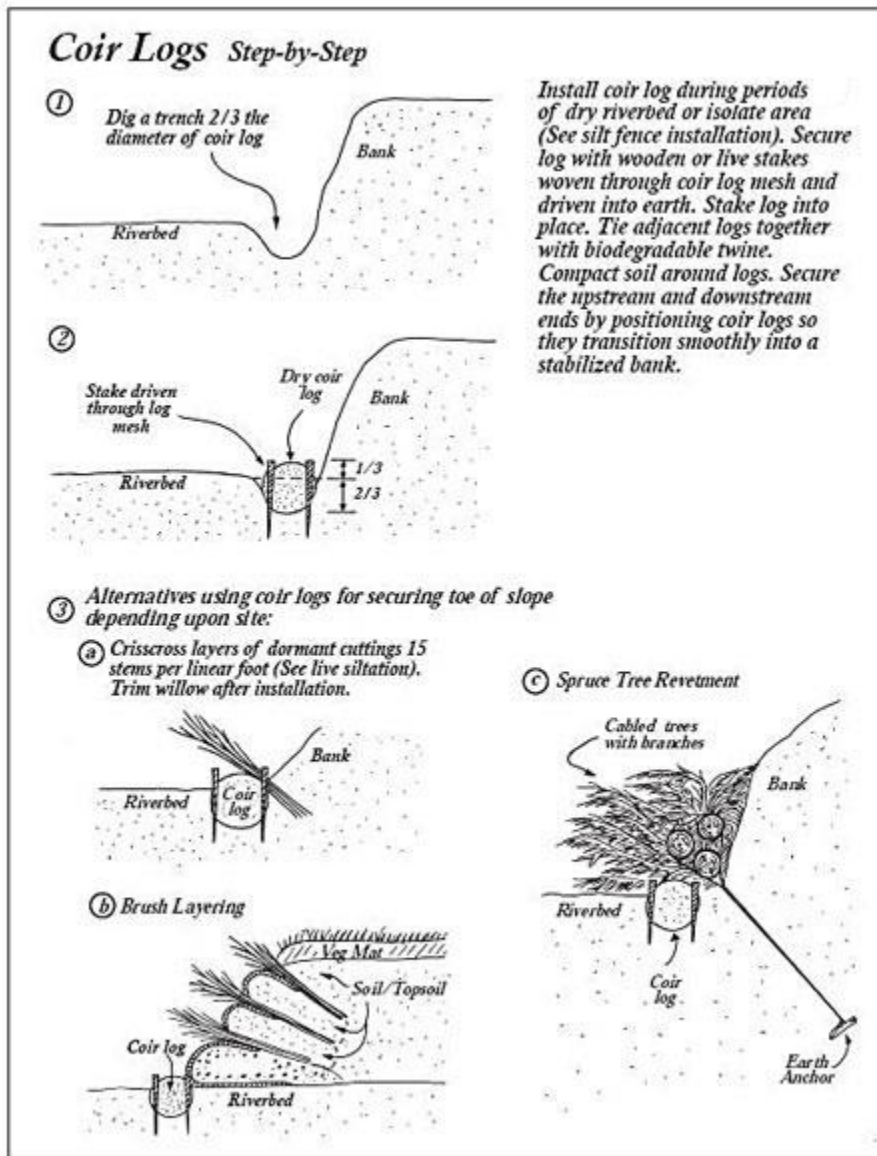
Figure 6- 32. Step-by-step guide to coir log construction (ADFG, 2005).

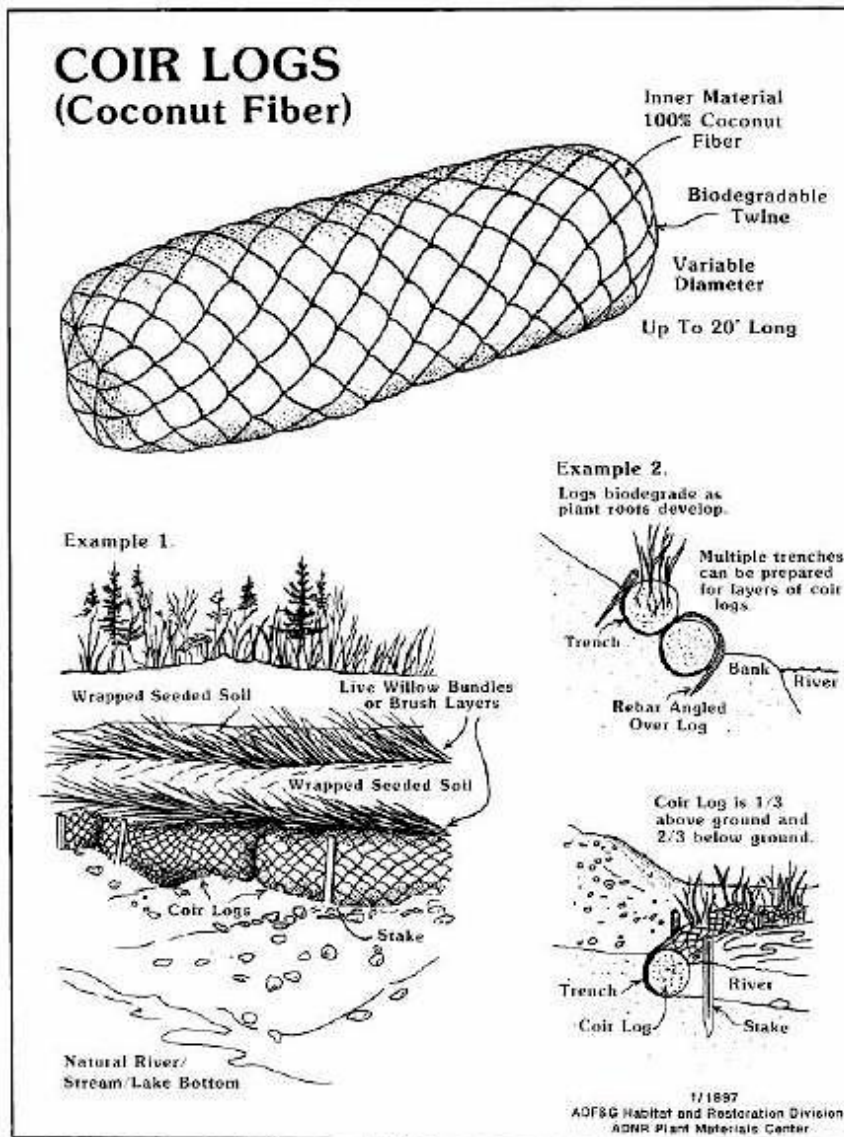
Figure 6- 33. Coir log installation (may be up to 20 feet long) (ADFG, 2005).

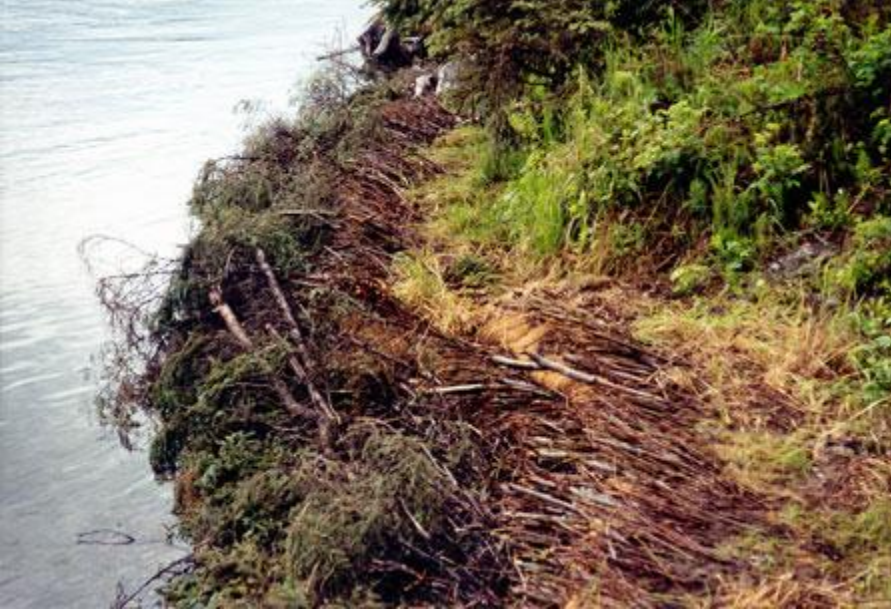
Figure 6- 34. Cabled spruce trees and brush layering immediately after installation of a conifer tree revetment, Ciechanski Recreation Site, Kenai River, Alaska (ADFG, 2005).

Conifer tree revetments protect streambanks from erosion and provide increased bank protection (Figure 6-34). This is a relatively inexpensive and functional bank protection technique. Conifer tree revetments trap sediment, and over time, aid in rebuilding bank structure and establishing long-term bank stability. The tree limbs reduce near-bank water velocities, provide protection from scour and erosion, provide cover for juvenile fish, and act as a source of organic debris.

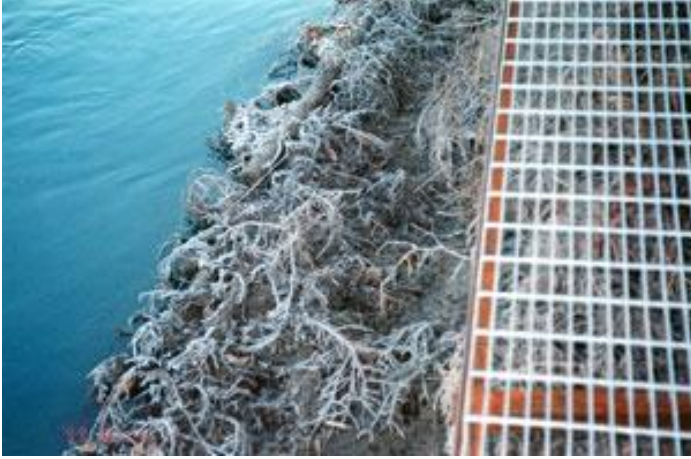
Figure 6- 35. Sediment in cabled spruce trees in a conifer tree revetment, Kenai River, Alaska (ADFG, 2005).

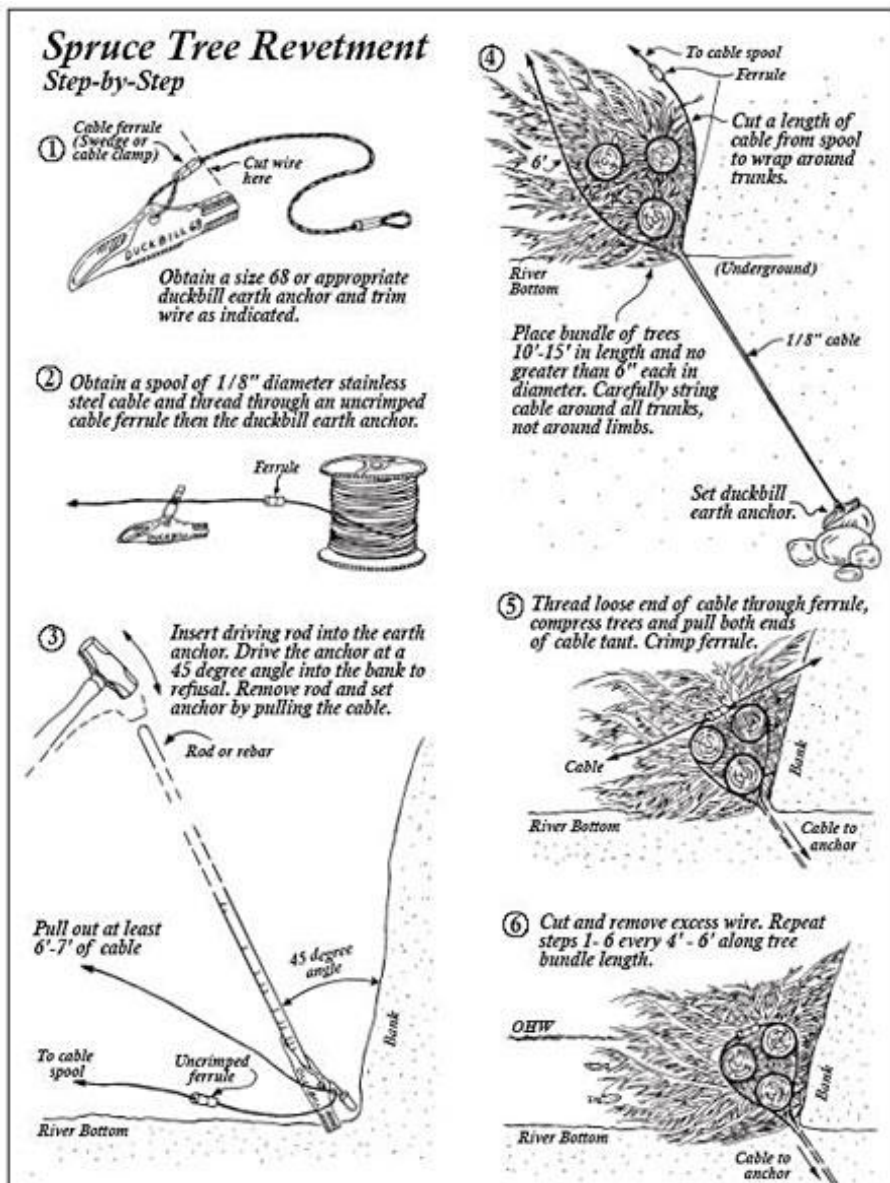
Figure 6- 36. Step-by-step guide to conifer tree revetment placement. The example shows a spruce tree revetment (ADFG, 2005).

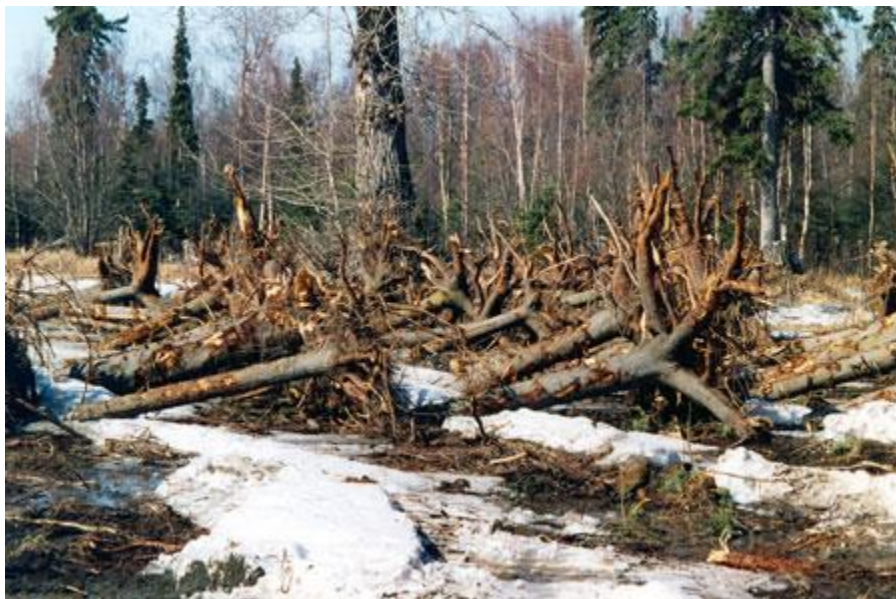
Figure 6- 37. Harvested rootwads before installation (ADFG, 2005).

- Identify a collection site and obtain permission to remove trees. Collect root wads from forested areas being cleared for development, or selectively remove from treed area (Figure 6-37). Do not remove trees from riparian zones. Be careful to avoid damage to other trees and vegetation during collection and clearing of root wads. Larger diameter trees (minimum of 12 inches DBH diameter breast height) can be pushed over when soils are not frozen, leaving root fans intact. The tree tops should be removed, leaving the trunks (boles) a minimum of 10 feet in length with root fans attached. Optimal root fans are a minimum of 5 to 6 feet in diameter.

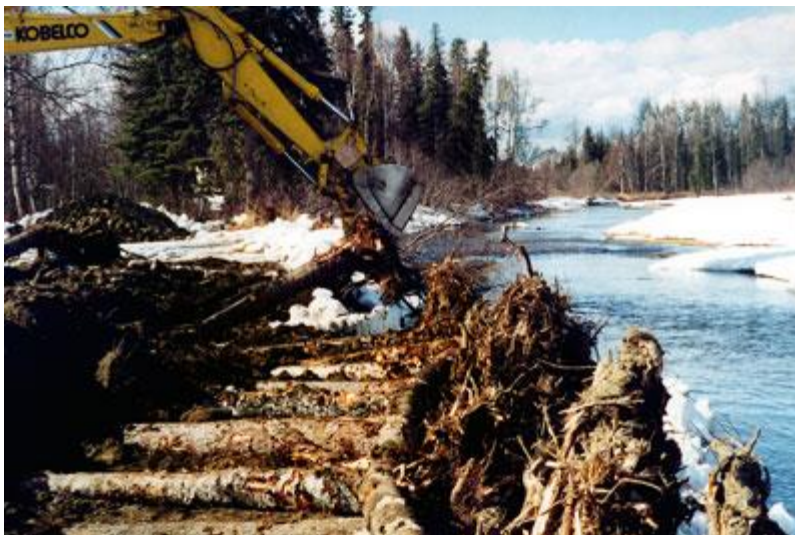
Figure 6- 38. Rootwad installation at Pioneer Lodge, Willow Creek, Alaska (ADFG, 2005).

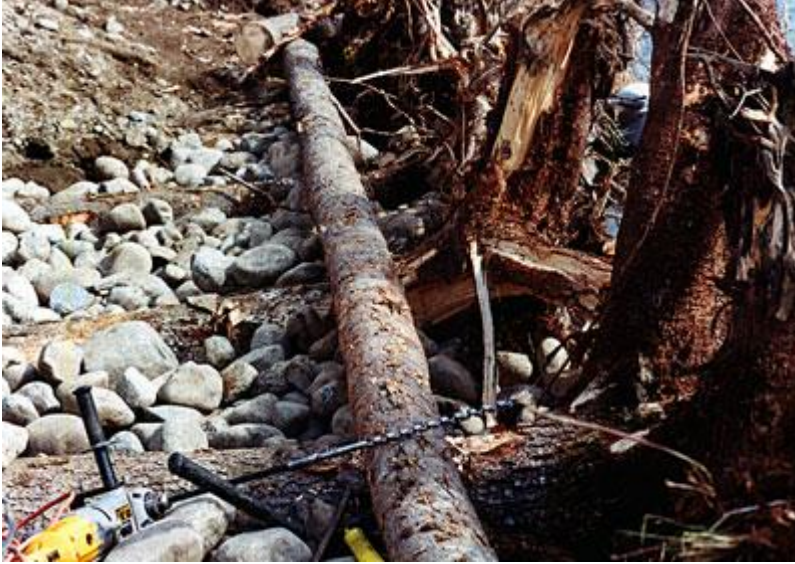
Figure 6- 39. Root wad, rock layer with header pinning (ADFG, 2005).

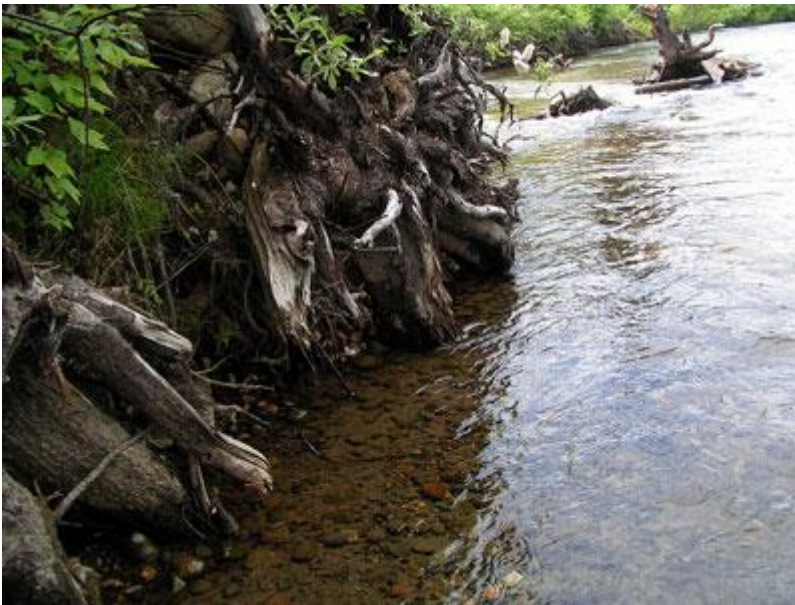
Figure 6- 40. Pioneer lodge root wads at low water levels (ADFG, 2005).

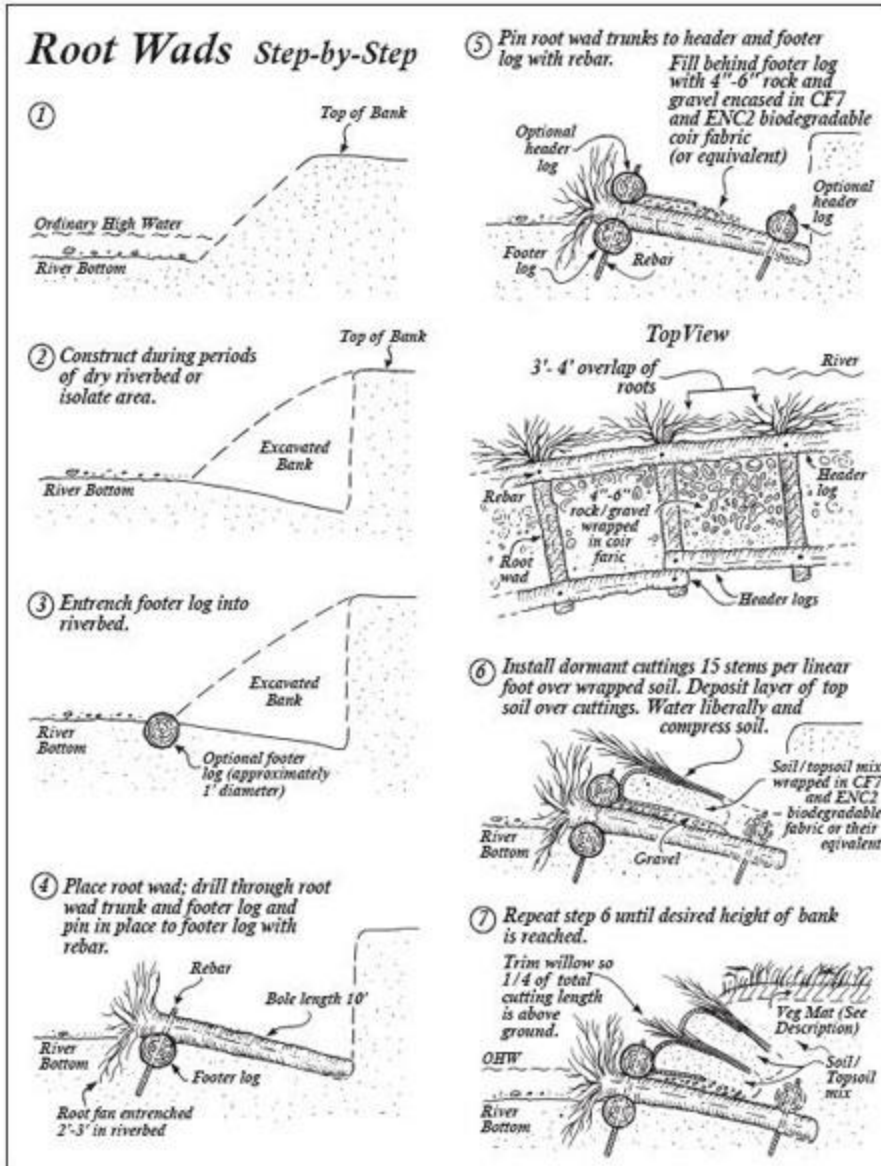
Figure 6- 41. Root wad step-by-step installation guide. (Consult an experienced professional to ensure rootwad placement is as effective as possible.) (ADFG, 2005).

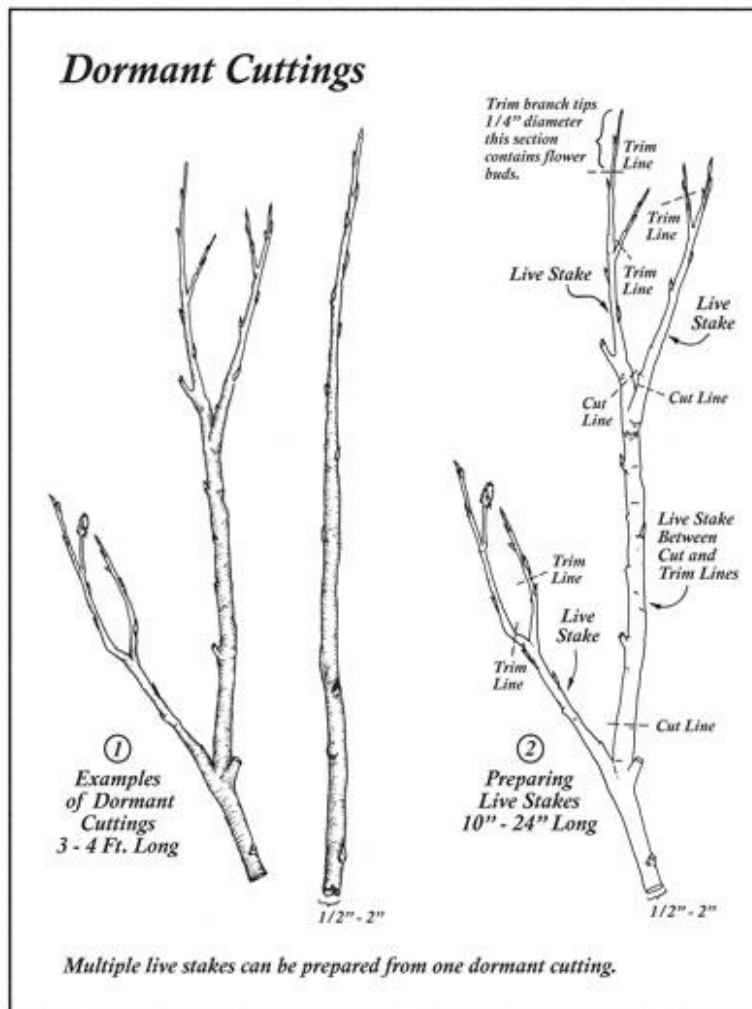
Figure 6- 42. Dormant cuttings - the essential building block of nearly every bank stabilization technique (ADFG, 2005).
