Winter Lake Restoration Effectiveness Monitoring

Report: Year 1

Created by:
Julie Huff, Monitoring Coordinator
Coquille Watershed Association

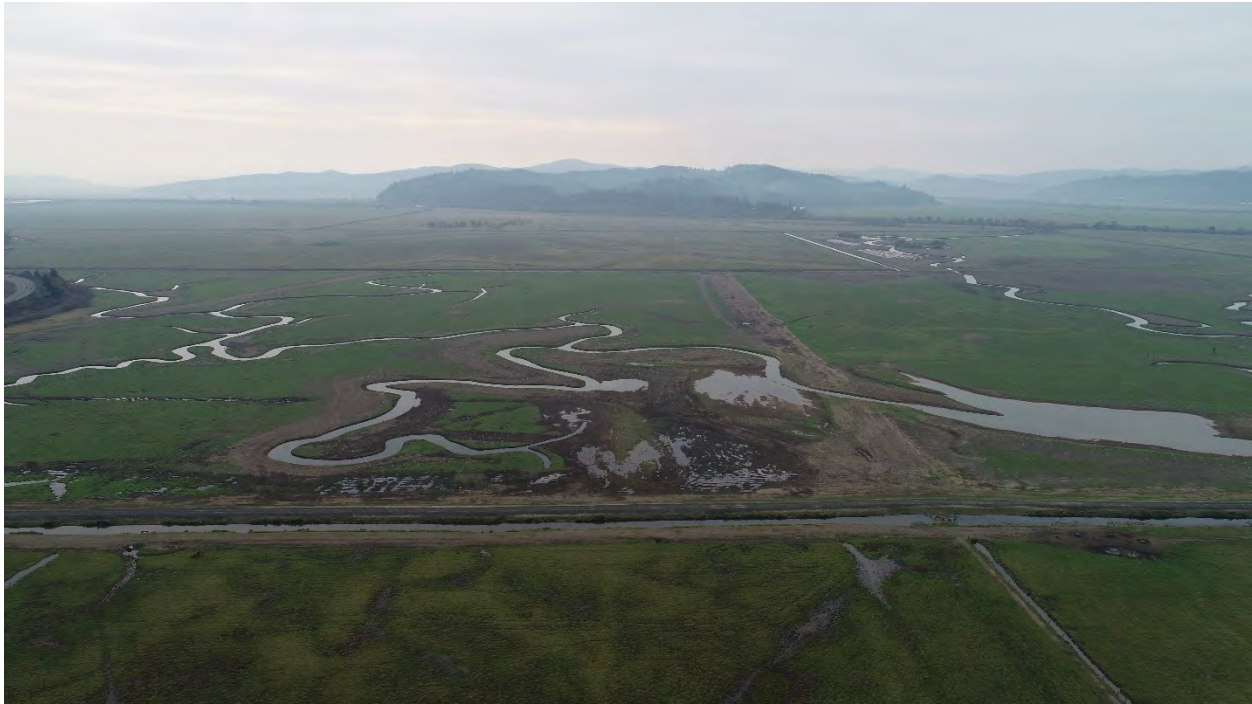
Figure 4. Winter Lake Unit 2 restoration channels following completion of installation, October 2018.

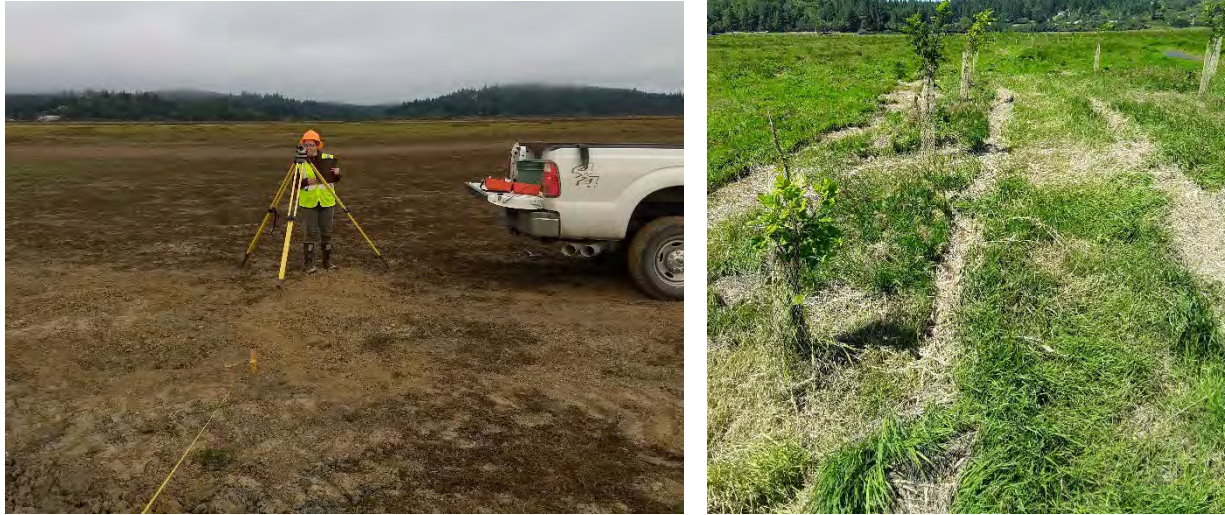
Figure 4. Channel cross section surveys post restoration completion, September 2018 (left). Vegetation survival and composition, September 2019 (right).

Vegetation composition and survival surveys are completed on an annual basis. A total of 20 plots were surveyed following the procedures outlined in Coos Watershed Association's Riparian Silviculture Guideline (2003). The plots are situated in either riparian areas or wildlife mounds and the boundaries have been marked with wooden stakes. All living trees and shrubs were identified to species and counted, all dead trees and shrubs were counted and identified, if possible (Figure 4). A simple analysis of percent survival of all standing trees and shrubs was completed.

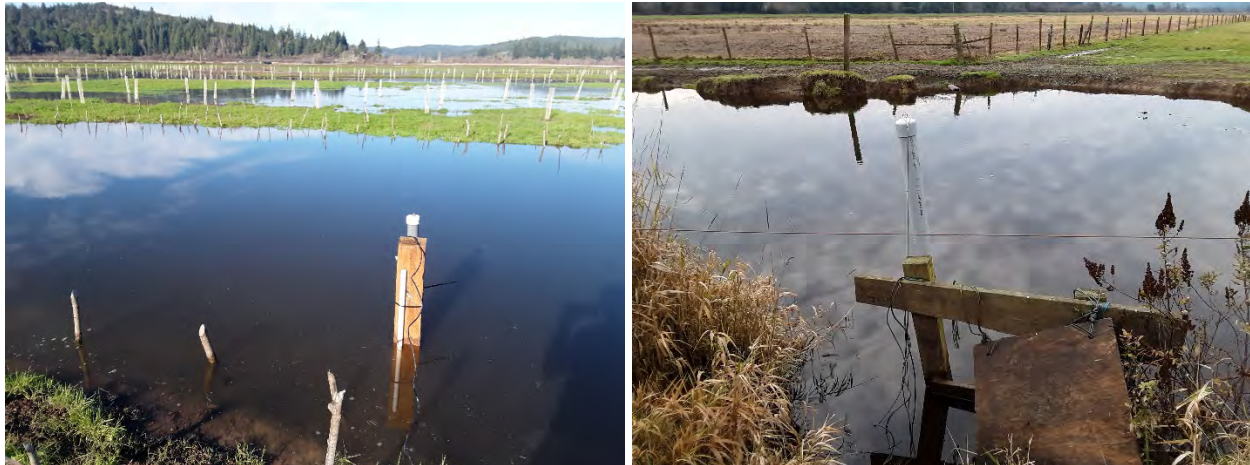
Figure 5. Permanent wooden posts with PVC stilling wells attached to house water level loggers within (left) and hang DO loggers from the cap (right). Temperature is collected by both water level and DO loggers.

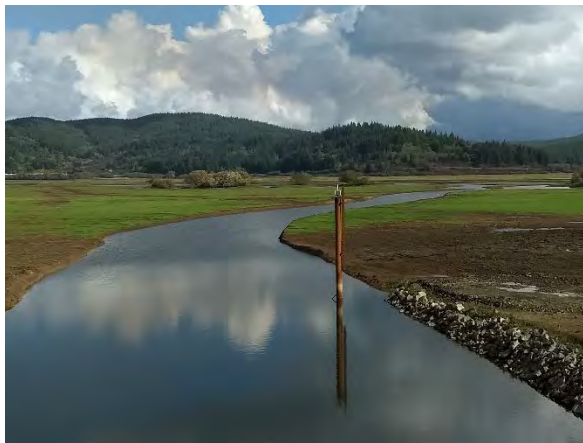
Figure 6. Permanent steel stilling wells house water level loggers maintained by Northwest Hydraulic Consulting (NHC), left. Data is transmitted via RTU to the network computer on-site every 15 minutes.

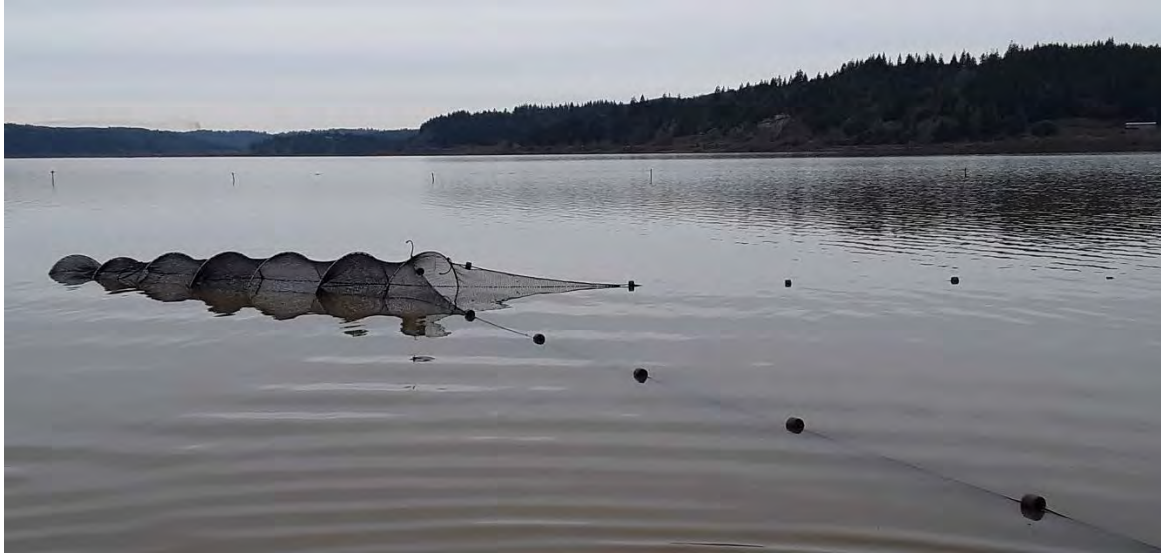
Figure 7. During flood stage 3 ft hoop traps are deployed in flooded pasture (only lead floats are visible).

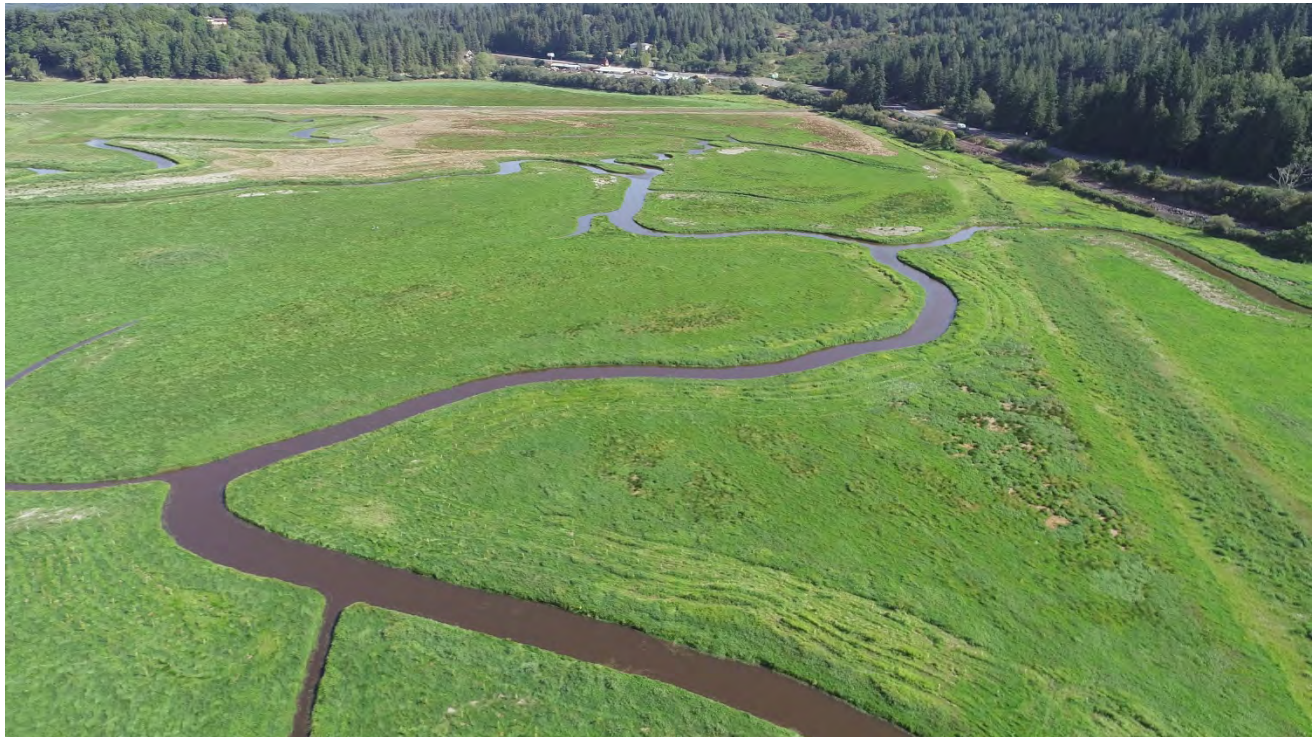
Figure 15. Aerial photo of the Northeast corner of the Winter Lake Restoration Unit (Unit 2), photo taken Aug. 16, 2019.

MAMP Thresholds (Table 2): The final Restoration design that was implemented resulted in construction of just over 27,000 ft of channel based on post-built engineering surveys. Sinuosity and other complexity features such as depth variation were visually assessed when the channel was dry just prior to introduction of water. The complexity was equal to or exceeded engineered design features and the MAMP thresholds. All segments of channel provided for fish passage at a level that was considered optimal (as assessed through visual inspection by ODFW and CoqWA staff) and exceeded the threshold in the MAMP (Table 2).

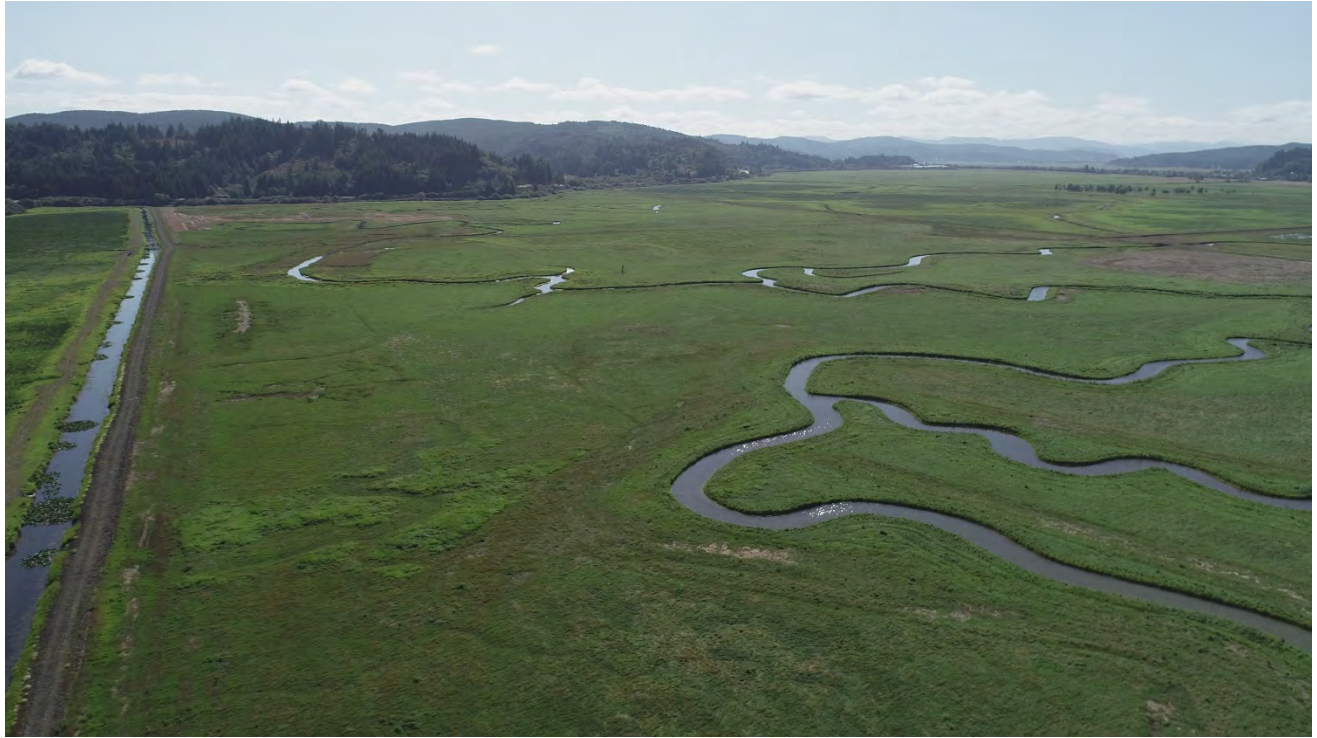
Figure 16. Aerial photo of the Winter Lake Restoration Unit (Unit 2) from the northwest corner looking south, photo taken Aug. 16, 2019.

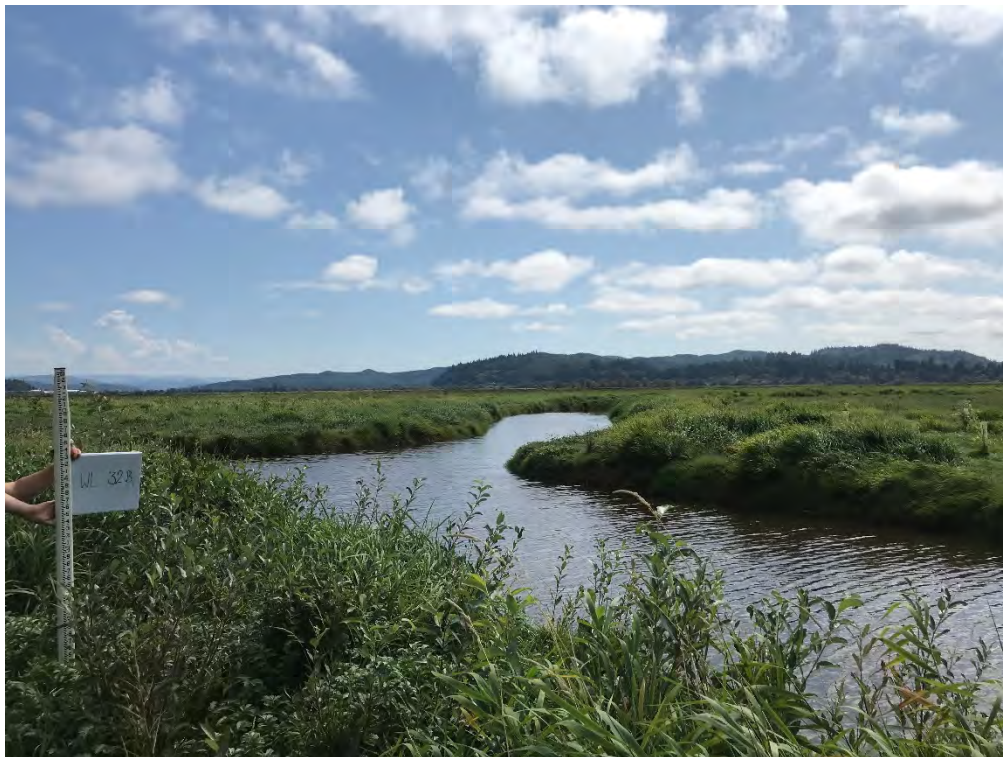
Figure 18. Upstream facing photo of location WL32 of the Winter Lake Restoration Effectiveness Monitoring.

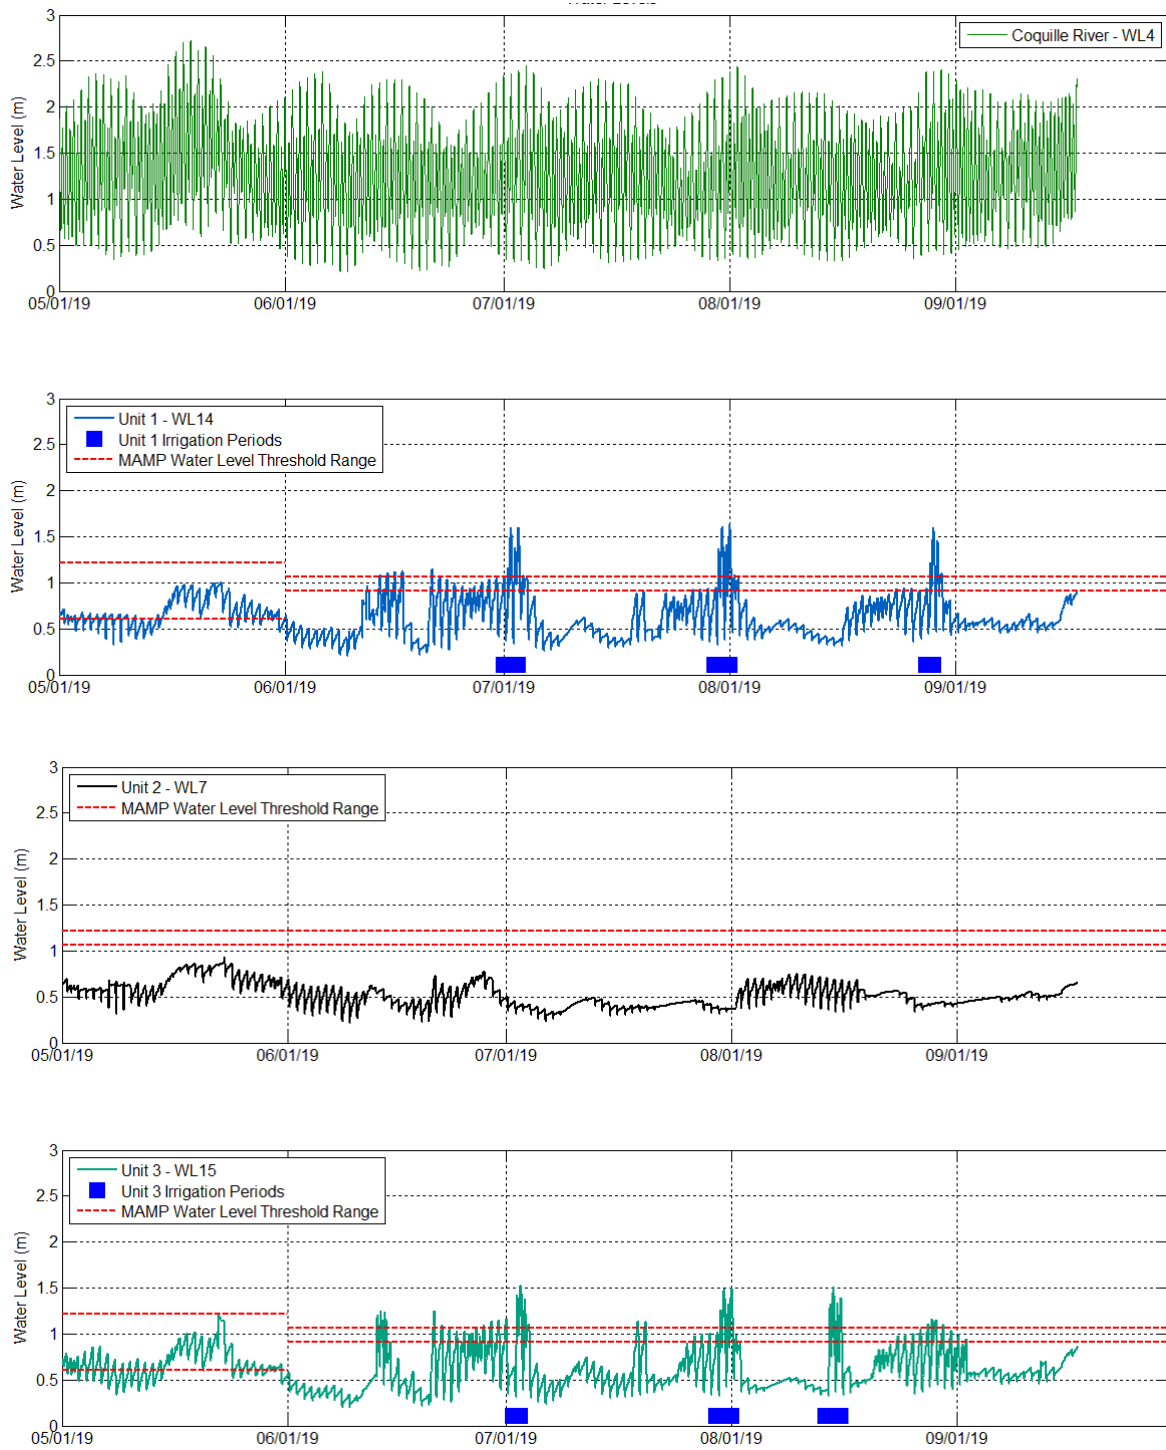
Figure 29. Water levels during the dry season, May 1 – Sep 17. Note the three irrigation events (blue lines) during the summer months in the agricultural units (Unit 1 and 3). The MAMP threshold range is depicted by two red dashed lines and varies depending on season and Unit.

During the summer water levels remained low for all Units except during irrigation periods in Units 1 and 3, (Figure 29). Water levels in Unit 2 were intentionally kept low due to the need to construct additional channels and other maintenance issues described below in Water Level Management (5.D). Water level data stops September 17, 2019 due to issues with the NHC Portal. Overall, there is much natural variation in water levels due to rain or the absence of rain and the influence on river levels and pasture accumulation of water. Future water level management will be closer to the MAMP thresholds.

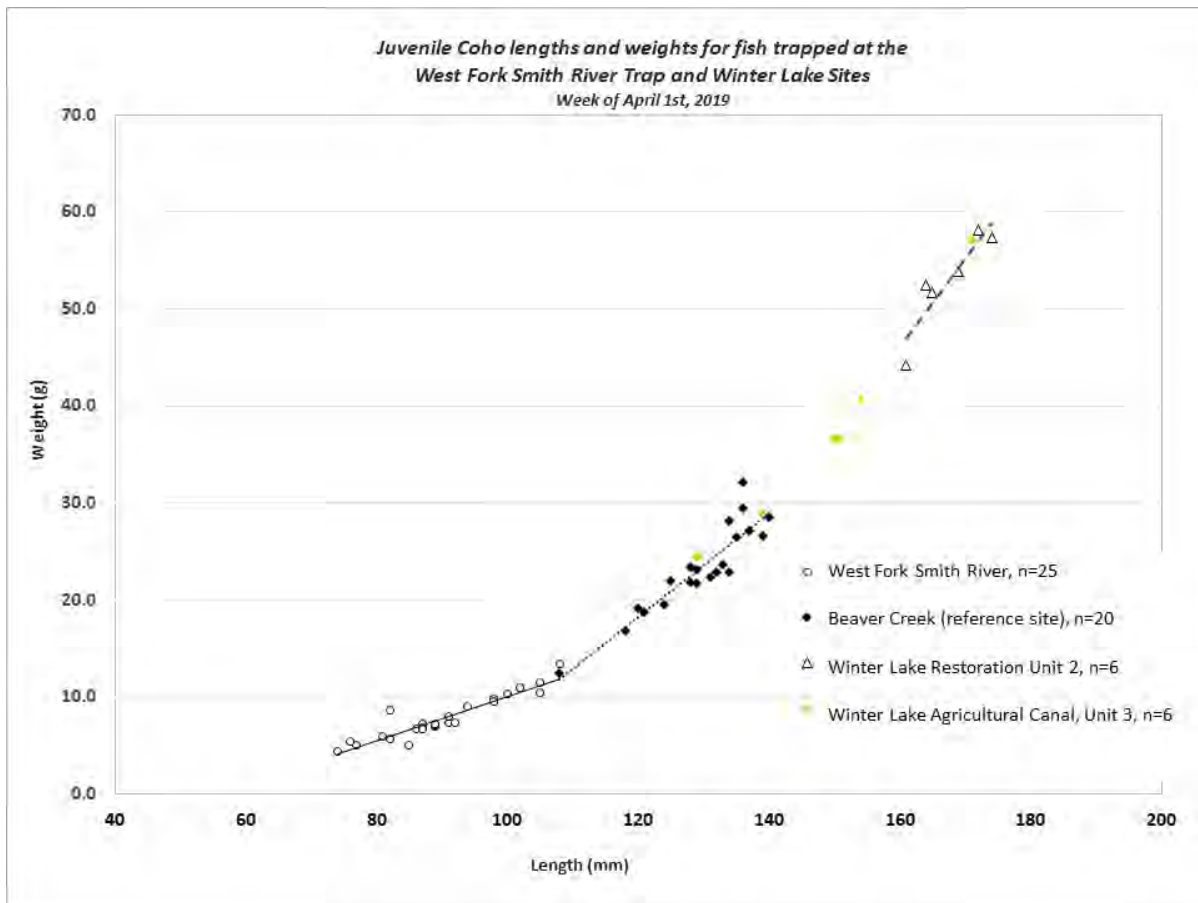
Figure 32. Comparative analysis of Coquille Basin floodplain reared coho juveniles captured in the Winter Lake project area, with coho juveniles considered to be of riverine rearing disposition captured in the W.F. Smith River basin. Fish were roughly presumed to be of the same age as they were captured with a seven day period in April, 2019 at both sites.

We analyzed fish length and weight relationship as well for the fish captured at Coquille Working Landscapes rearing in floodplain wetland habitats compared to fish that were presumably reared under primarily riverine and stream conditions and captured at the West Fork Smith River ODFW Life Cycle Monitoring trap. Fish were obtained from the two sites during the same week in April and thus, in theory, are of similar age. Fish captured in the Coquille Working Landscapes sites were on average longer with greater weight (Figure 32).
