# **Dement Creek Basin Assessment and Restoration Prioritization**

**A Tributary of the South Fork Coquille River**

Coquille Watershed Association

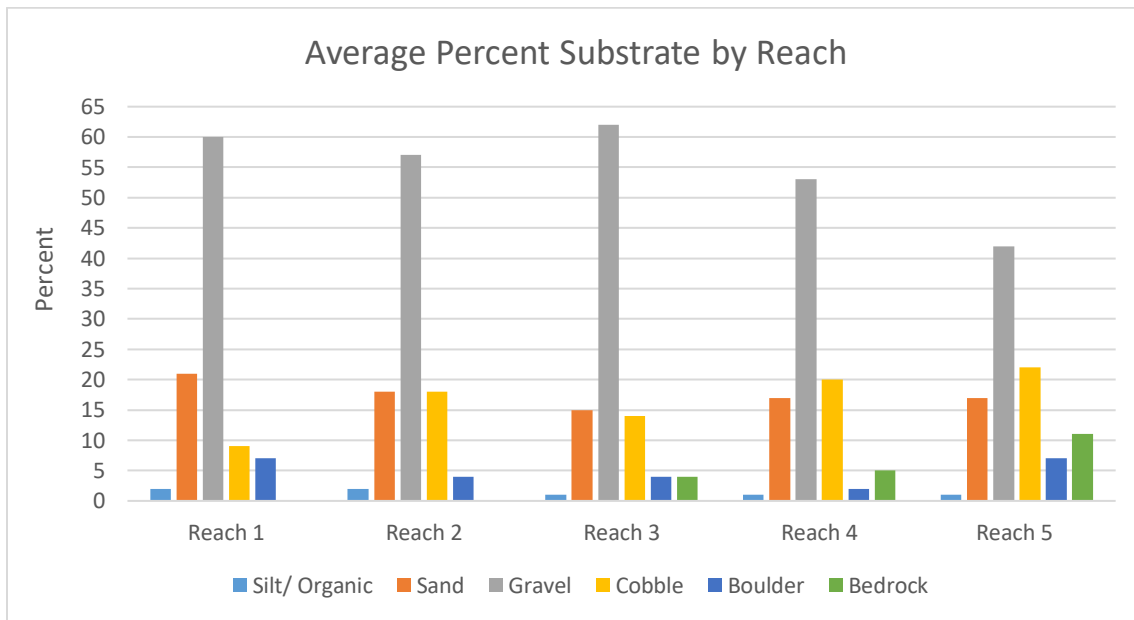
Figure 4: Average percent substrate for Dement Creek

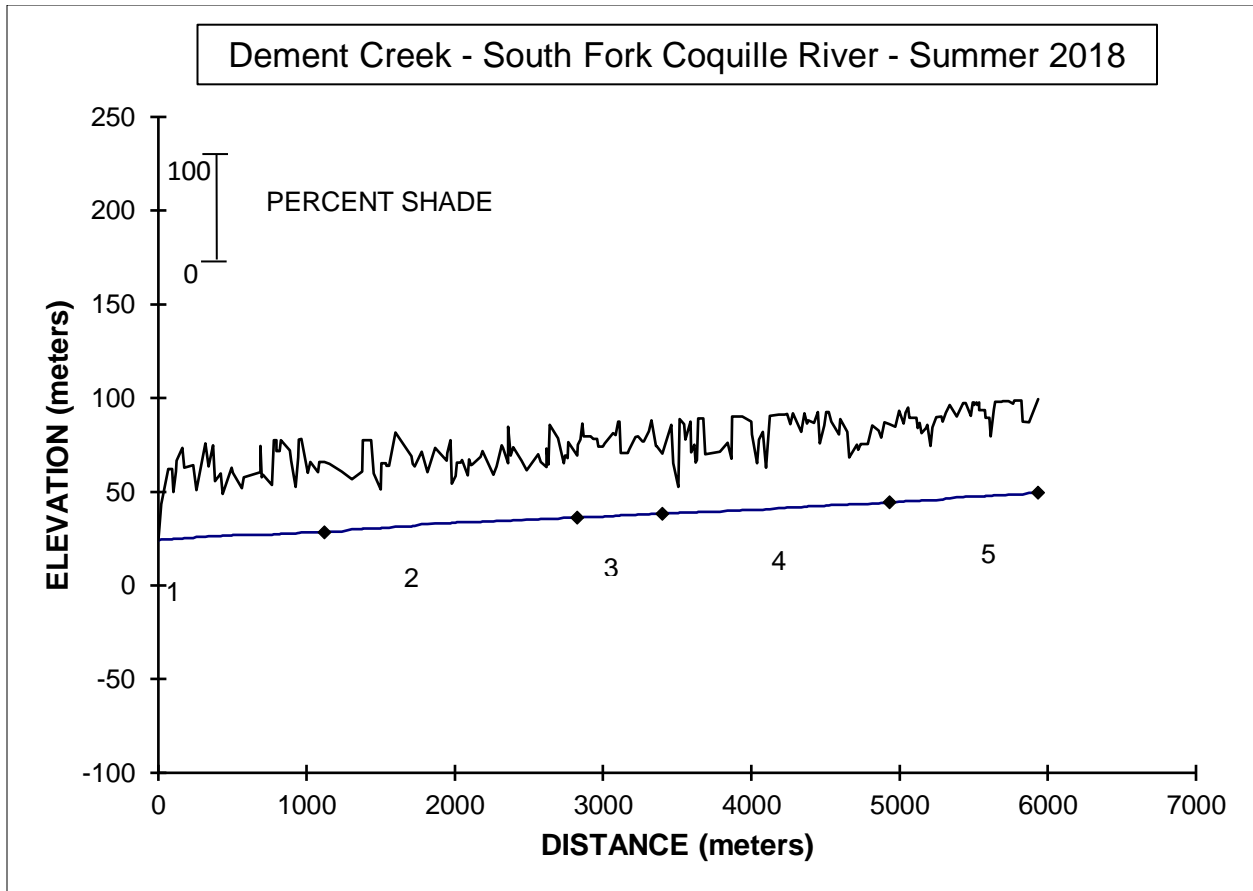
Figure 8: Percent shade for all surveyed reaches within Dement Creek

All five reaches within Dement Creek are dominated by large or second growth deciduous trees, then shrubs and other herbaceous species. Conifers are more abundant in the riparian areas of reach 3 and in higher areas of the basin where there is timber harvesting (however were not surveyed beyond reach 5). Figure 7 shows an overview of percent conifers versus hardwoods according to the 30m transects taken every 10 units during the survey. Figure 8 shows the percent shade for all surveyed riparian areas of the five reaches.

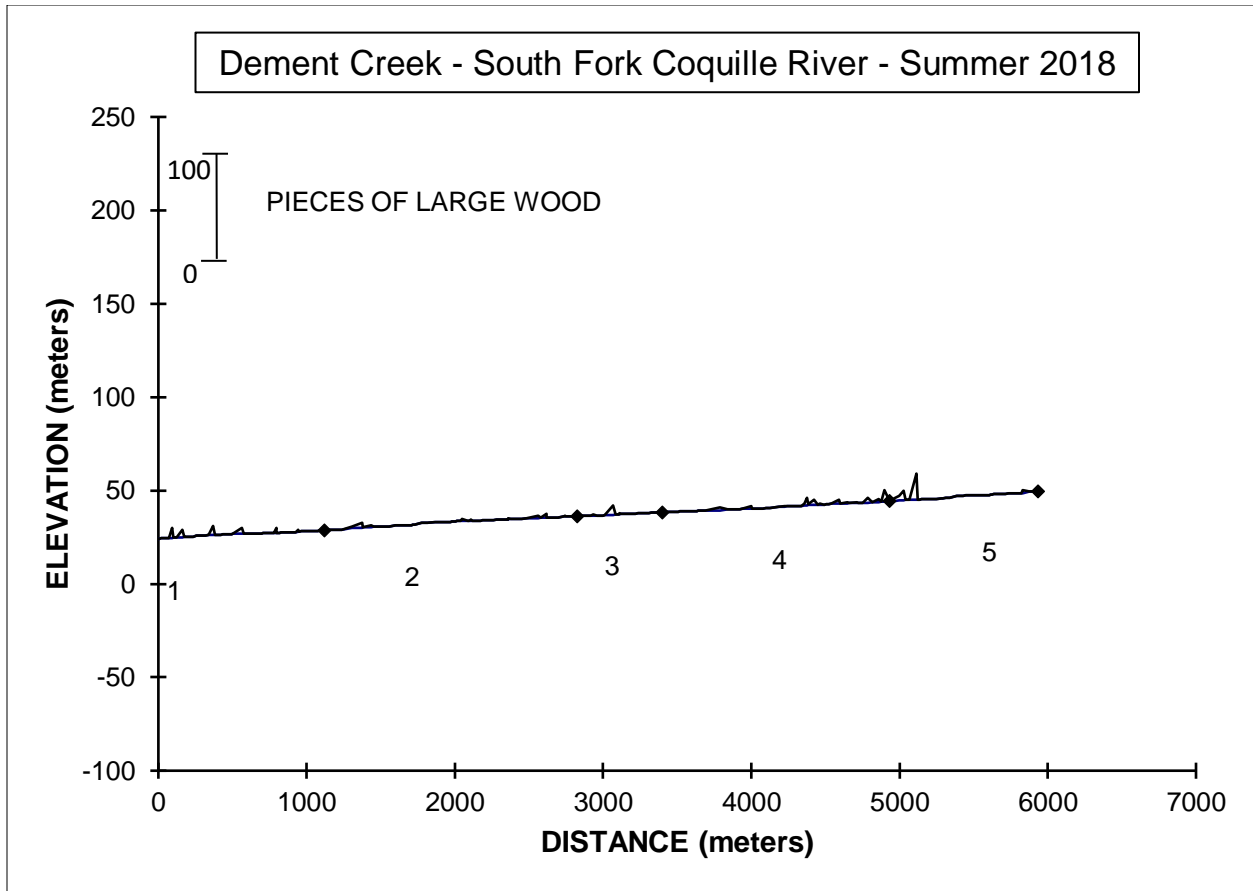
Figure 10: Distribution of large wood pieces throughout the surveyed reaches of Dement Creek

Large woody debris (LWD) was counted with a minimum diameter of 0.15m and a length of 3m, whereas key pieces were counted with a minimum diameter of 0.6m and a length of 12m. LWD is displayed in total pieces and as the number of pieces per 100 meters of stream channel per reach (Figure 9). Figure 10 shows the distribution of large wood pieces throughout the surveyed reaches of Dement Creek and that overall, large wood is a limiting factor. Dement Creek does have a small distribution of key pieces in reaches 3, 4, and 5, however is a limiting factor in reaches 1 and 2 (Figure 11).

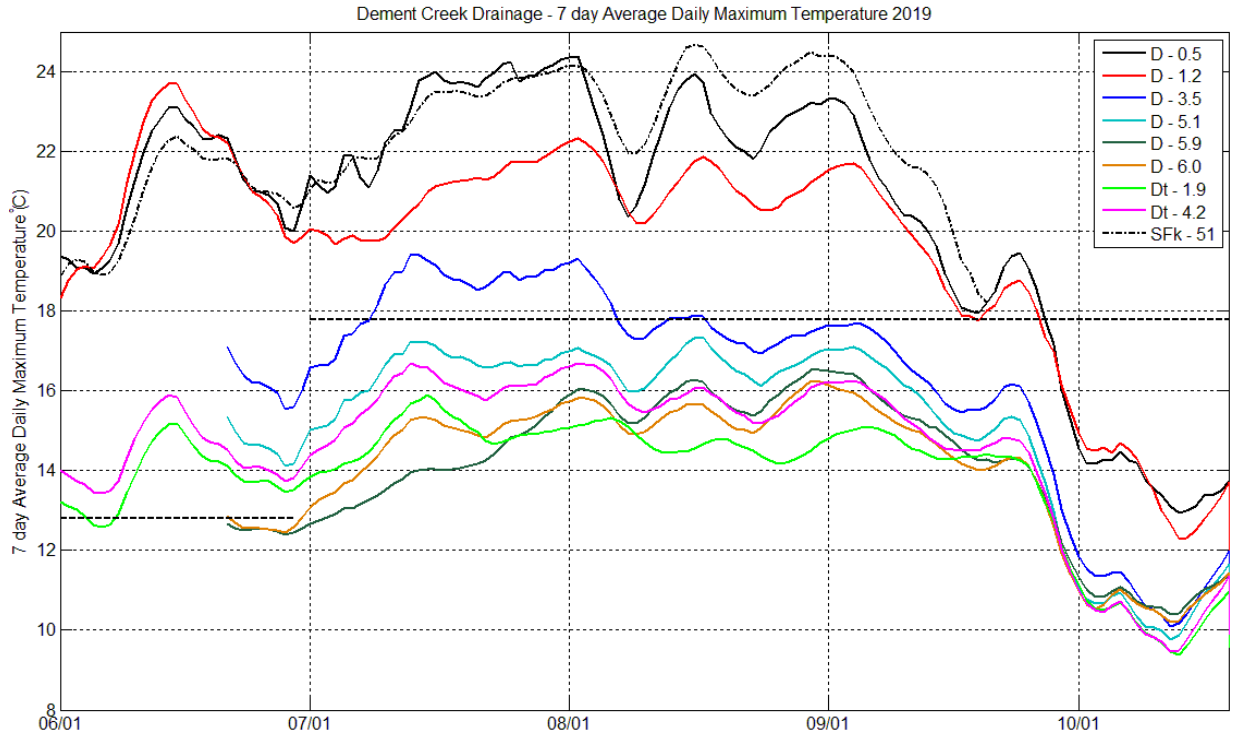
Figure 16. 7-day average daily maximum temperature of the Dement Creek temperature monitoring study for the 2019 season. The cold water protection criteria are displayed as a dashed black line.

The 2018 and 2019 7-day moving average and 7DADMax for all temperature monitoring locations are presented in Figure 13 – Figure 16. During both the 2018 and 2019 monitoring seasons the maximum 7-day moving average temperatures of D – 0.5 and D – 1.2 reached nearly the same peak, ~21 °C, while the 7DADMax was higher in 2018 than 2019. Additionally, for both 2018 and 2019, D – 0.5 and D – 1.2 had significantly different 7-day average and 7DADMax trends. This is likely due to the difference in mean daily change in temperature (Mean Daily ΔT, Table 6 and Table 7) as cooler night time temperatures of D – 0.5 help drop its 7-day moving average temperature whereas 7-DADMax just reflects the maximum temperatures

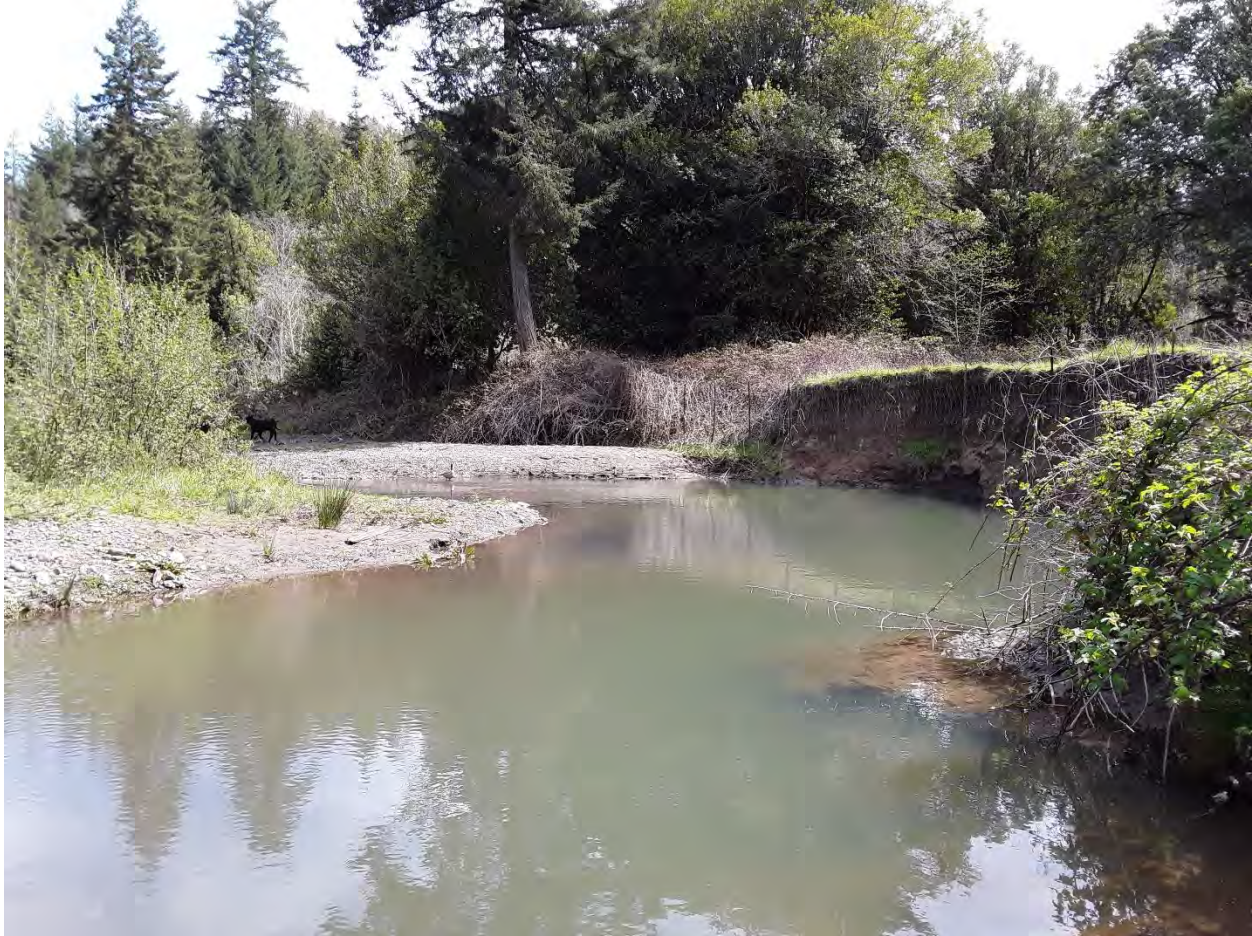
*Figure 23: Example site for large wood and boulder placement that needs to be designed to protect the bank. Design options would include placing LWD upstream of this spot. Rootwads would be strategically placed to deflect water to the left side of the bank and slow down water velocity. There are also existing conifers to key into above this area.*

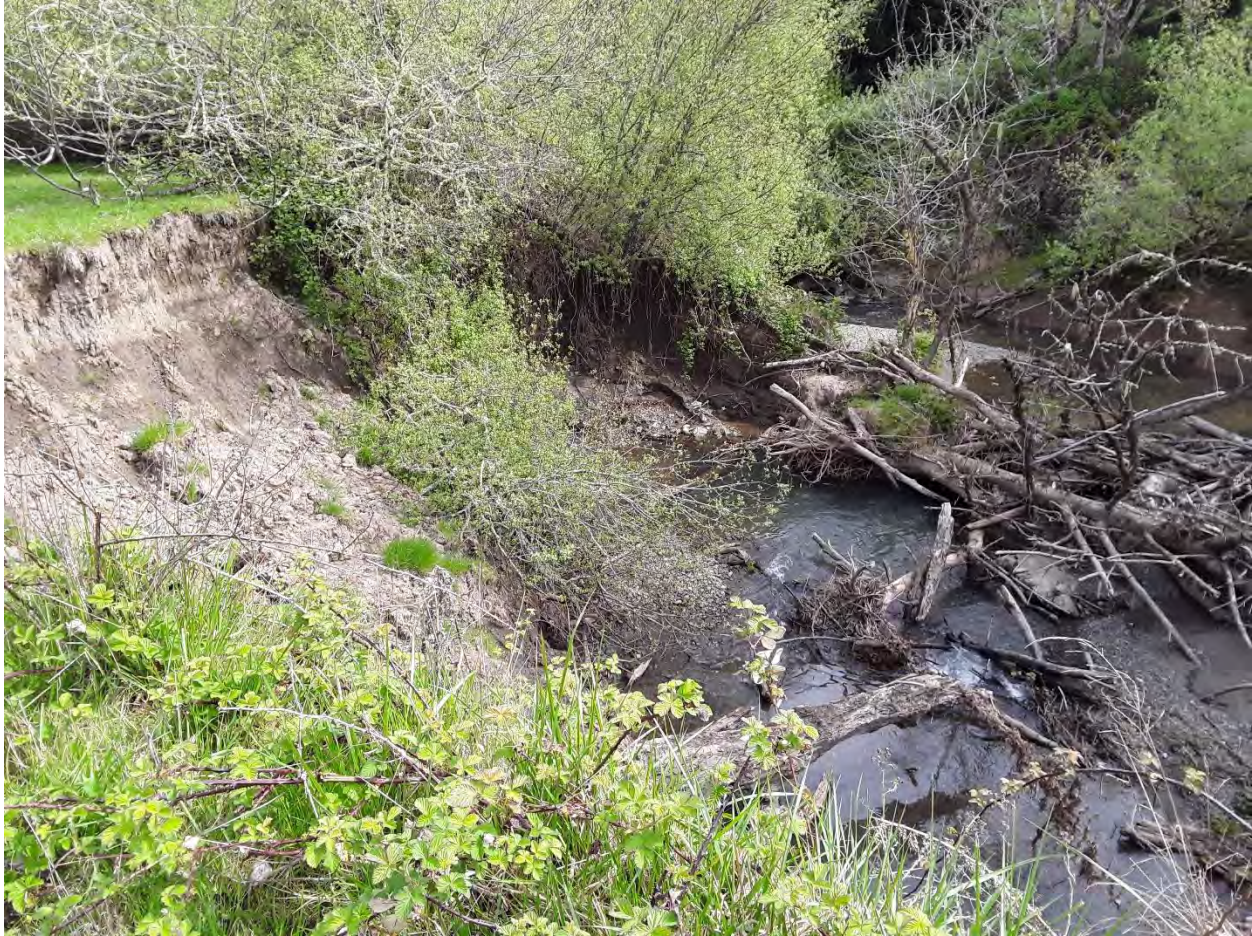
*Figure 24: Example area within reach 1 that has a natural structure creating fish habitat, however it also appears to be assisting in the bank erosion near a pasture. Other design options would include reshaping the bank 1:1, setting the fence back, and replanting.*

Access for log and boulder structures shown in Figure 22 will be a challenge as the private landowners have the riparian area well fenced off with little to no gates. In some stretches, one or both sides of the bank are too steep for excavator access. A budget will need to include fence repairs and excavator time to build ramp access and road maintenance. Some sites may also need a temporary road crossing to haul equipment and boulders. Some areas with multiple instream sites only have one way of access, so an excavator will need to ford the stream to reach any upper and lower sites. There is a railcar bridge near some of the proposed instream sites, so landowner approval will be needed to cross this bridge. Structures are not being proposed in reach 1 as the landowner wants to avoid erosion and bank undercutting of the lower pastures (Figure 24).
