Winter Lake Restoration Effectiveness Monitoring

Report: Year 2

December 30, 2020

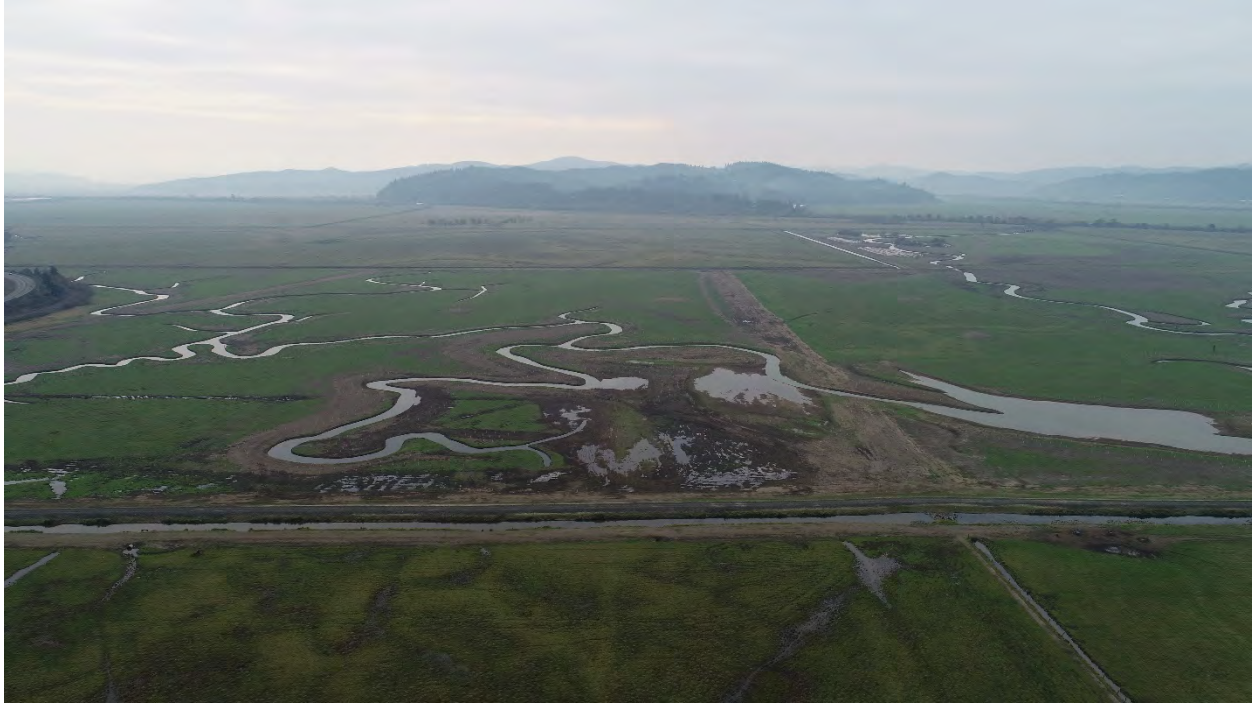
Figure 4. Winter Lake Unit 2 restoration channels following completion of installation, October 2018.

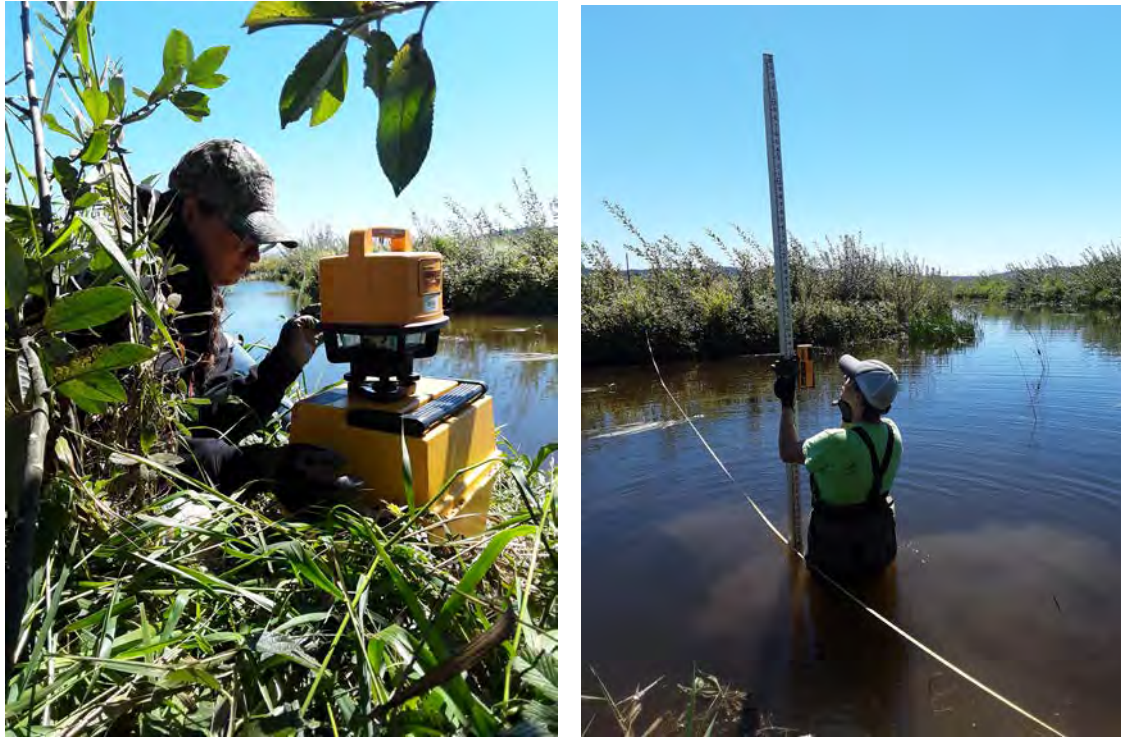
Figure 10. A laser level was used to complete some channel cross-sections in 2020 (left). If water depth allowed, 2020 channel cross-sections were completed on foot to maximize accuracy.

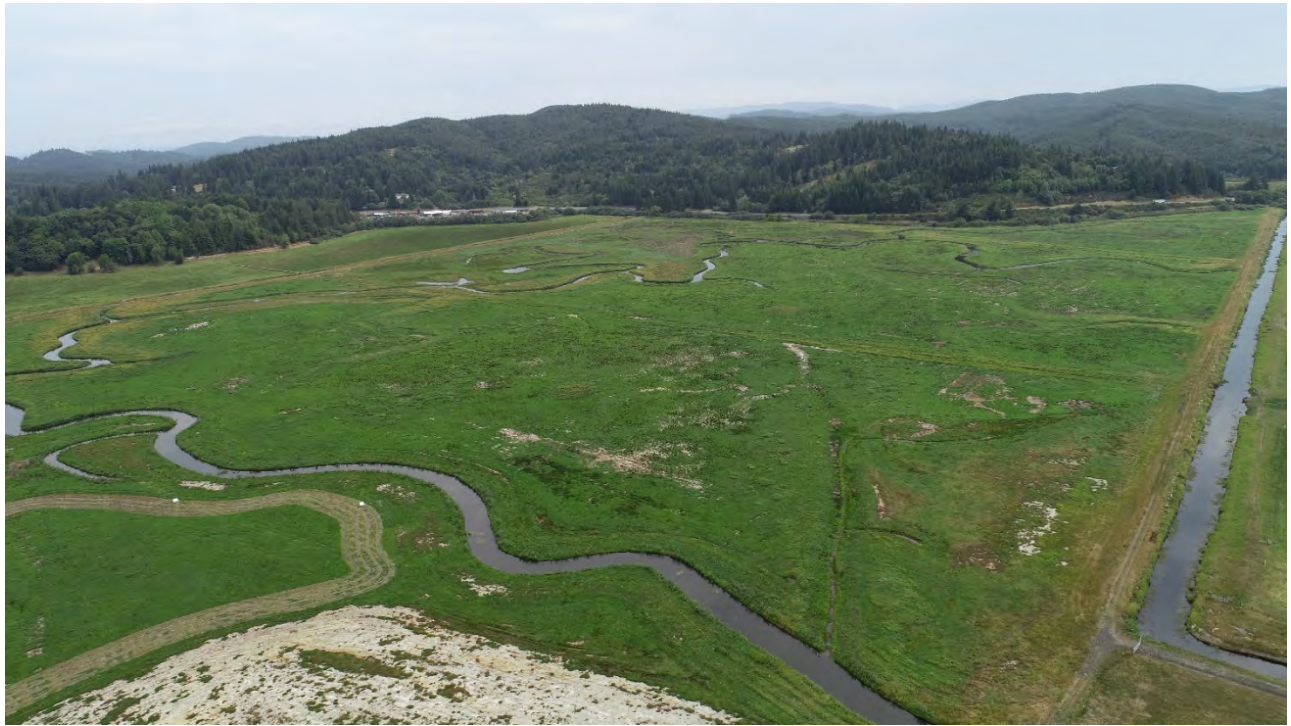
Figure 11. Aerial photo looking towards the Northeast corner of the Winter Lake Restoration Unit (Unit 2), photo taken July 27, 2020.

Channel complexity is captured through aerial photographs taken by an UAS on an annual basis. As seen in the 2020 aerial photographs of the Restoration Unit (Unit 2) (Figure 11 and Figure 12), the channels are highly complex in both sinuosity and size. Post-construction channel configuration was at least as sinuous as the original engineered designs. Several additional channels were constructed in 2019 that were not on the original final design. This additional 3,700 ft of shallow channel was constructed in order to further the ability of fish to immigrate and emigrate from low level ponded water areas in Unit 2. These new channels will also assist with addressing mosquito production concerns.

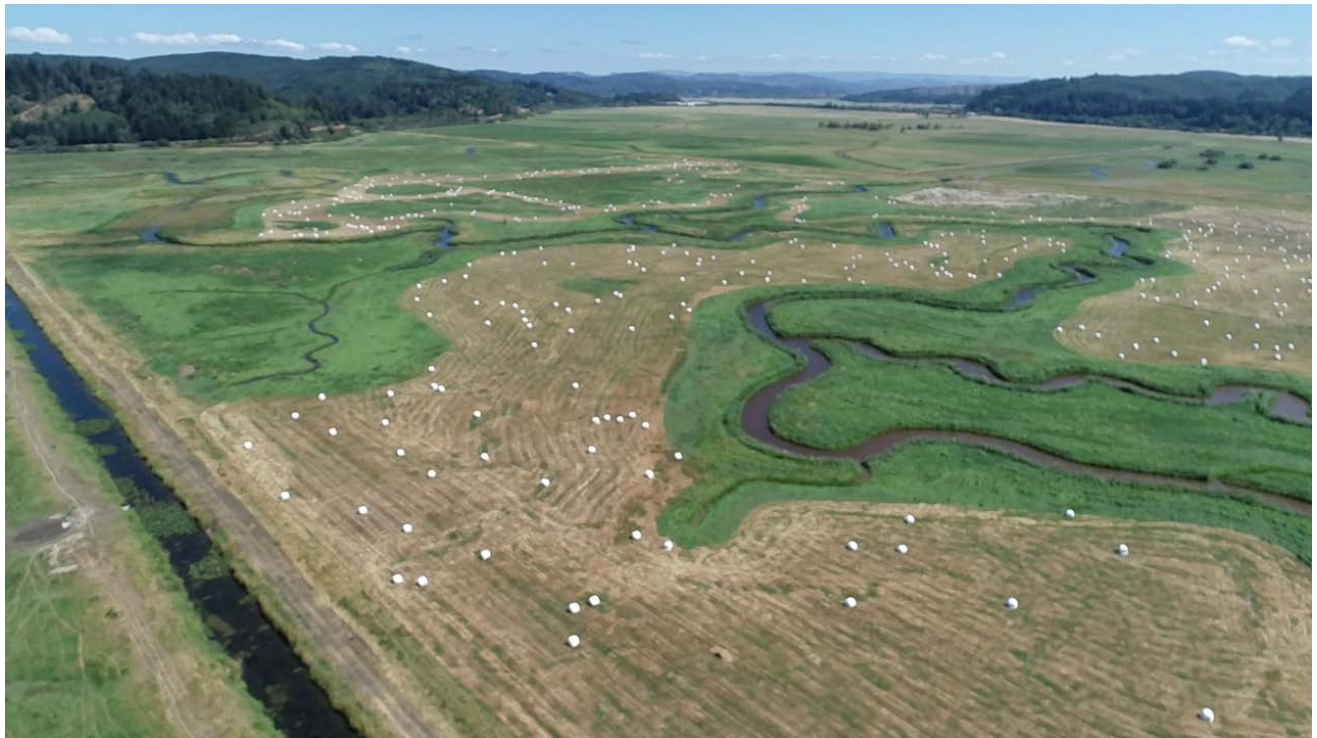
Figure 12. Aerial photo of the Winter Lake Restoration Unit (Unit 2) from the northwest corner looking southeast, photo taken Aug. 3, 2020.

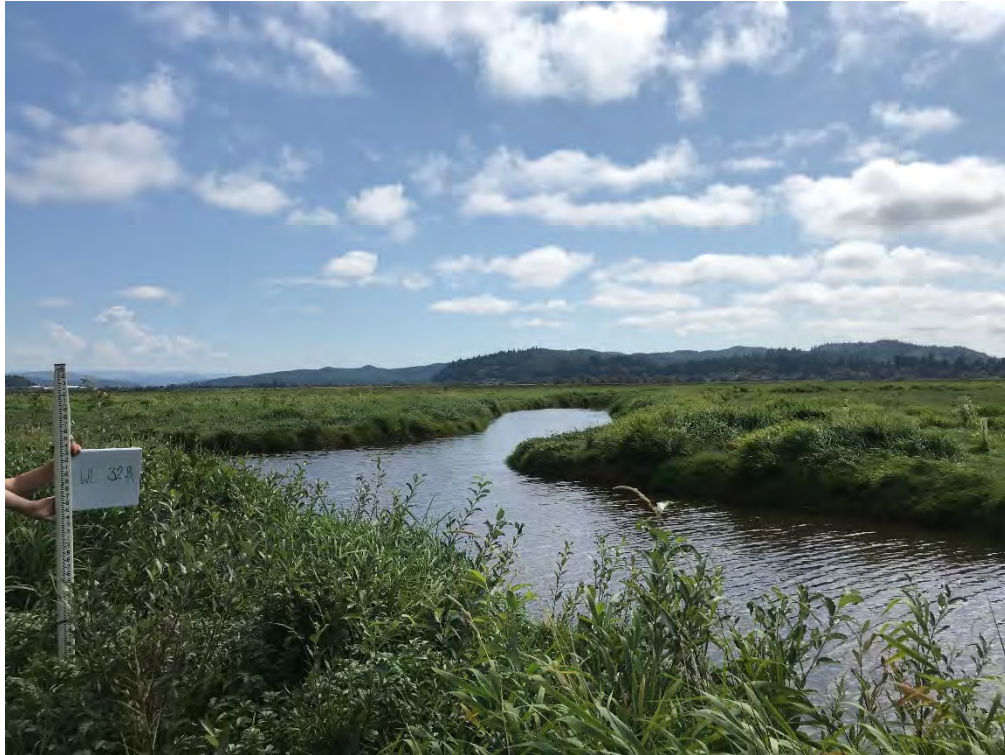
Figure 14. Upstream facing photo of location WL32 of the Winter Lake Restoration Effectiveness Monitoring, August 2020 (taken on river right).

To evaluate channel stability and depth, six channel cross-sections are measured and photo points are taken annually. During both 2019 and 2020 surveys depth was adequate for fish passage at all sites surveyed. In 2019, all of the six cross-sections but one remained stable. Location WL32 had slight scouring on the left side (facing downstream) (Figure 13 and Figure 14). Again in 2020, all of the six cross-sections but one remained stable. In 2020, the cross-section that showed a change was WL3 (Figure 15 and Figure 16) and it experienced deposition and not scour, unlike WL32 in 2019. It is likely that the scour and deposition at these two locations are an artifact of measurement error due to the fact they were both completed with a kayak. The Winter Lake site experiences strong winds and currents during tidal exchanges creating difficult conditions while measuring channels. To improve accuracy, in 2020 all channels that were shallow enough (all except WL3 and WL28) were completed on foot using waders or dry suits. Cross-sections of WL28, 29, 30 and 31 can be found in Appendix C and a subset of photo points can be found in Appendix D.

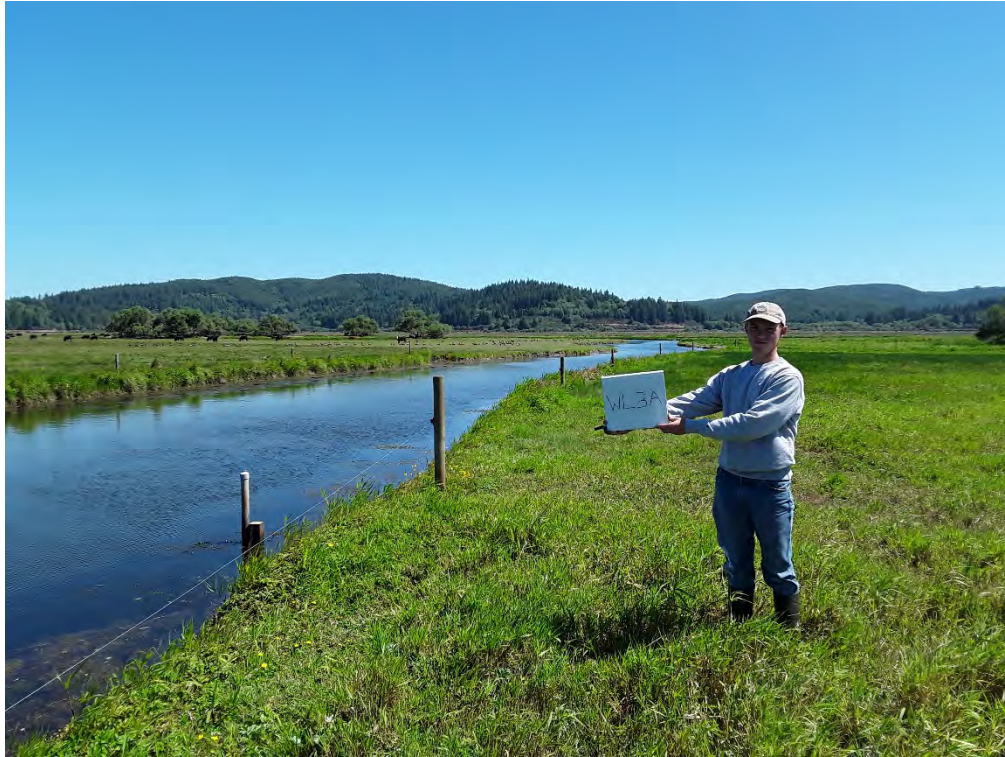
Figure 16. Upstream facing photo of location WL3 of the Winter Lake Restoration Effectiveness Monitoring, August 2020 (taken on river left).

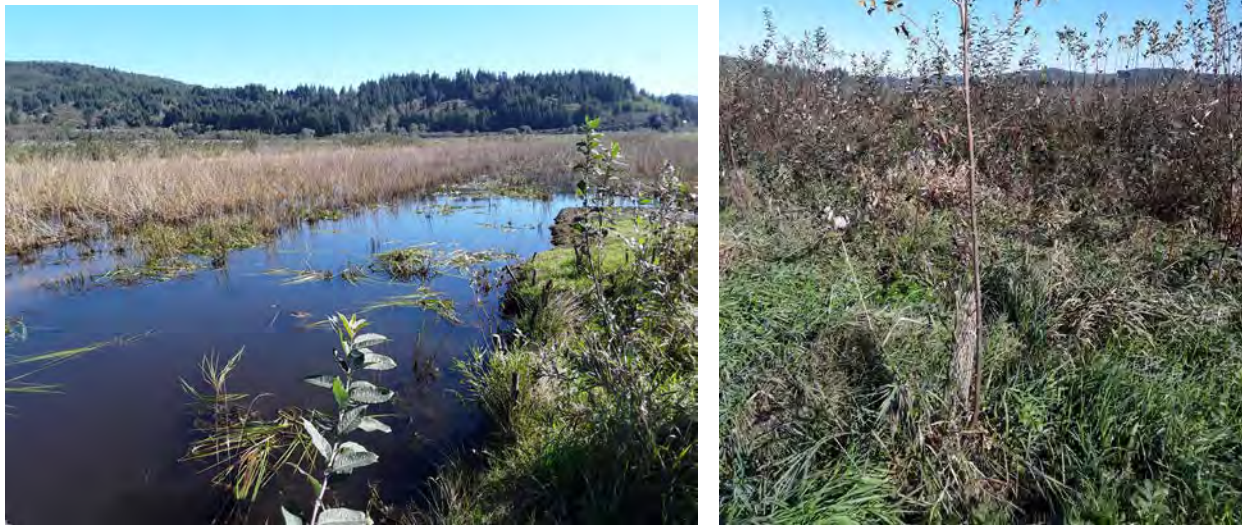
Figure 17. Thriving willows in the foreground and wild rice growing in tidal pools in the background (left). An alive Ash from plot 20 of the vegetation survival and composition survey, October 2020 (right).

Riparian Silviculture Guideline (2003). The plot locations were chosen to be representative of the different landscape features (wildlife mounds vs riparian areas) or channel size (8-20m wide) of the Restoration Unit (above, Figure 9). The plots are established in the 2018 planting areas, situated in either riparian areas or wildlife mounds and the boundaries have been marked with wooden stakes. All living trees and shrubs were identified to species and counted, all dead trees and shrubs were counted and identified, if possible (Figure 17). A simple analysis of percent survival of all standing trees and shrubs was completed.

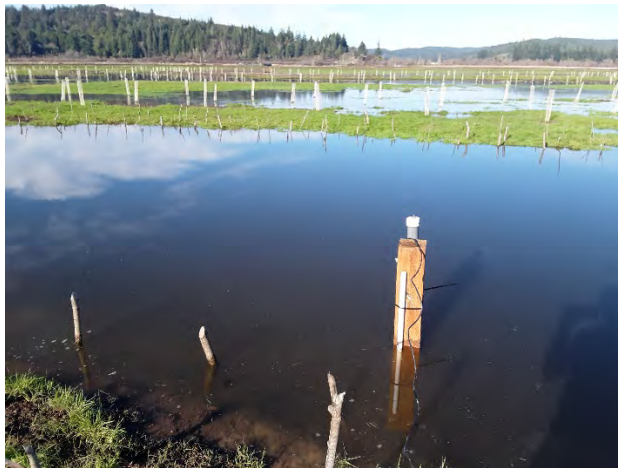
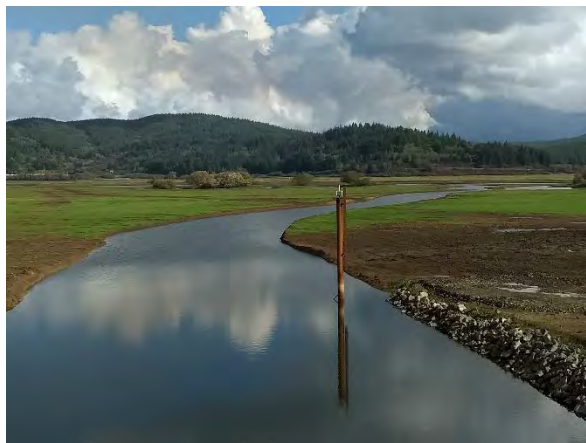
Figure 19. Permanent wooden posts with PVC stilling wells attached to house water level loggers within (left), temperature is collected by water level loggers. Permanent steel stilling wells house water level loggers installed by Northwest Hydraulic Consulting (NHC), right. Data is transmitted via RTU to the network computer on-site every 15 minutes.

basis (pending field conditions) and field audits are performed at each download to assess data quality. In addition to the data loggers there are six permanent water level sensors installed in stilling wells throughout the Winter Lake area (Figure 19). Data from these water level sensors are sent via remote terminal unit (RTU) to the network computer in the tide gate control house and uploaded to the online portal supported by NHC. CoqWA downloads the portal data on a monthly basis for local use and storage. Groundwater analysis compares water level in the paired wells in a qualitative manner to see how management of each unit has an effect on localized groundwater levels. Surface water levels are analyzed through comparison of water levels with the thresholds set by the MAMP (Table 2).

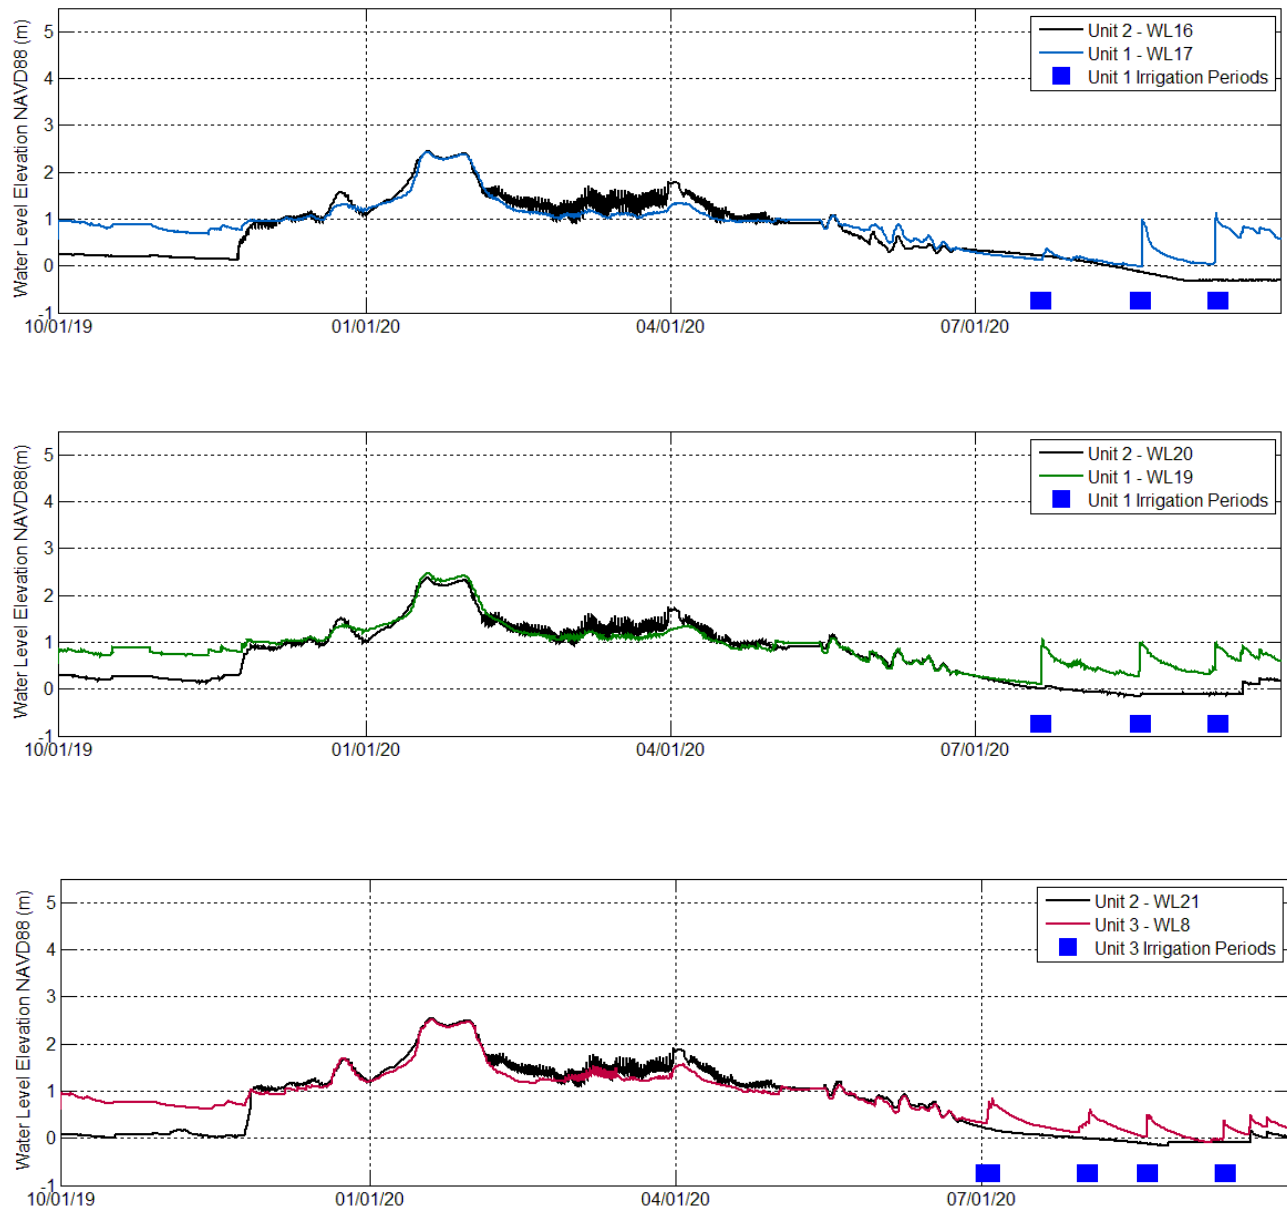
Figure 23. Groundwater levels of paired wells in Winter Lake project area. The top two figures show paired wells in Unit 1 and 2, with irrigation (blue bars) playing a significant role in summertime groundwater levels. The bottom figure shows the paired wells in Unit 2 and 3. During the winter months the water levels correspond to surface water levels since the wells are located in a floodplain.

Since the groundwater wells are located in the floodplain, they all record the flood waters that occurred during the winter months (Figure 23). Overall, the groundwater levels show that periodic irrigation increases groundwater levels, which is beneficial to the survival and health of grasses, forbs, shrubs, and trees of the project area.

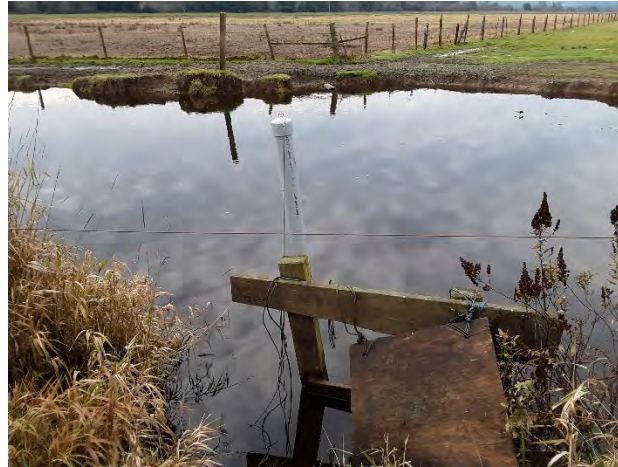
Figure 24. The stilling well at dissolved oxygen monitoring location WL22. The logger is hung off the cap of the stilling well to allow for better flow around the optical sensor.

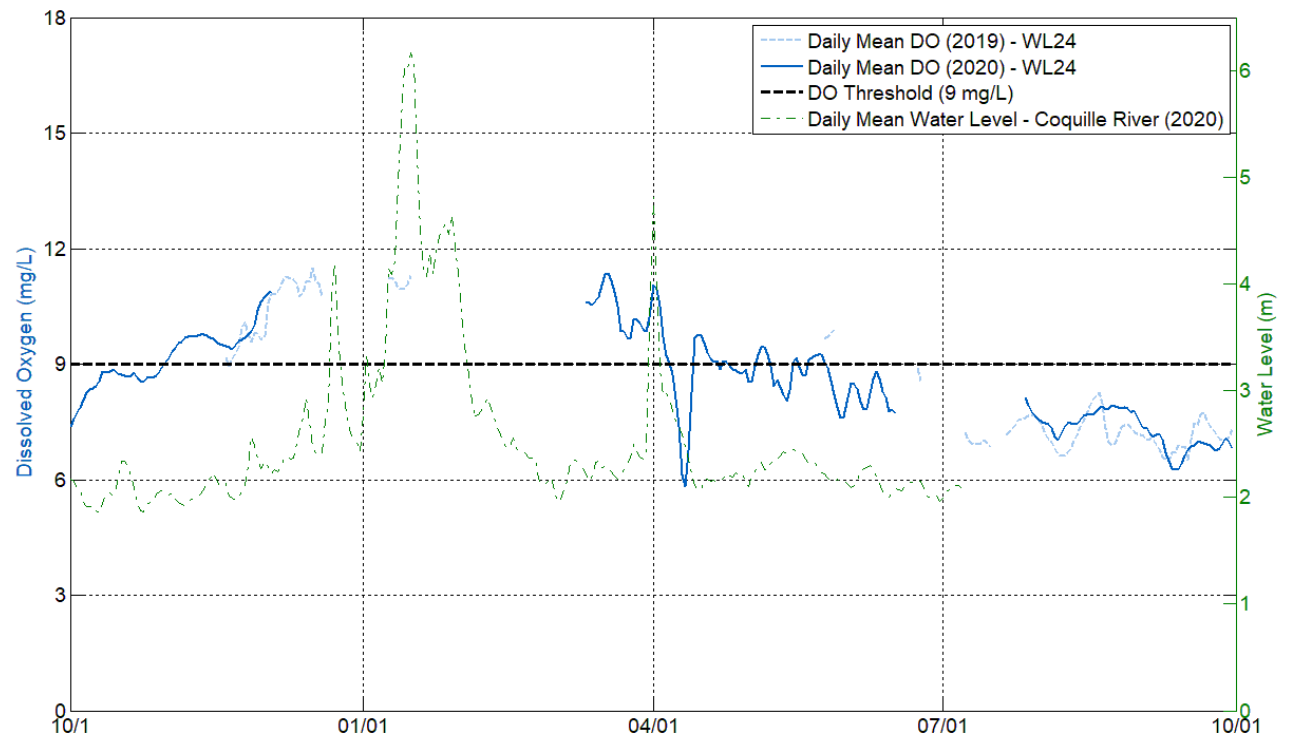
Figure 31. Dissolved oxygen trends for the Coquille River in 2019 (light blue) and 2020 (dark blue).

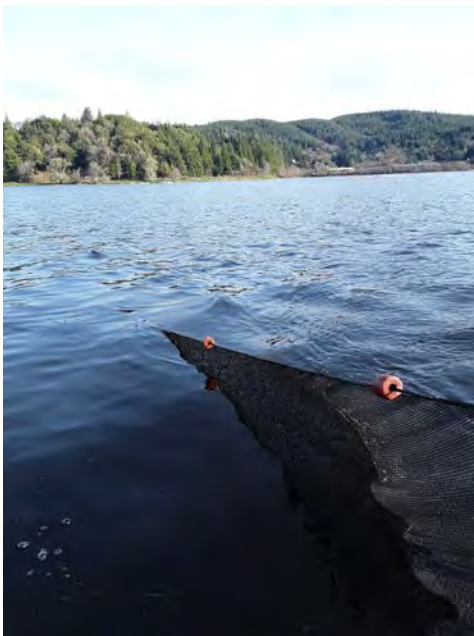
Figure 37. During flood stage 4 ft hoop traps are deployed in flooded Unit 2 (Hoops are submerged only the wings are visible).
