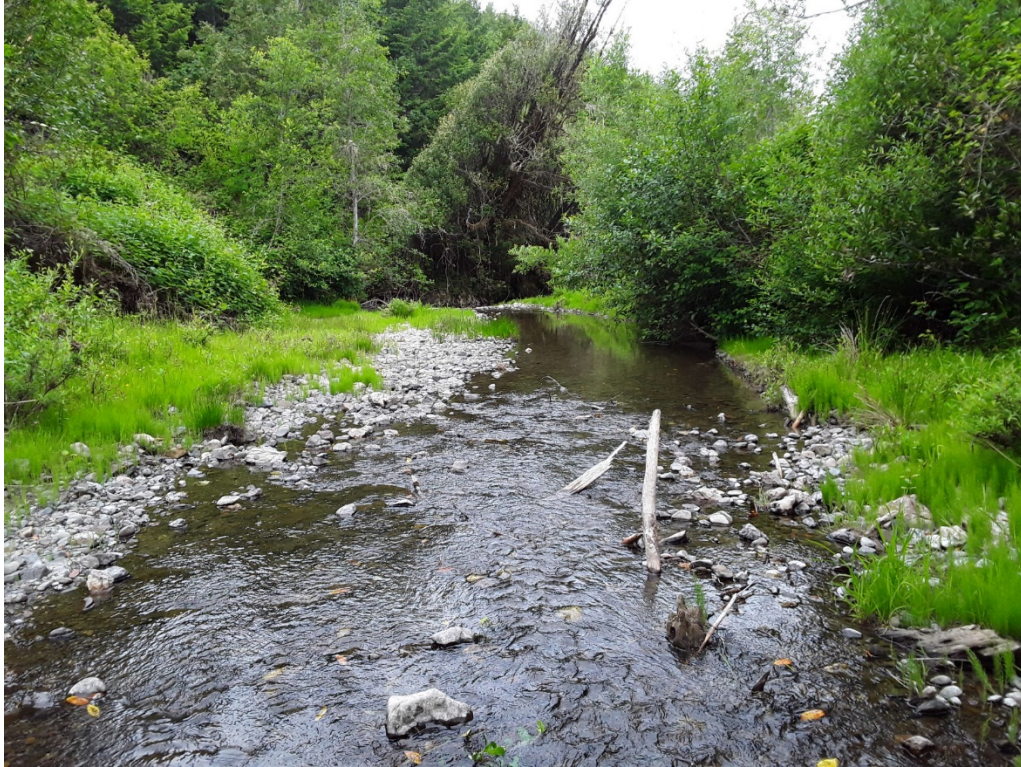
*Figure 1: LWD & Boulder site on Mainstem Dement Creek. Notice wideness of creek. Large logs with rootwads and boulders will be needed to keep structures in place.*

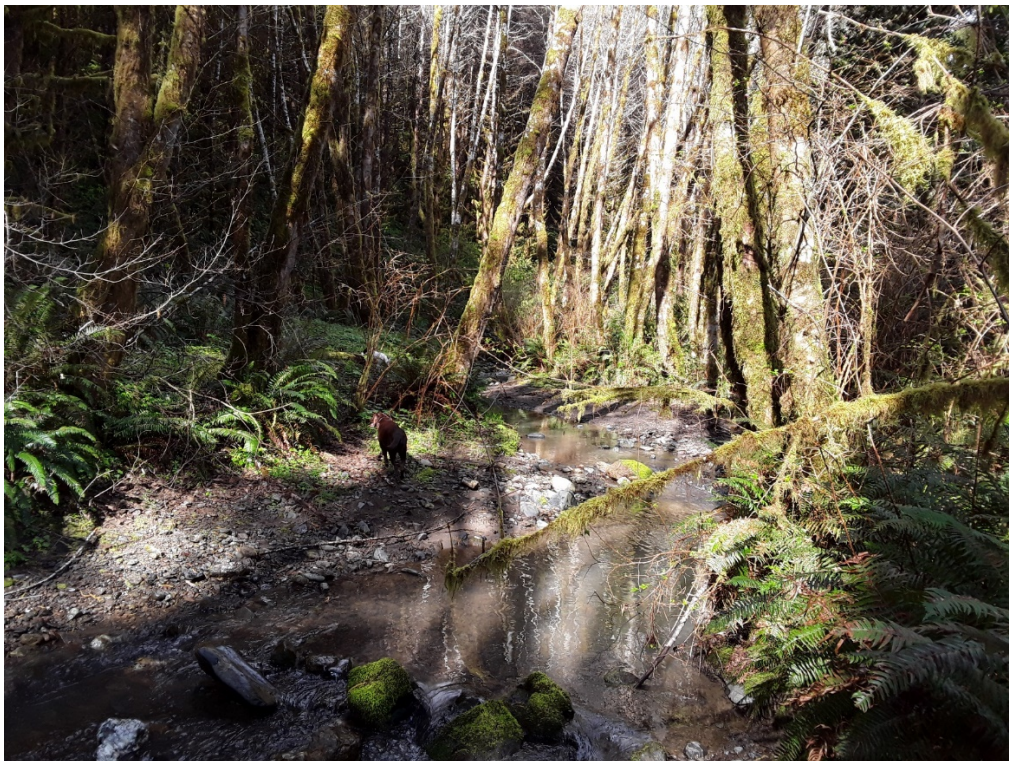
*Figure 2: LWD site on Upper Dement Creek. Notice abundance of trees to key logs into. This is an area where boulders will not be needed.*

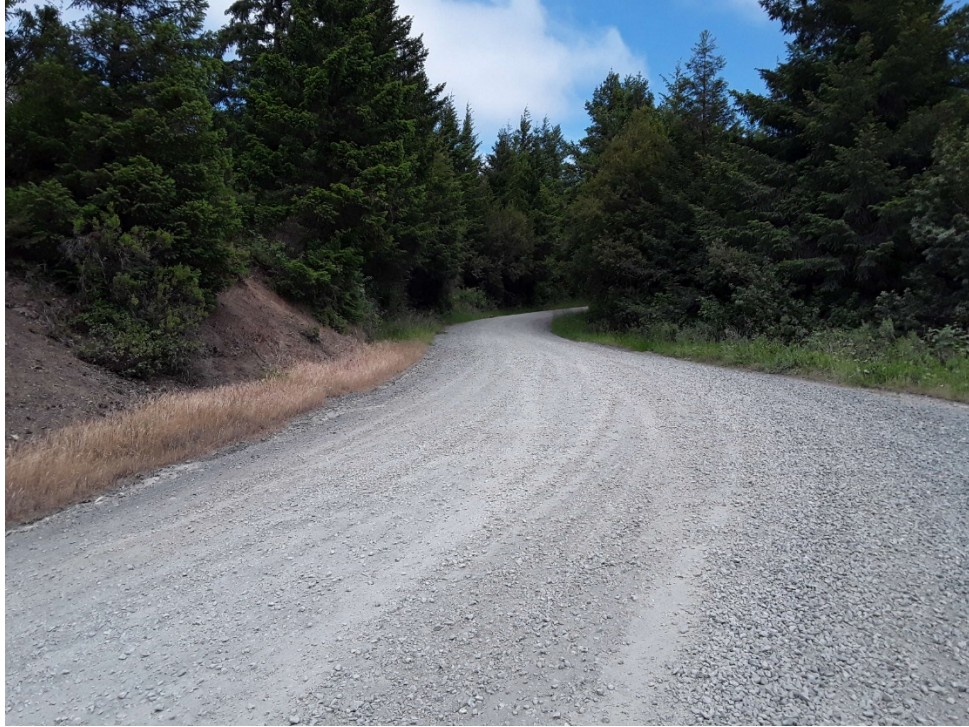
*Figure 3: Eckley Mountain Road. Notice it's a steep, rocky road with no drainage culverts. Rainfall will quickly wash this road out and deposit the sediment into the creek.*
