Twelvemile Creek Basin Assessment and Restoration Prioritization

A Tributary of the Middle Fork Coquille River

Coquille Watershed Association

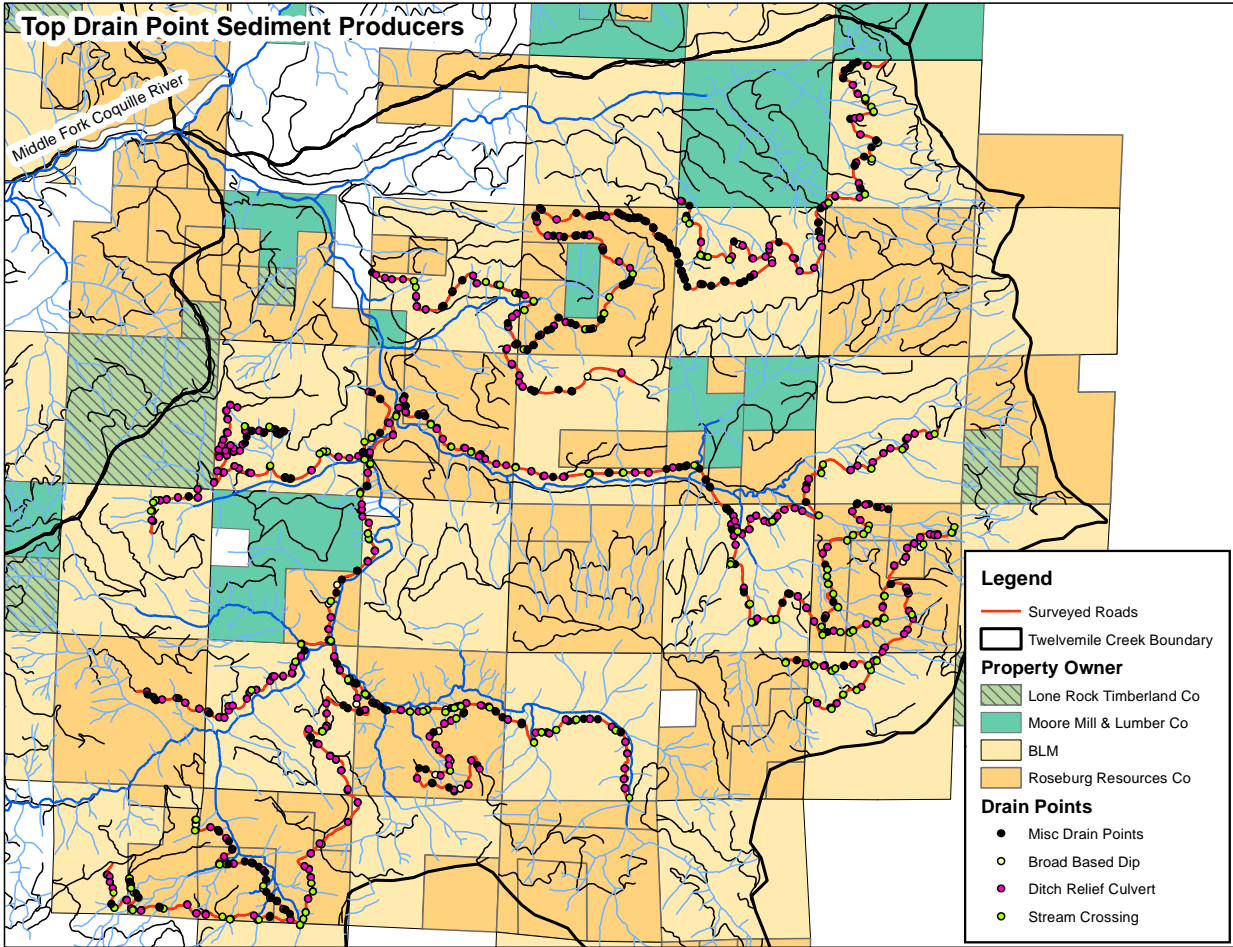
GRAIP surveys were completed on over 42 miles of roads in the Twelvemile Creek Basin, these roads are managed by Roseburg Resources and BLM, Figure 10. Within these roads there were 150 seasonal and perennial stream crossings, 323 ditch relief culverts, 34 lead off ditches, 610 other miscellaneous drain points, 41 gullies and 5 active and inactive landslides.

Figure 10. GRAIP Road survey completed by CoqWA in summer of 2019 covered 42 miles of road in the Twelvemile Creek Basin.
